**Preliminary Assessment for
Per- and Polyfluoroalkyl Substances (PFAS) Ault Field**

Naval Air Station Whidbey Island
Oak Harbor, Washington

November 2018

Prepared for NAVFAC Northwest
by CH2M HILL, Inc.
Bellevue, Washington
Contract N62470-16-D-9000
CTO 4041

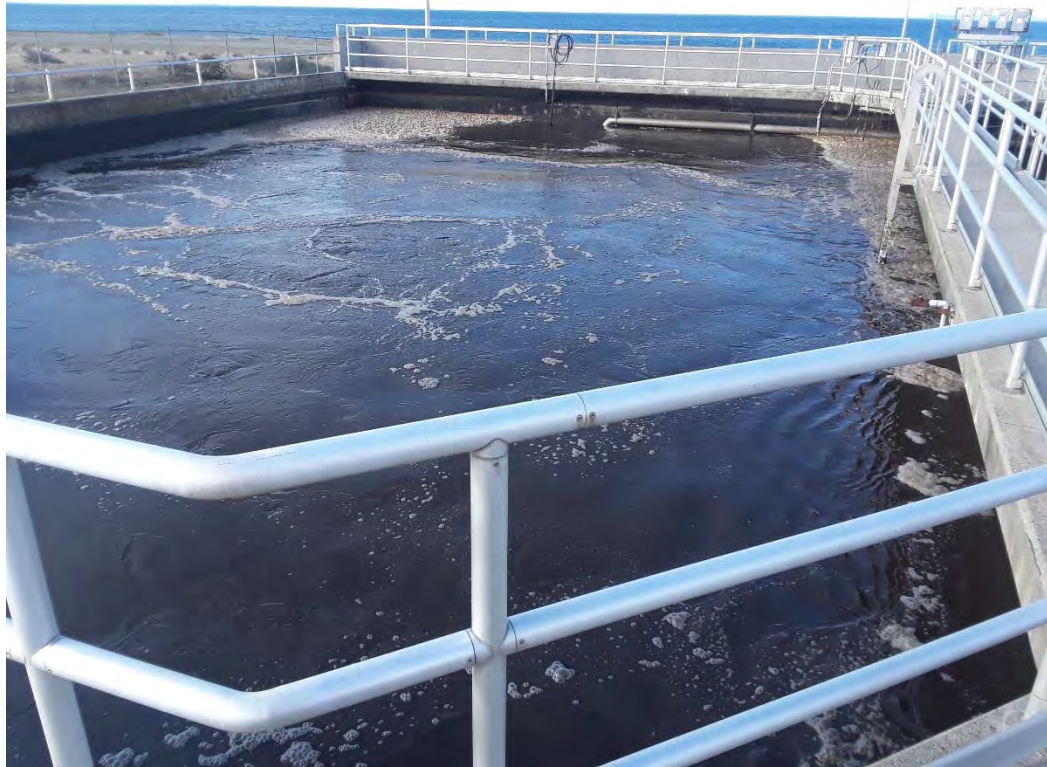
-Wastewater treatment pond (facing west)

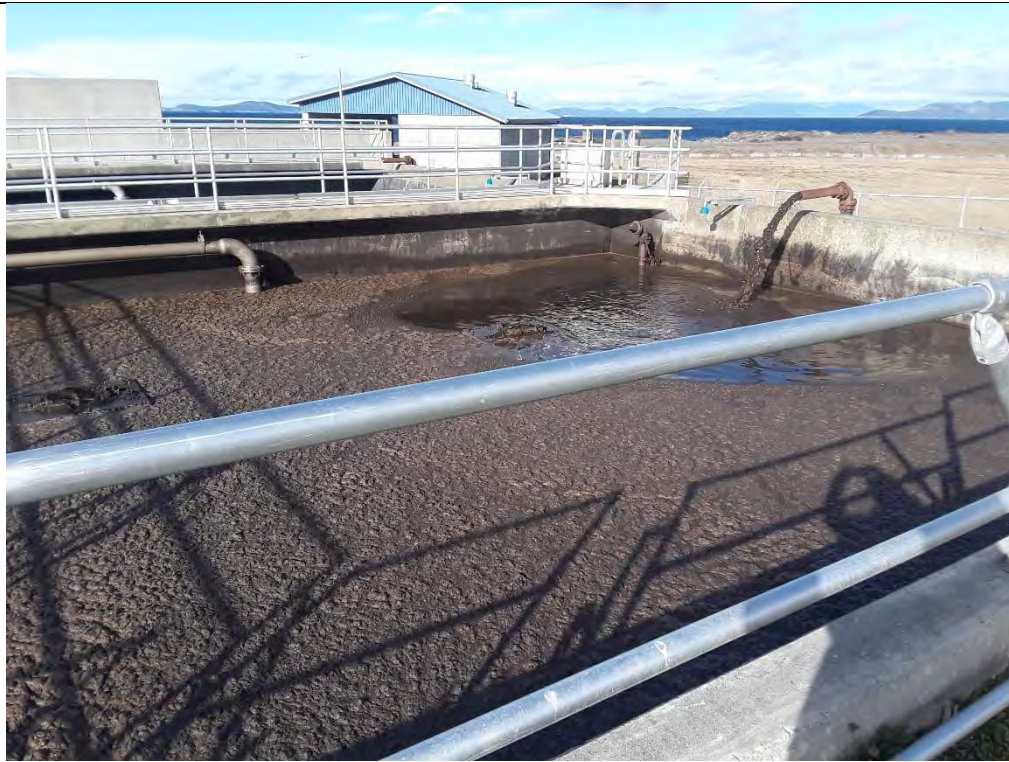
-Treatment pond (facing northwest)

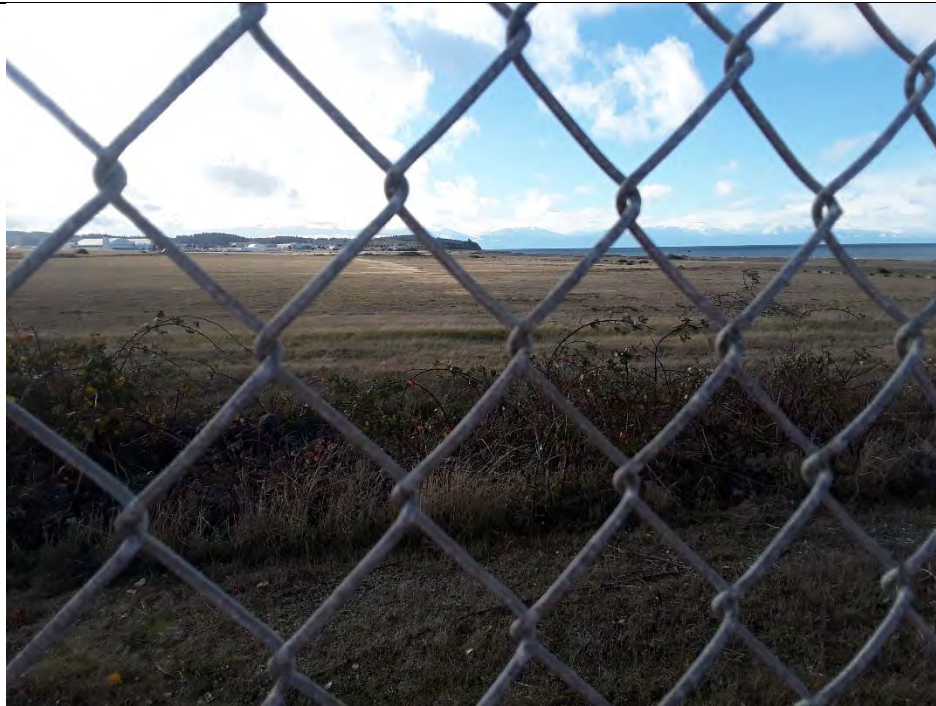
-Looking through fence at Former Sewage lagoons, couldn't get on other side of fence since it is too close to flight line (facing southwest). Extent of former ponds is visible through abrupt elevation changes around the edges.

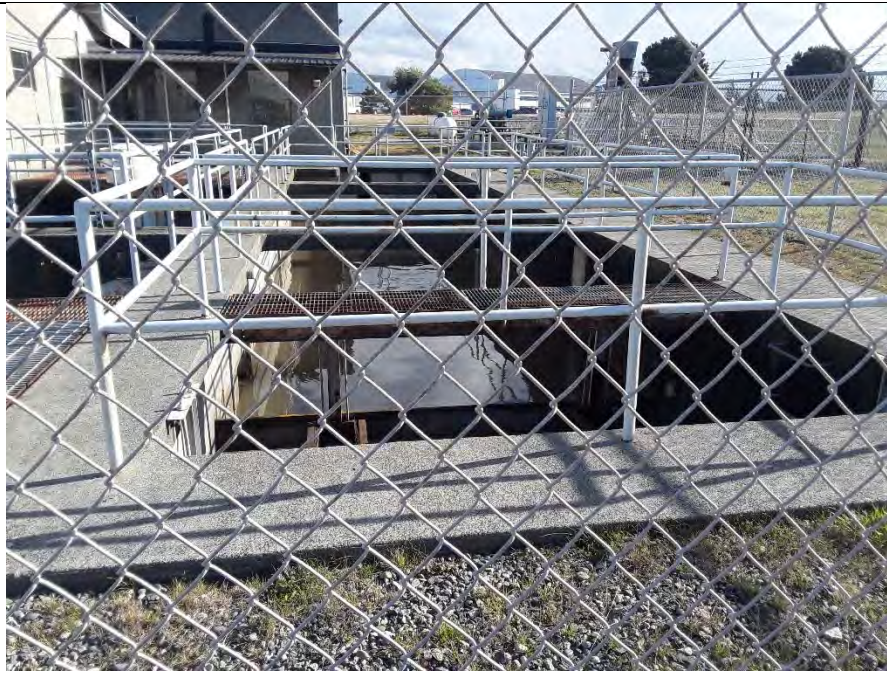
-Confirmed this to be one of the two clarifier tanks holding AFFF-contaminated water (approximately 60,000 gallons in this tank-Scott Lenke) (facing east)

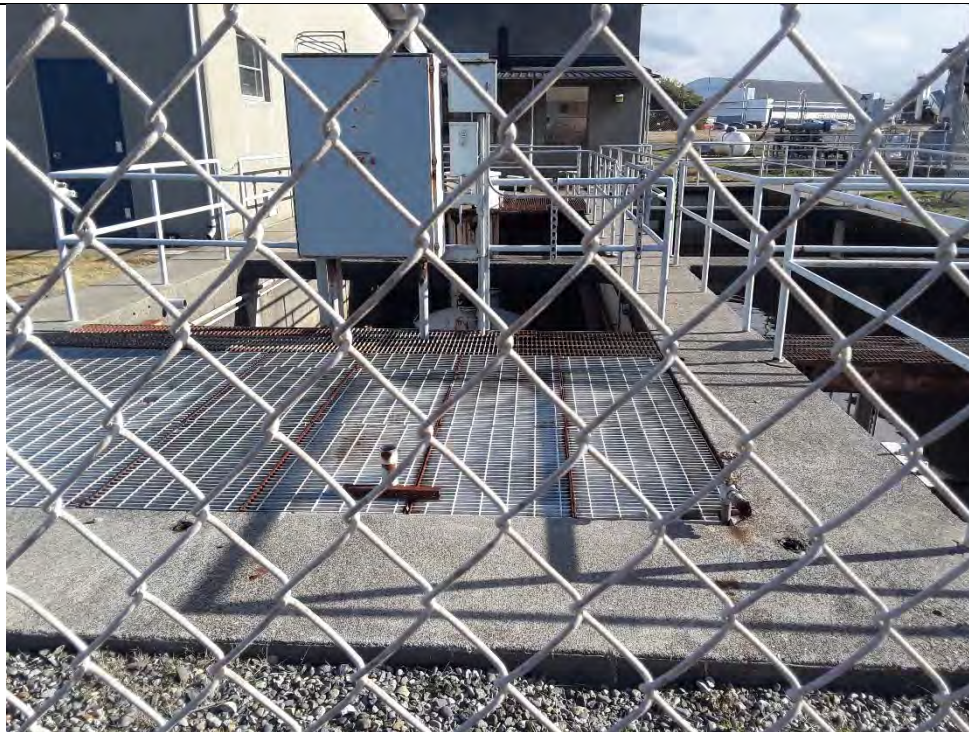
-Confirmed to be the second clarifier tank holding AFFF-contaminated water (approximately 20,000 gallons-Scott Lenke)

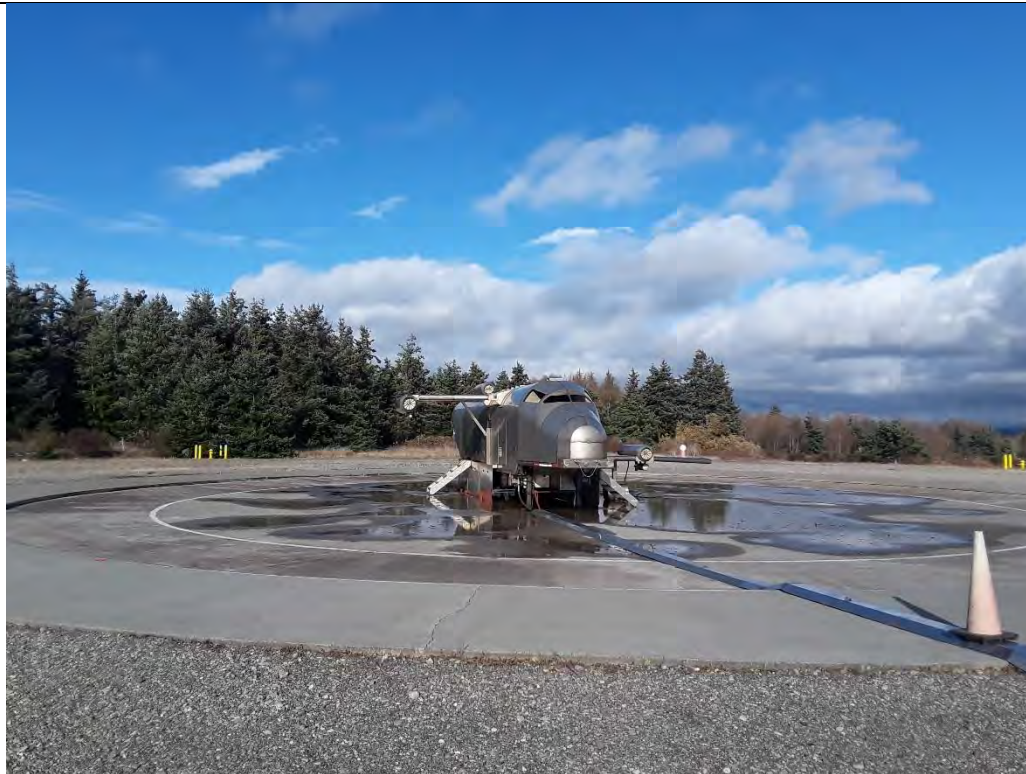
-Current fire training pit and mock aircraft (facing northwest)

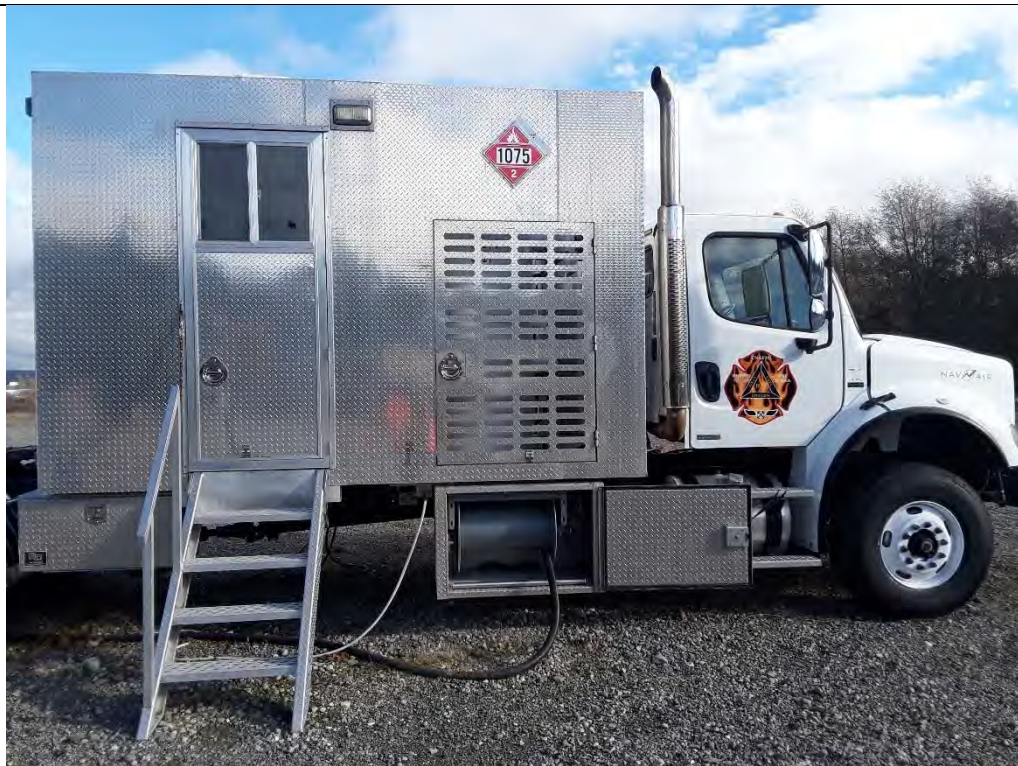
-Propane truck connected to mock aircraft (propane used since 2007)(facing east)

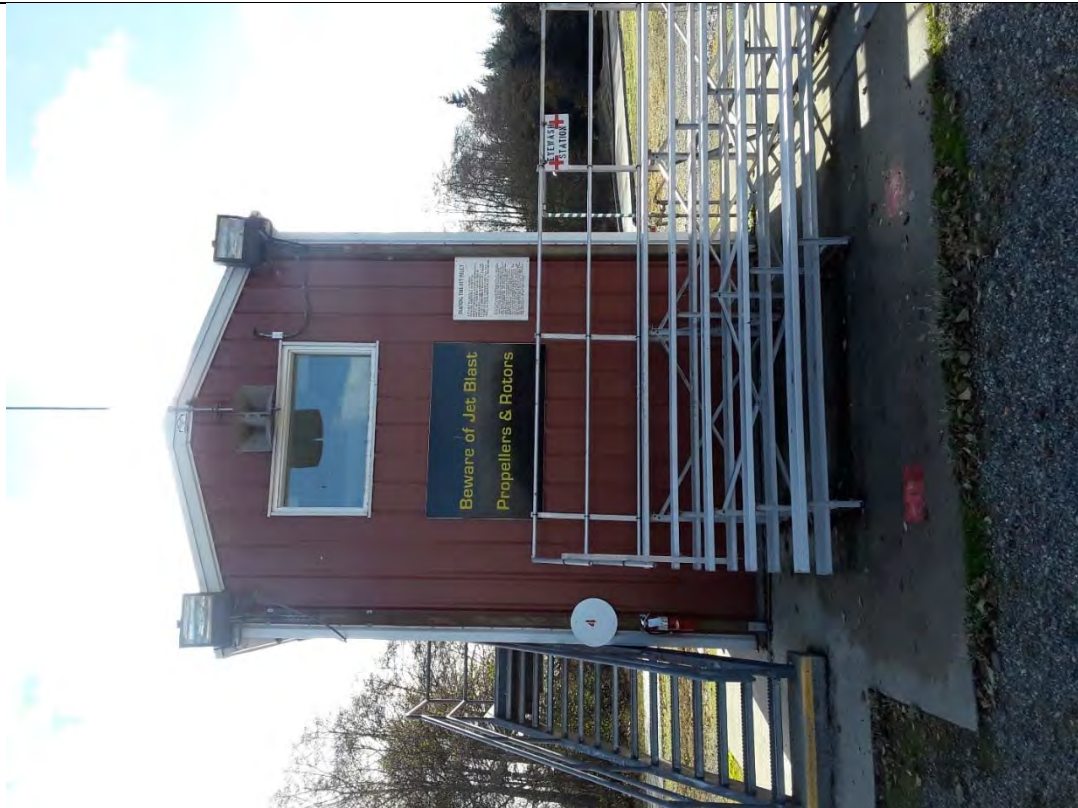
-Control tower for fire training area (facing southeast)

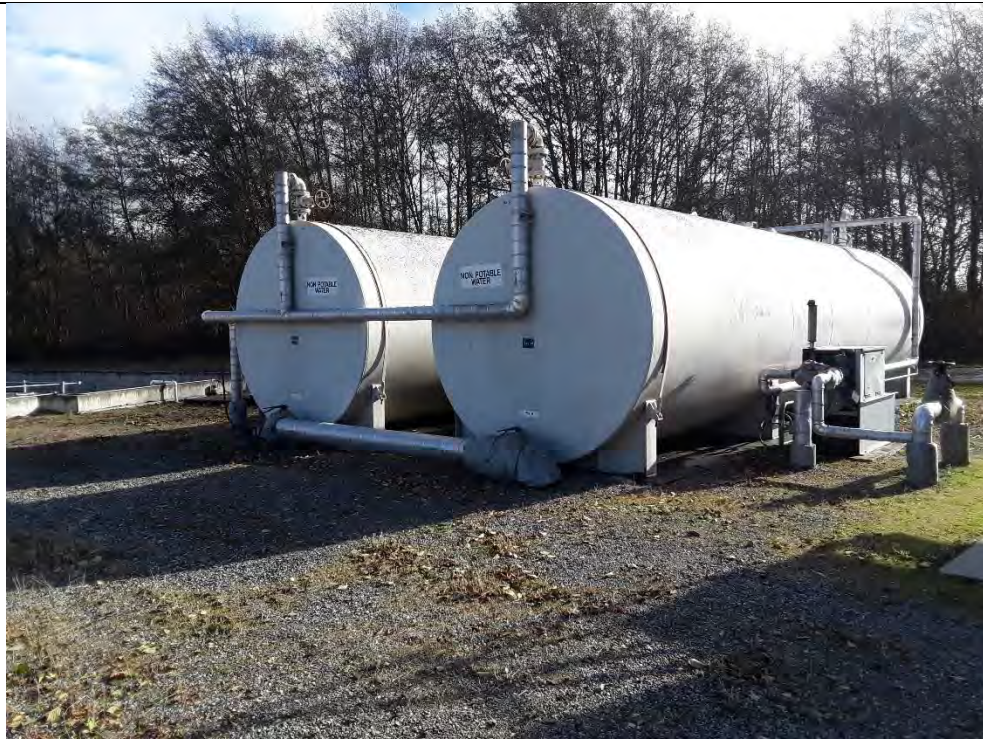
-Water storage tanks (all water used onsite is stored and recycled) (facing southeast)

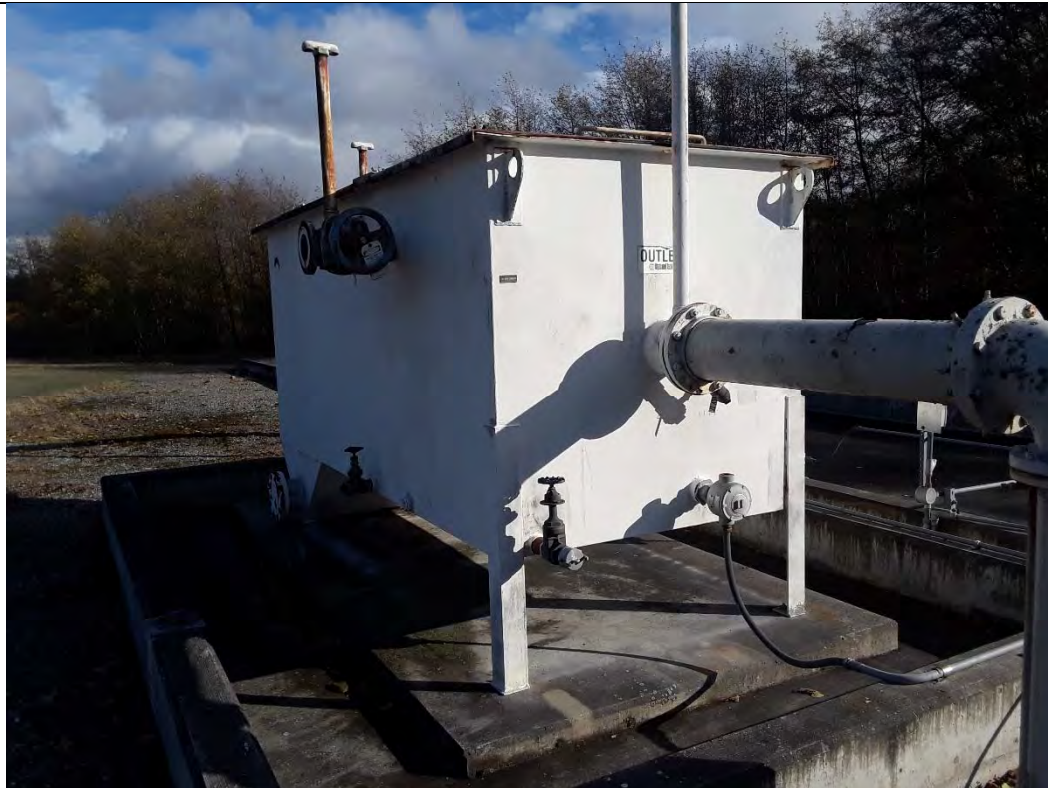
-Aboveground oil/water separator (facing southeast)

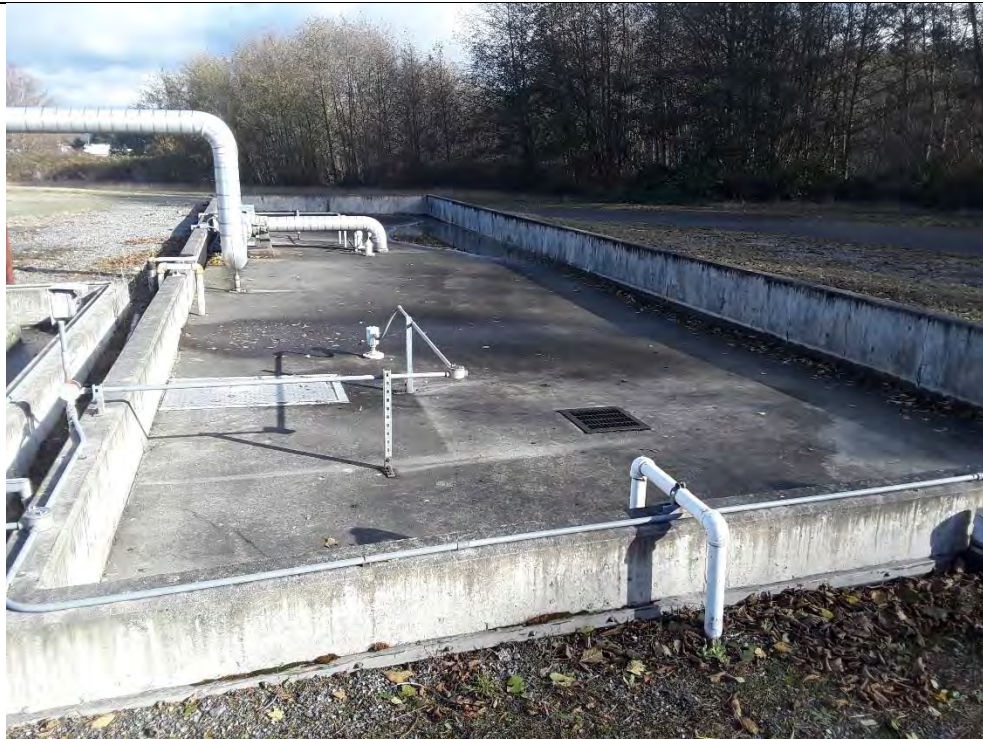
-Detention pond – water was stored here prior to entering oil/water separator (facing east)
