**Preliminary Assessment for  
Per- and Polyfluoroalkyl Substances (PFAS)**

Naval Base Kitsap Bangor and  
Associated Special Areas  
Silverdale, Washington

December 2020

Prepared for NAVFAC Northwest  
by CH2M HILL, Inc.  
Seattle, Washington  
Contract N62470-16-D-9000  
CTO N4425518F4117 (4117)

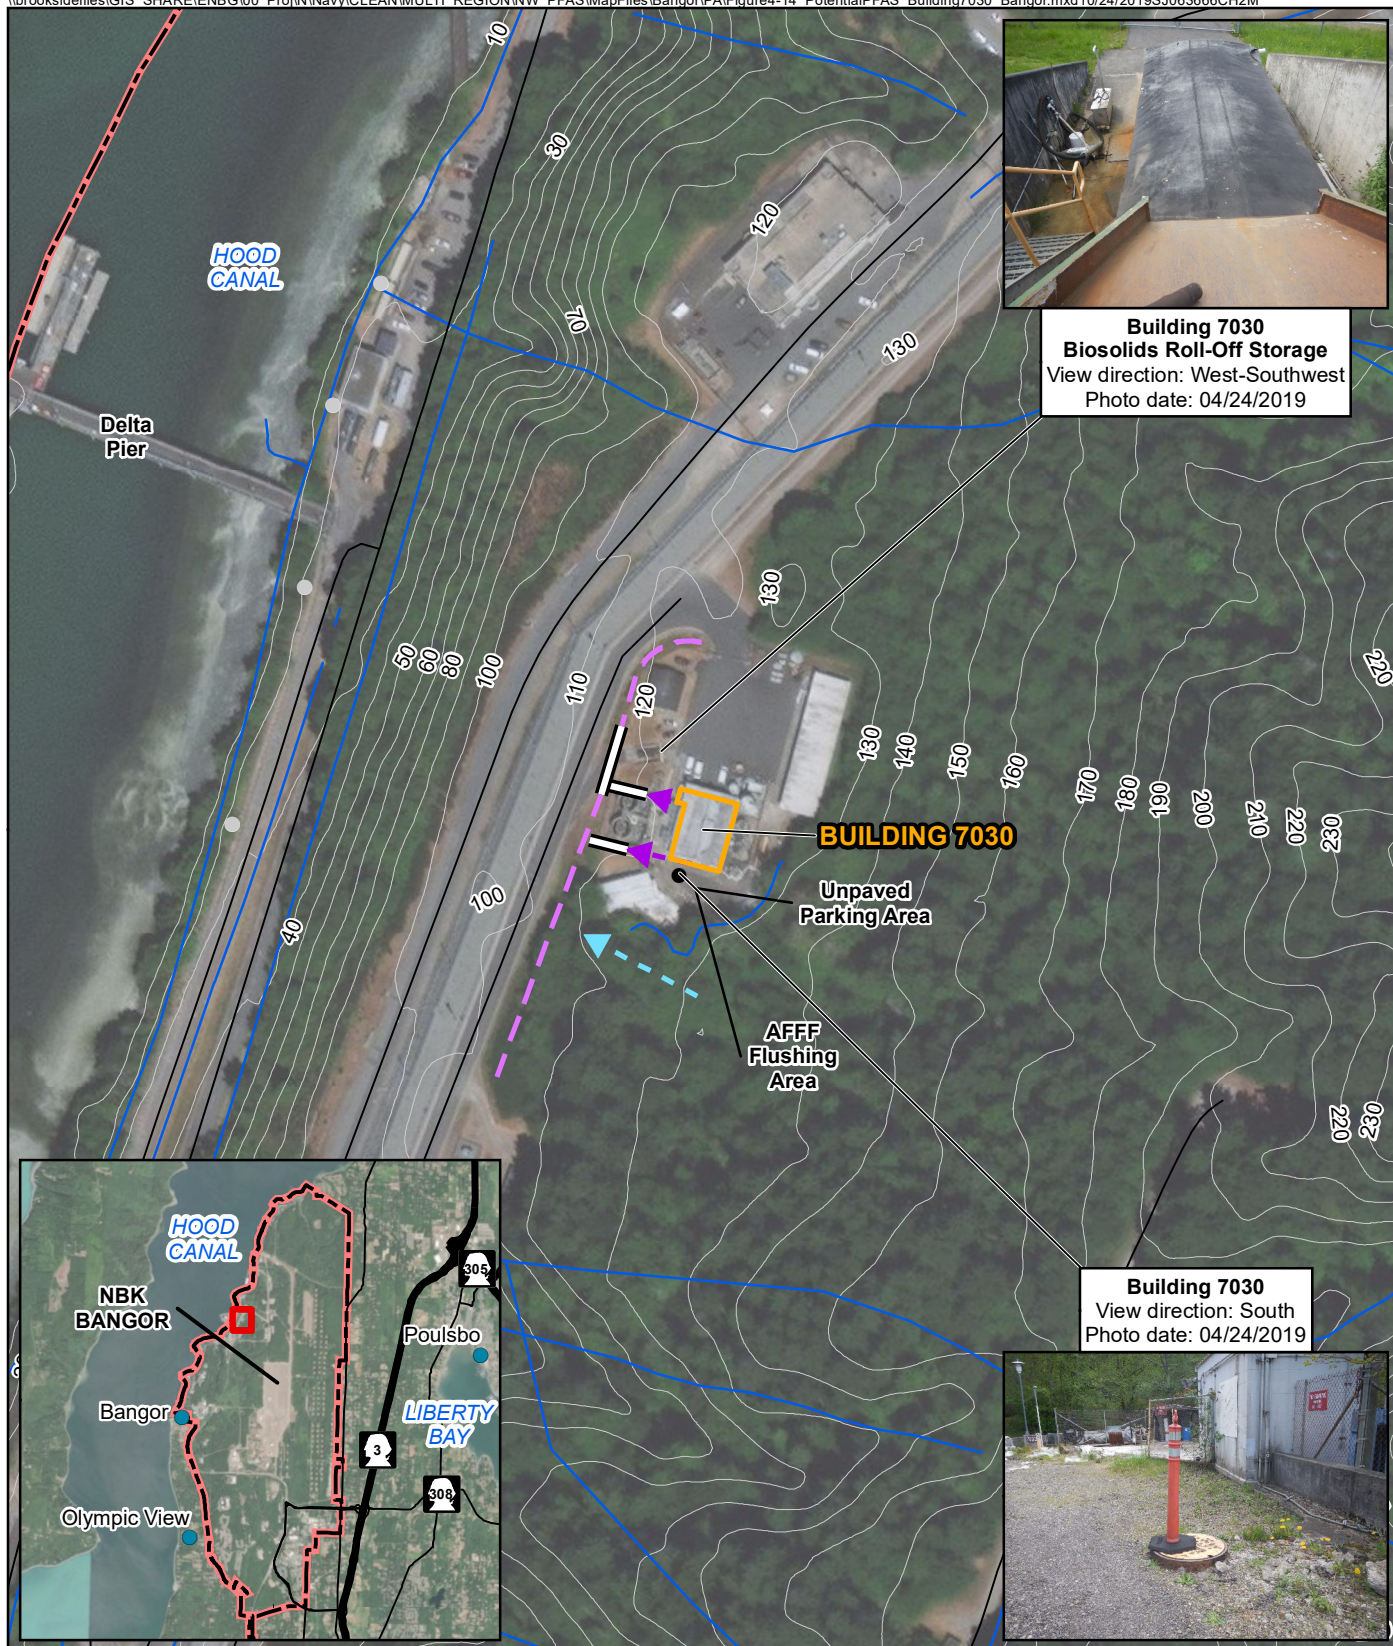
**Figure 4-14**  
Potential PFAS Source Area: Building 7030  
Preliminary Assessment for PFAS  
NBK Bangor, Silverdale, Washington

Area	Potential PFAS Source Area (Yes/No)	Rationale
<b>Wastewater Treatment Plants and Associated Disposal Areas<sup>6</sup></b>		
Building 7030	Yes	Building 7030 is located on Runner Road, east of Delta Pier ( <b>Figure 4-4</b> ) and is used as an industrial waste treatment facility. Industrial waste from a variety of sources is treated at Building 7030. AFFF was stored at this location and trickled into the treatment system from a manhole to the south of Building 7030. See <b>Section 4.3.12</b> for additional information and <b>Section 5</b> for the recommended path forward.
Former Wastewater Lagoon (Site F)	No	The Former Wastewater Lagoon at Site F is located west of Trigger Avenue in central NBK Bangor ( <b>Figure 4-3</b> ). Site F was used between approximately 1960 and 1970 for the disposal of wastewater produced during the demilitarization of ordnance items in the adjacent Segregation Facility building. The site consisted of an approximately 300-square-foot unlined evaporation lagoon and overflow area. Prior to 1972, the final wastewater solution was discharged through a drain line directly into the former wastewater lagoon. Periodically the lagoon was drained, and waste materials at the surface were burned off in place with waste oil during the 1960s or transported to Site A for burning and disposal (Hart Crowser, 1994). The method in which the lagoon was drained is not known. Beginning in 1972-1973 wastewater was collected into 55-gallon barrels and delivered to the liquid waste incinerator. The lagoon soil contamination, including Royal Demolition Explosive (RDX) fuel, 2,4,6-trinitrotoluene (TNT) fuel, and 2,6-dinitrotoluene (DNT) explosive, extends to the water table (approximately 50 feet below grade) (Navy, 2005). In February 1972, 500 cubic feet of soil were excavated from the top several feet of the former lagoon area and delivered to Site A for burning. In 1980 the former lagoon area was filled in and covered with asphalt. Currently a groundwater containment system is in place that is designed to hydraulically limit migration of groundwater contaminants within the Shallow aquifer by groundwater extraction. The extracted groundwater is treated by granular activated carbon for ordnance and includes treatment for nitrates to achieve all groundwater cleanup action levels. The treated water is returned to the Shallow aquifer through reintroduction wells (Hart Crowser, 1994). There is no documentation of releases, emergency response activities, or spills associated with AFFF or PFAS-containing materials at Site F. Therefore, no further action is required for this area.

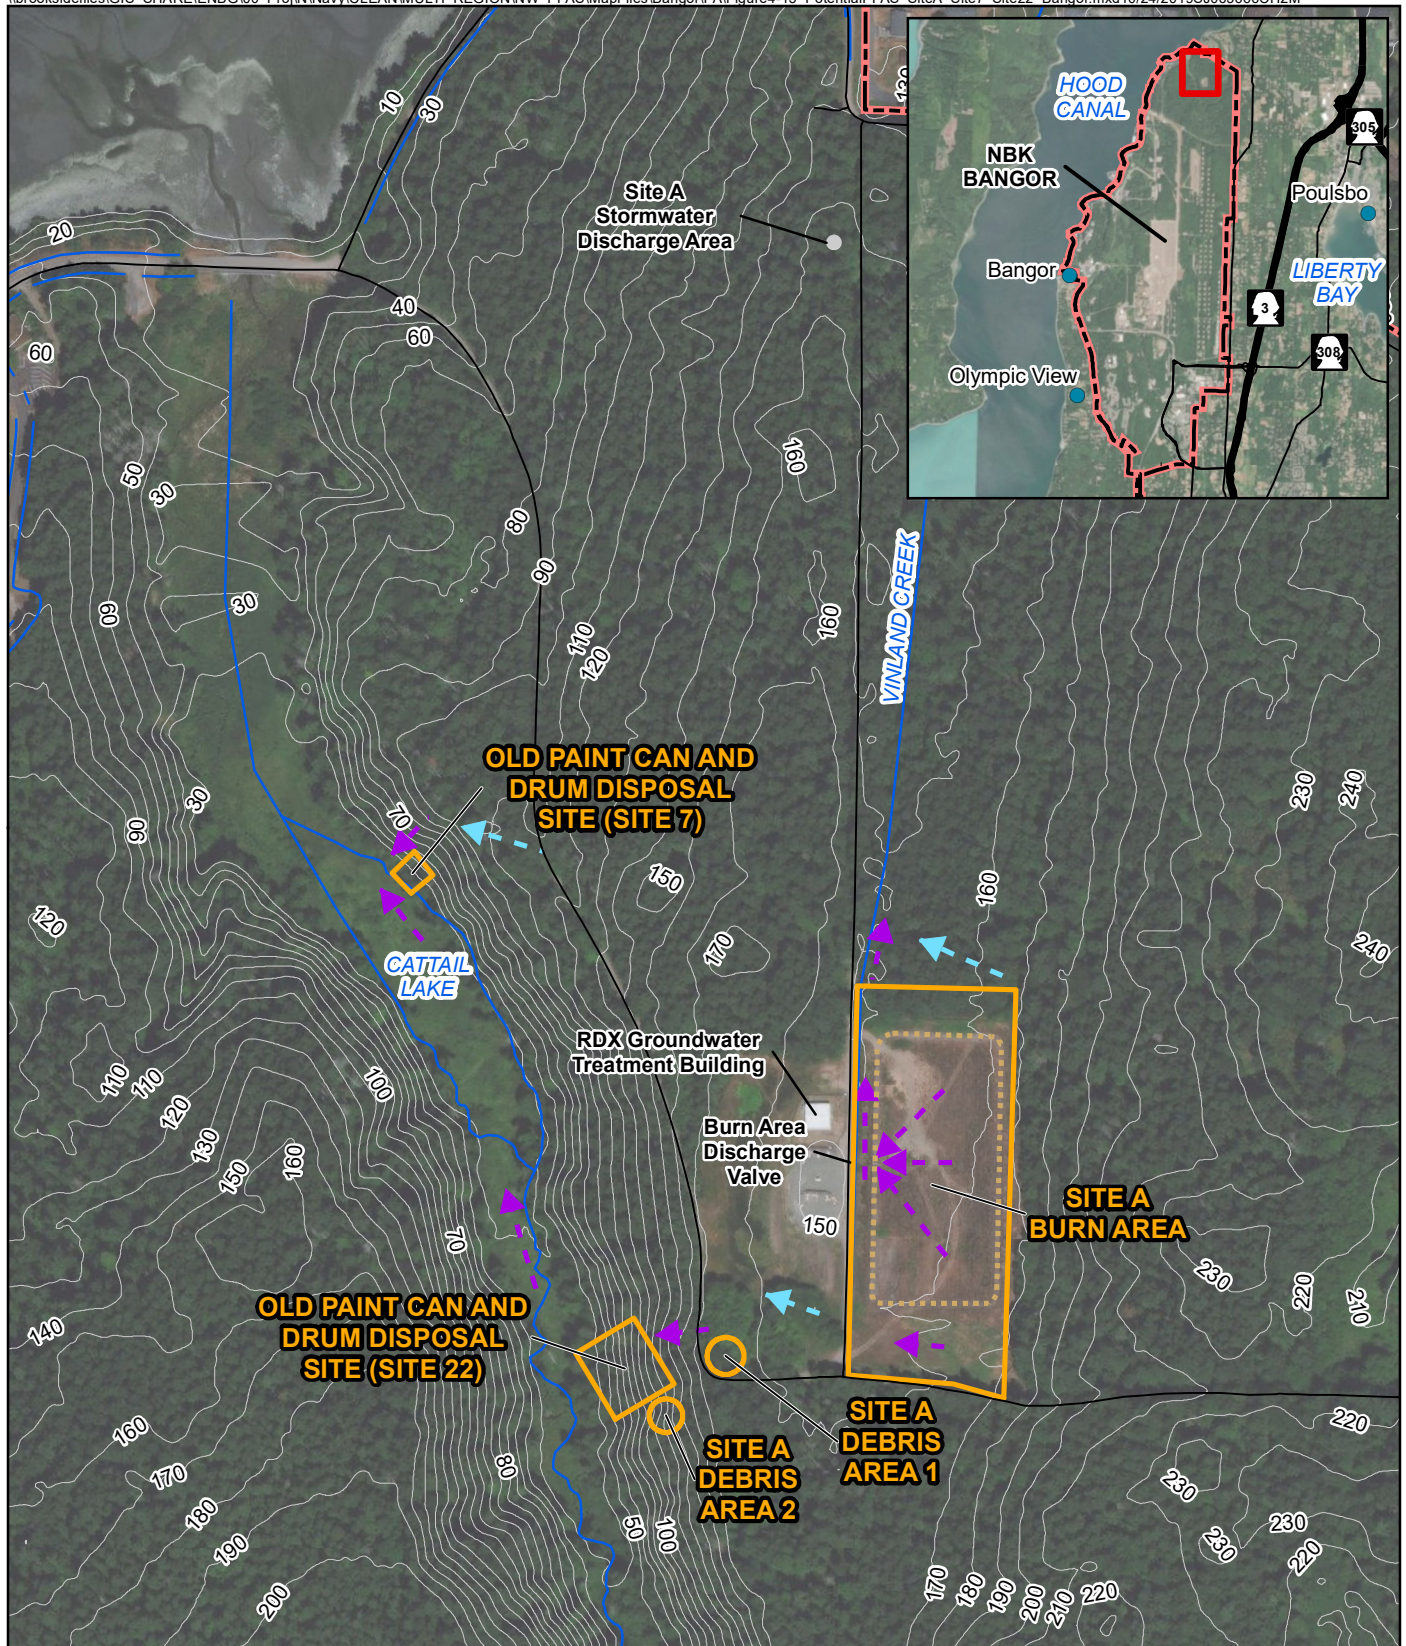
**Figure 4-15**  
Potential PFAS Source Area:  
Site A, Site 7 and Site 22  
*Preliminary Assessment for PFAS*  
NBK Bangor, Silverdale, Washington

<b>Landfills and Waste Disposal Areas</b>		
Site A	Yes	Site A is located on an elevated plateau surrounded by dense timber on the northern edge of NBK Bangor at the intersection of Pintado Road and Tinosa Road ( <b>Figure 4-4</b> ) (The Environmental Company Inc., 2002). Site A occupies 12 acres and consists of a historical 7-acre burn area, Debris Areas 1 and 2, and a stormwater discharge area. AFFF was released in the flat open area at Site A. See <b>Section 4.3.13</b> for additional information and <b>Section 5</b> for the recommended path forward.
Dunnage Canyon (Site 12)	Yes	Dunnage Canyon is an approximately 5-acre ravine area that served as a disposal site from about 1950 into the late 1970s ( <b>Figure 4-4</b> ). Dunnage Canyon was used as a disposal site during the time in which AFFF was used at NBK Bangor. See <b>Section 4.3.14</b> for additional information and <b>Section 5</b> for the recommended path forward.
