Completion Report for NARL Utqiagvik

PREPARED FOR: Gordon Brower/North Slope Borough
COPY TO: Kendra Leibman/NAVFAC NW
PREPARED BY: CH2M
DATE: April 11, 2018
PROJECT NUMBER: 679580
NORTH SLOPE BOROUGH PERMIT NUMBER.: 18-364

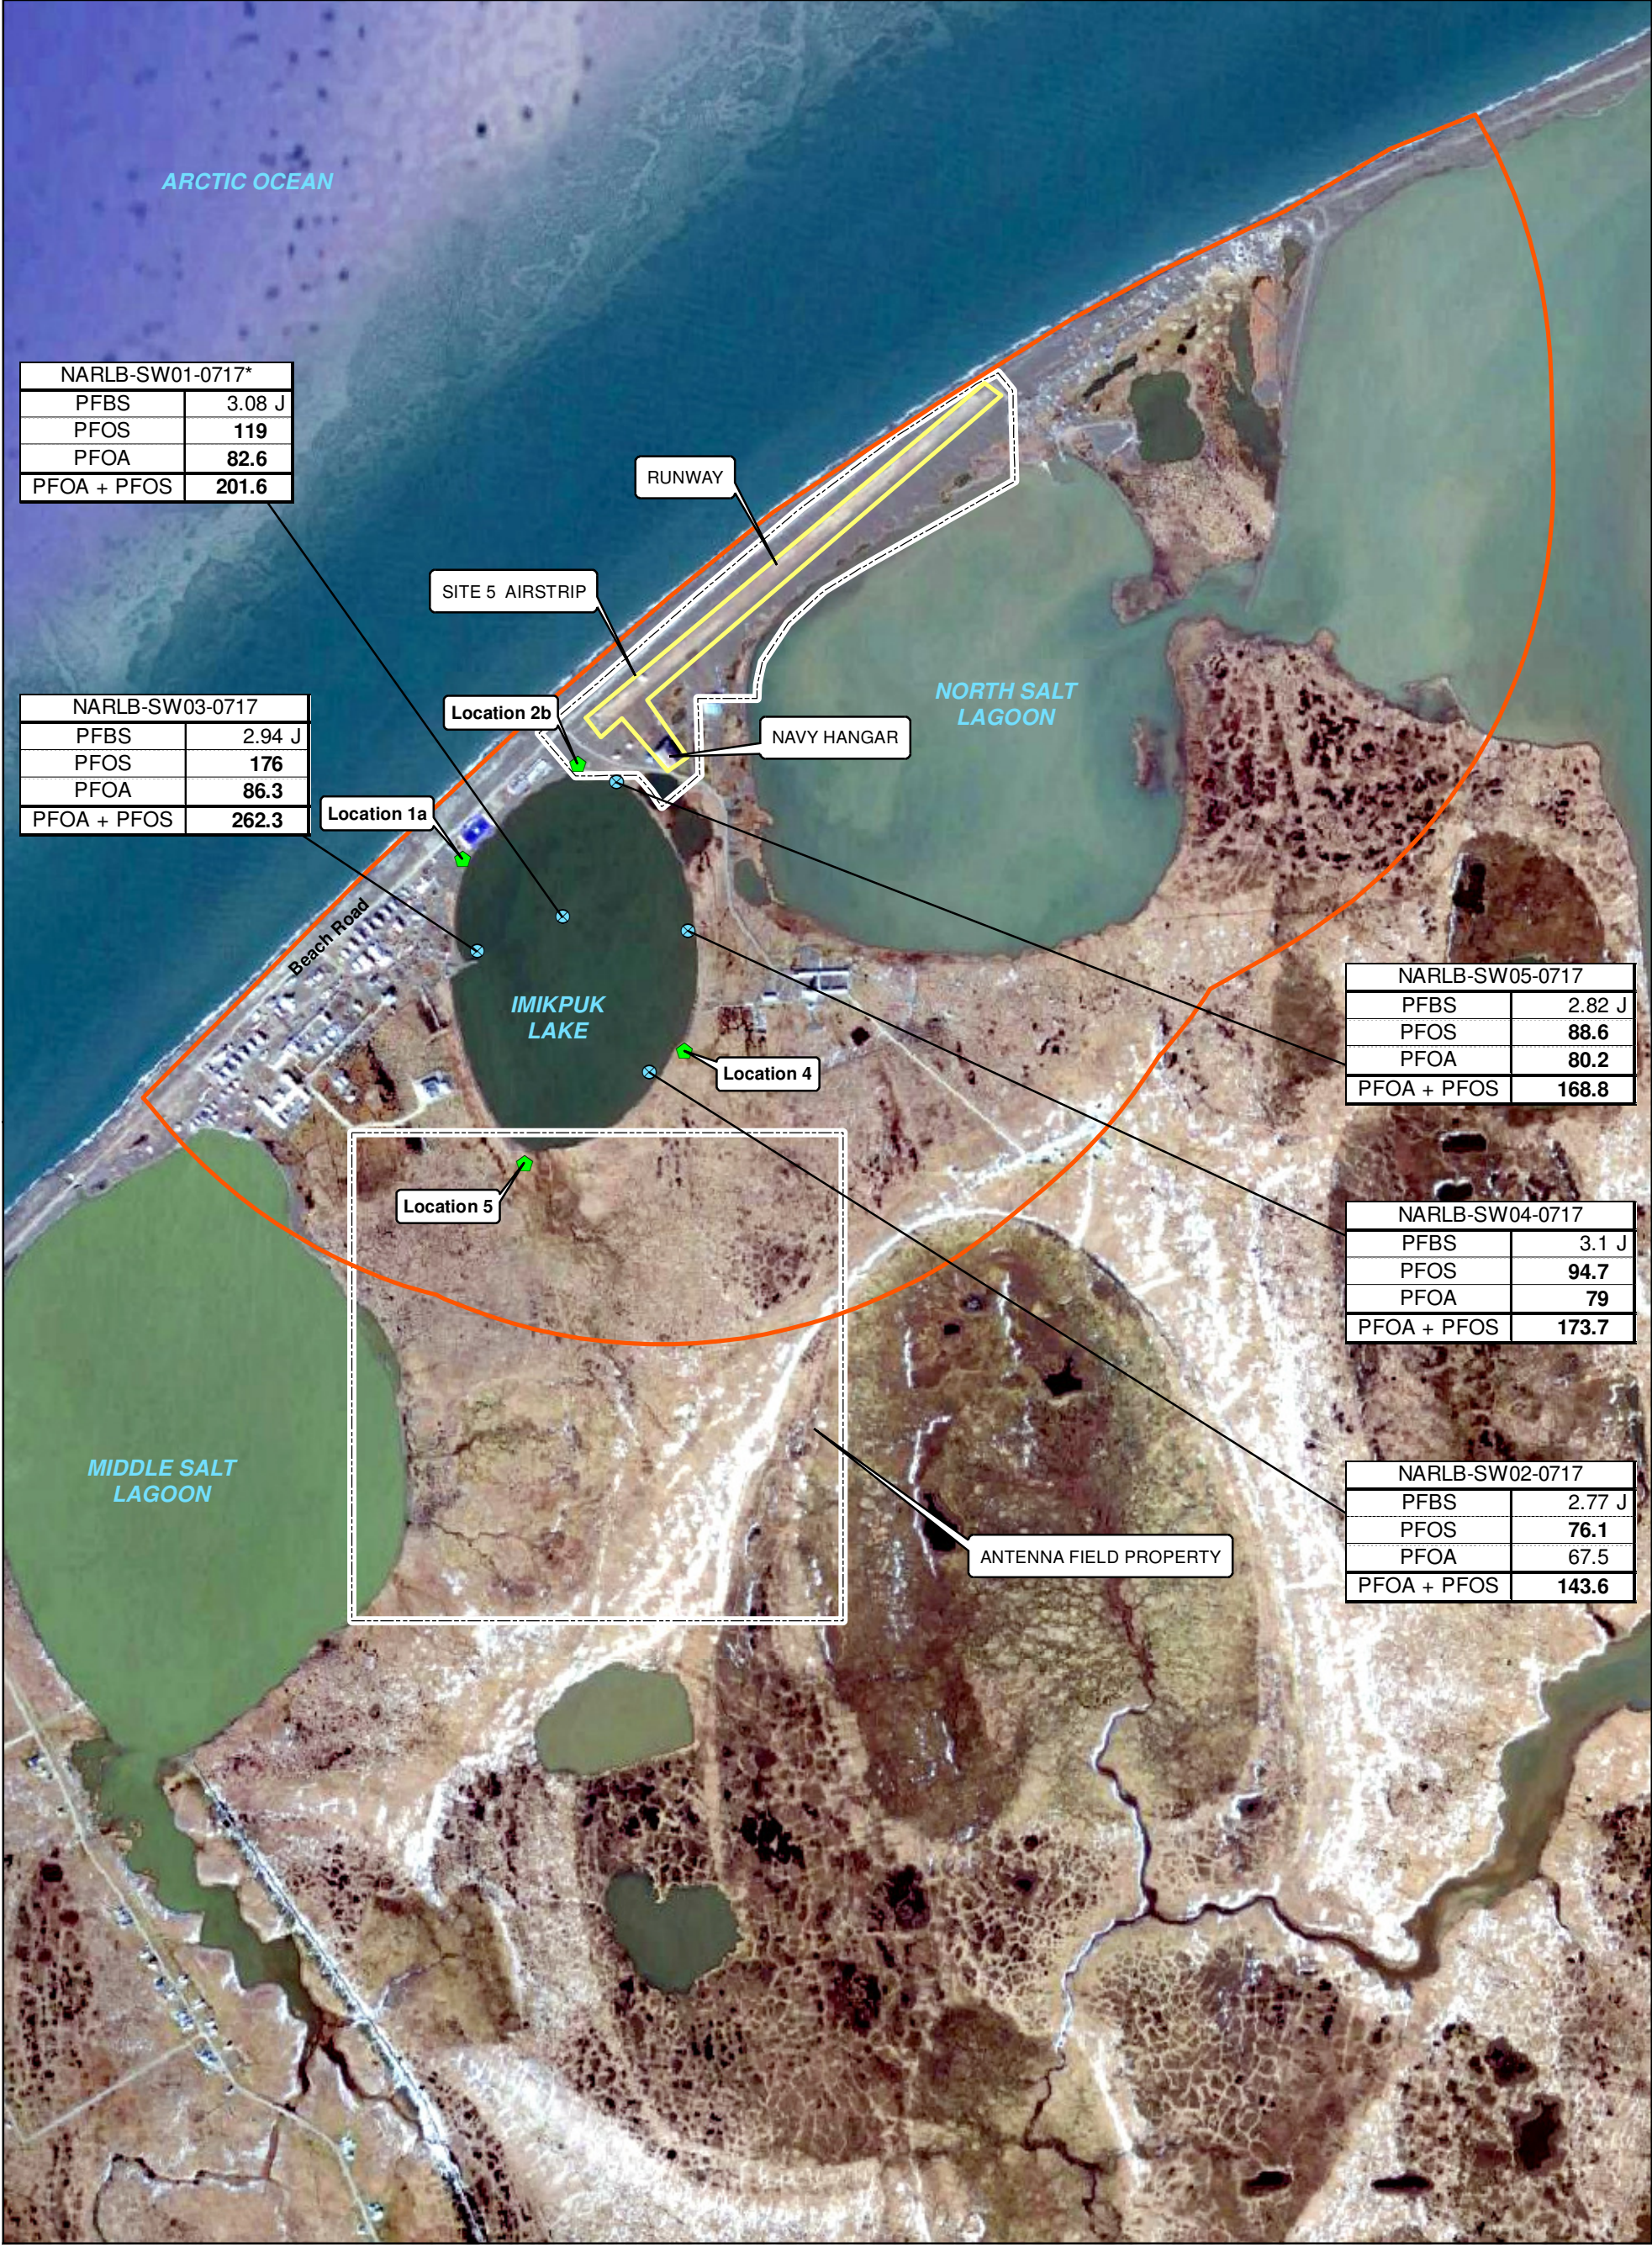
Figure 2
Site Map
Naval Arctic Research Laboratory
Utqiagvik, Alaska

From March 7 to 8, 2018, utility clearance was performed at three (3) of the planned sign installation locations (Figure 2). Planned Locations 1 and 2 were covered by snow push piles from road clearing activities, so these locations were moved. Utility clearance was also performed at these two (2) revised locations, renamed Locations 1a and 2b. Utility clearance was performed by clearing transects at each location with a ground penetrating radar (GPR) unit and a Rigid SeekTech SR-60 utility locator. At Locations 4 and 5, manual snow removal was performed by shoveling snow along the path of the GPR transects. This was necessary because the GPR unit in use has a maximum penetration depth of approximately 6 feet. With the snow cover at these locations, the GPR could not penetrate to the planned total depth of the boreholes, so snow was removed to increase the GPR range to the total planned depth of the borings. Access to all locations on these dates was via Ski-doo Expedition Sport snow machine by the team’s bear guard, or on foot.

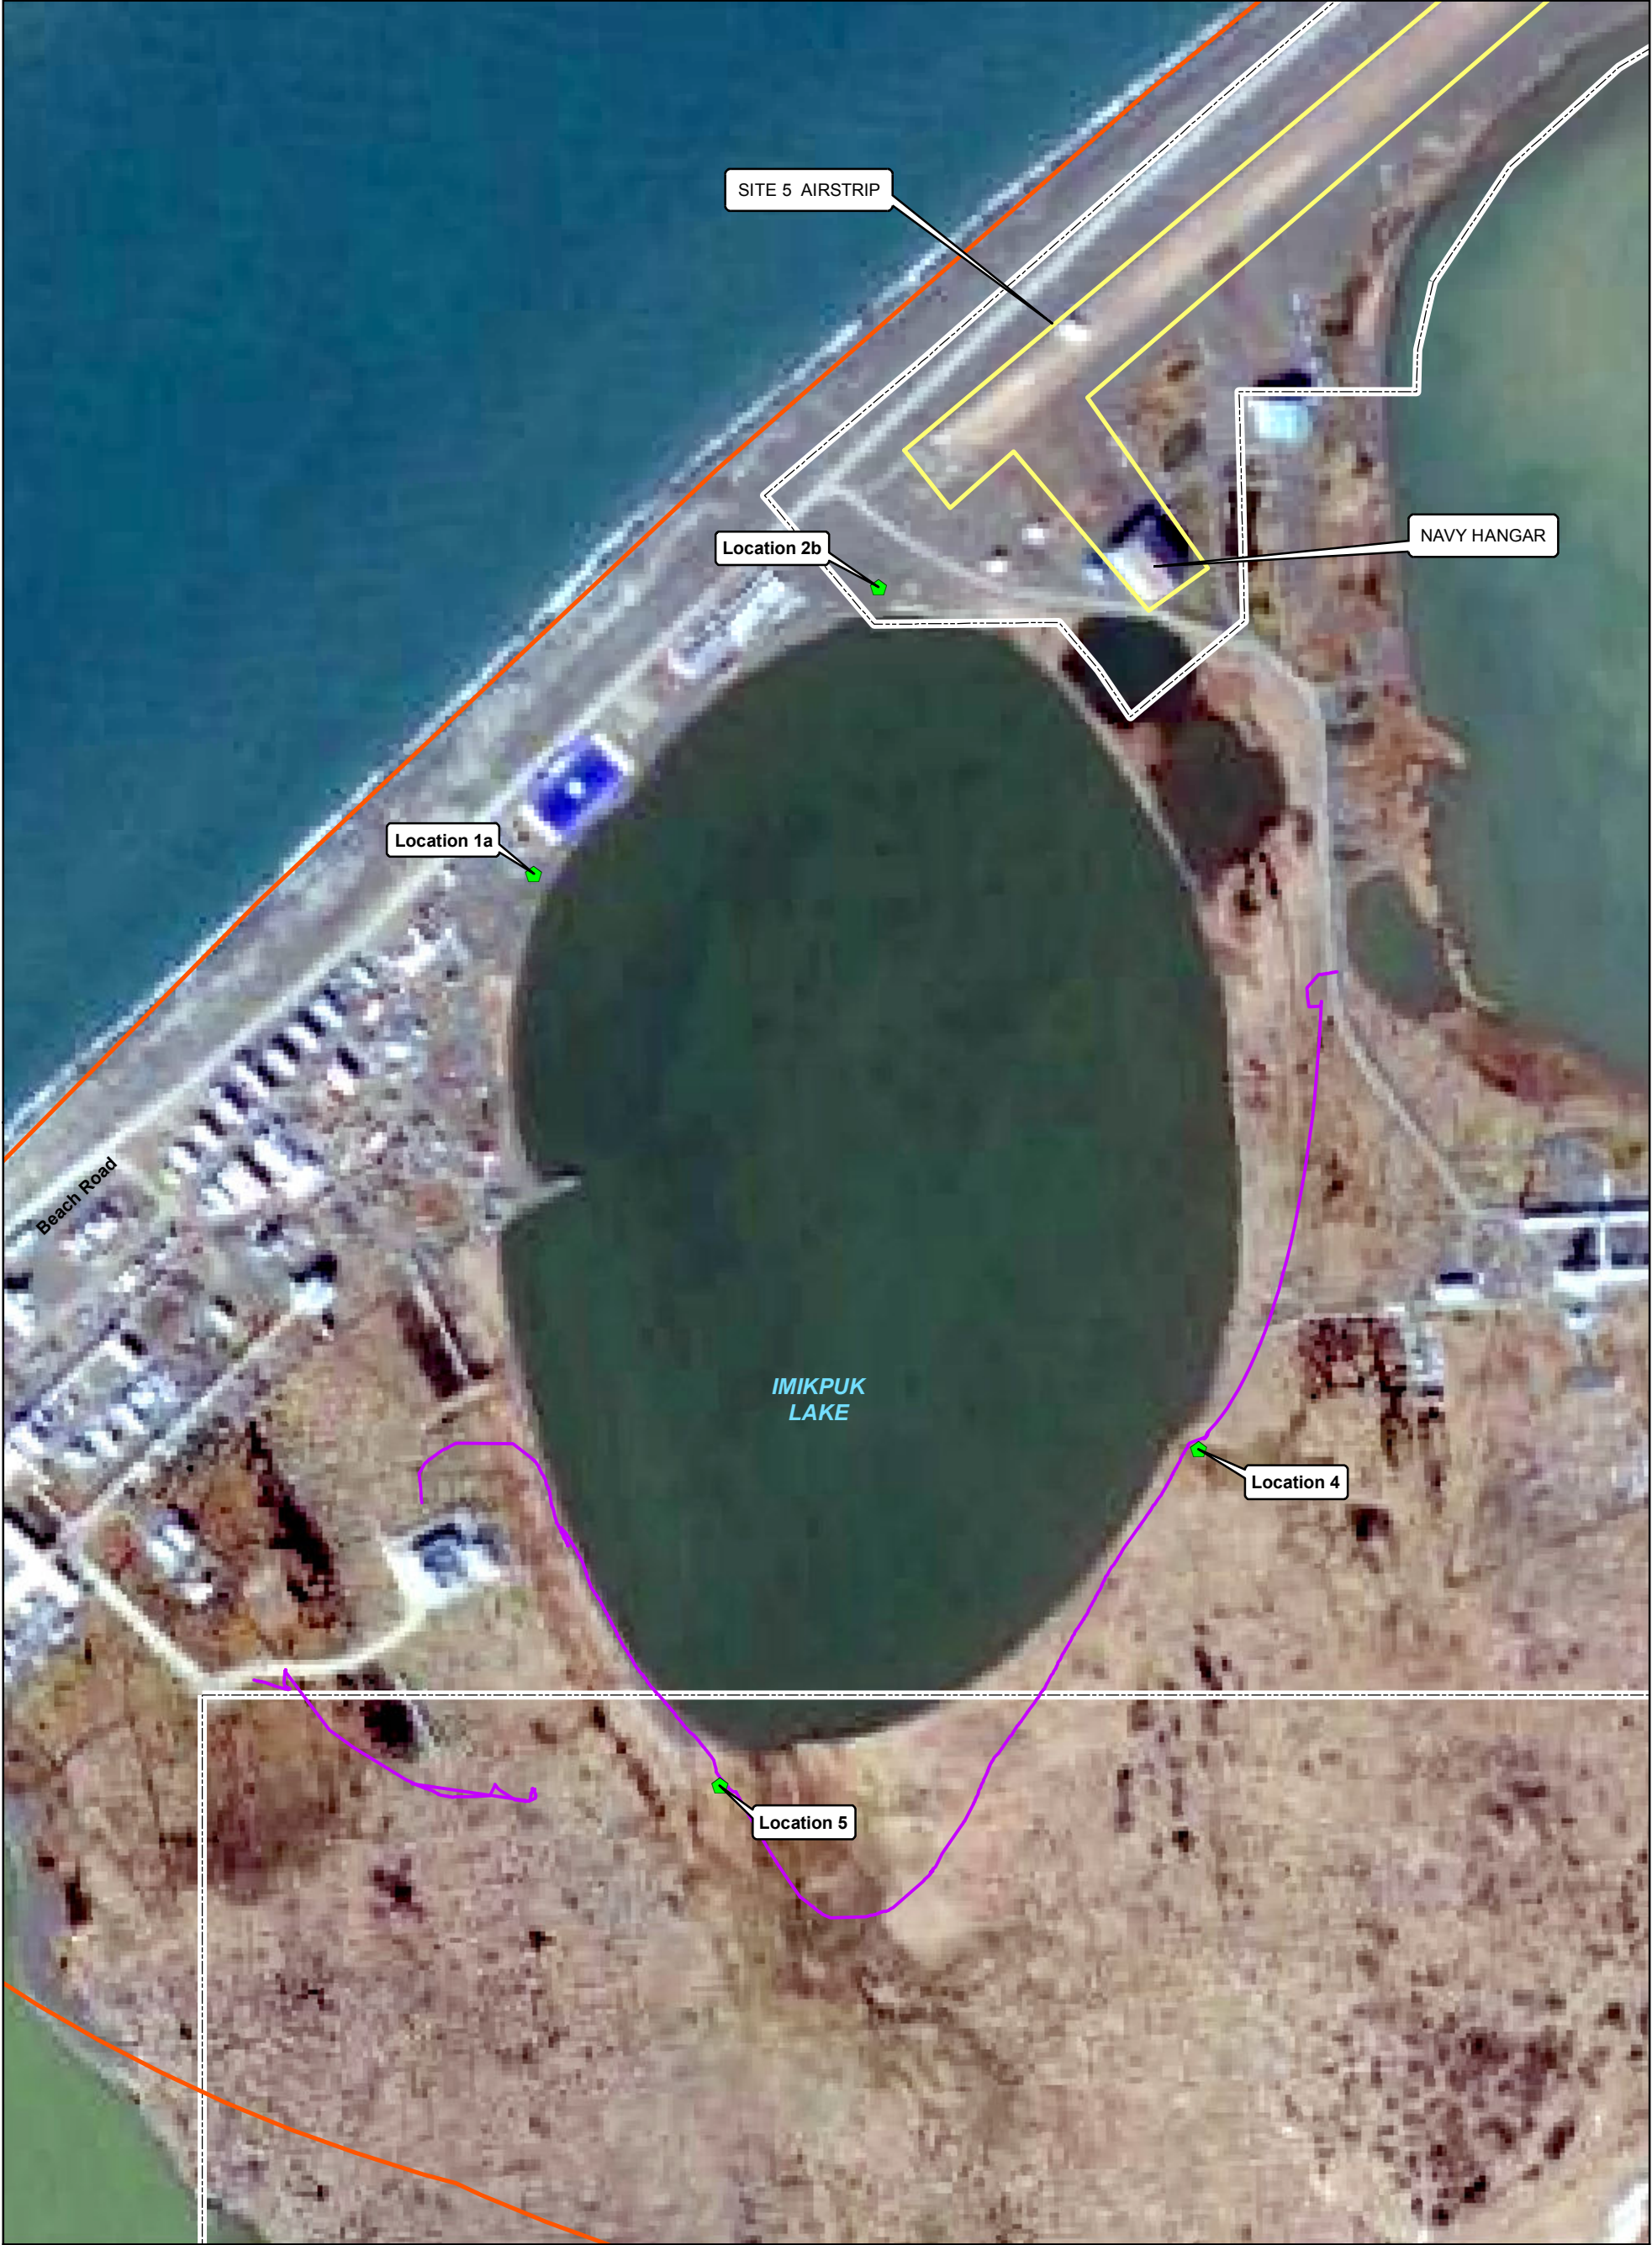
Figure 3
Routes of Tundra Travel
Naval Arctic Research Laboratory
Utqiagvik, Alaska

The drill rig accessed Locations 4 and 5 on the tundra from the UIC Science Building (Building 848) at NARL. The rig tracked from Building 848 to Location 5, continued across the tundra just south of the shoreline of Imikpuk Lake to Location 4, and then traveled from Location 4 to Dewline Road (Figure 3).

A first attempt was made to access Location 5 from the west side of Building 848, but this route was abandoned because drifted snow under overhead power lines south of the building prevented the drill rig from traveling under the powerlines to Location 5. The rig back-tracked along this travel route and then accessed Location 4 from the southeast side of Building 848. Borehole locations are listed in Table 1, and Figure 3 shows the locations and tundra travel routes, as well as the aborted travel route from the west side of Building 848. In addition to the drill rig, all locations were accessed on this date by the team's Bear Guard on a Ski-doo Expedition Sport snow machine.

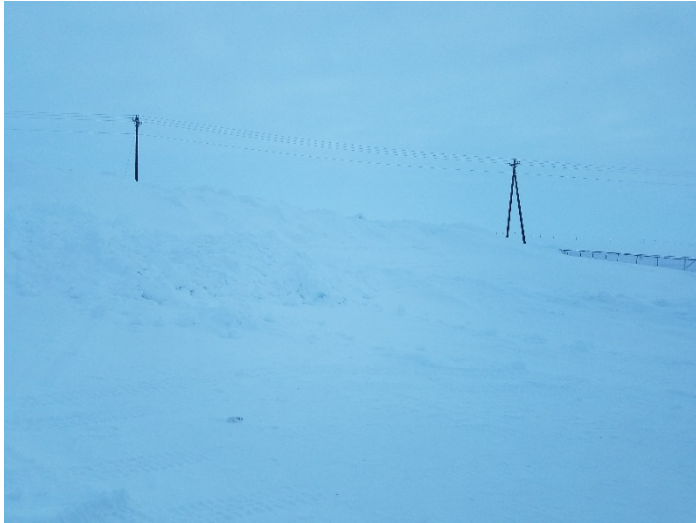
Snow push over planned Locatin 1 (Looking Southeast)
06 March 2018

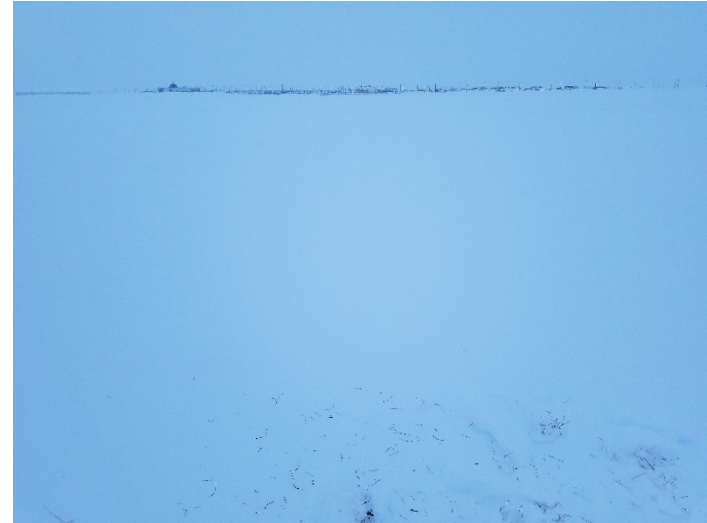
Pre-work conditions at Location 4 (Looking Northwest)
07 March 2018

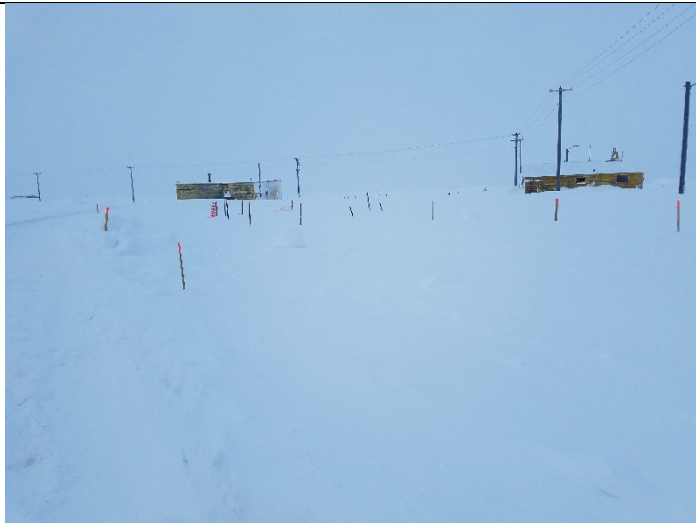
Pre-work conditions at Location 3 (Looking Northwest)
07 March 2018

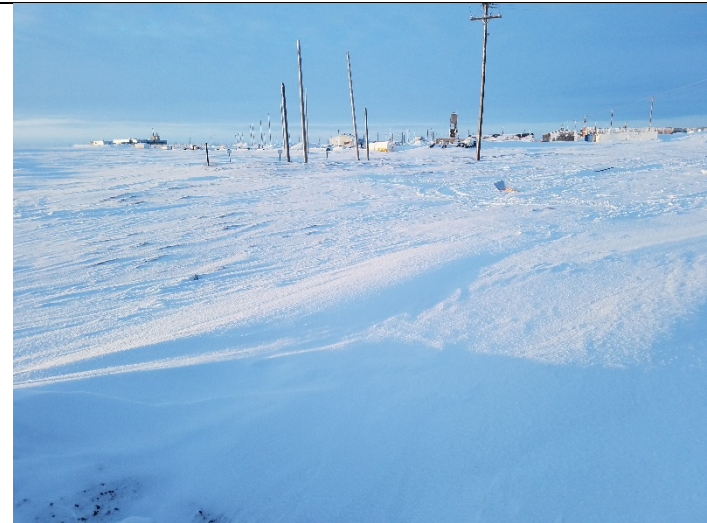
Pre-work conditions at Location 1a (Looking Northwest)
08 March 2018

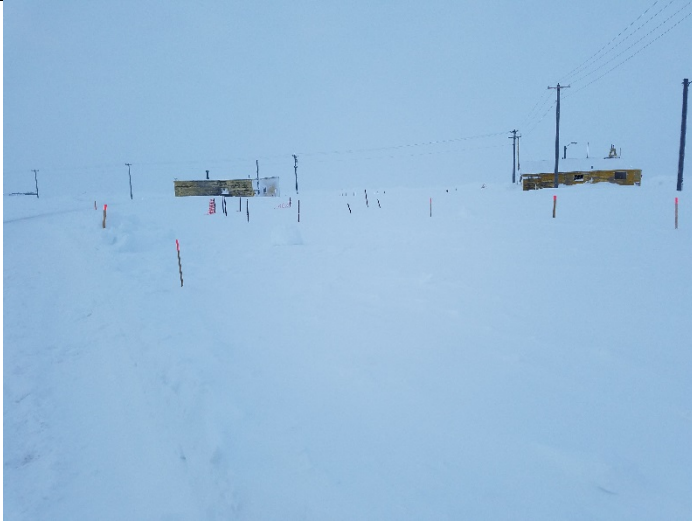
Pre-work conditions at Location 3 (Looking Northwest)
07 March 2018

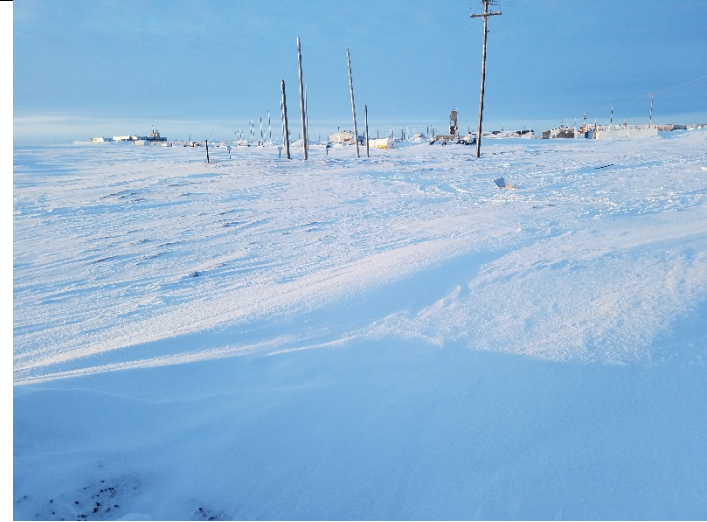
Pre-work conditions at Location 1a (Looking Northwest)
08 March 2018

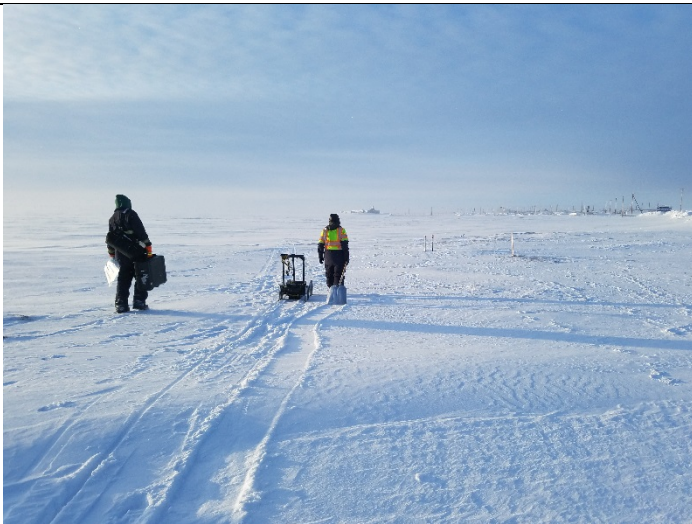
Pre-work conditions at Location 2b (Looking Southwest)
08 March 2018

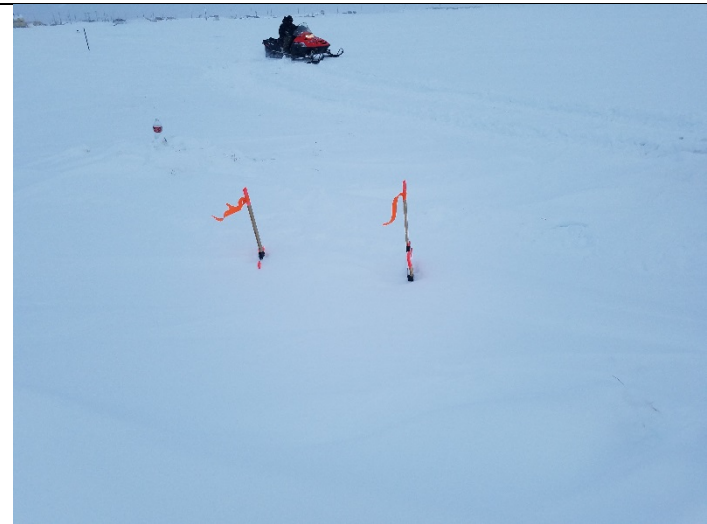
Pre-work conditions at Location 5 (Looking North)
13 March 2018

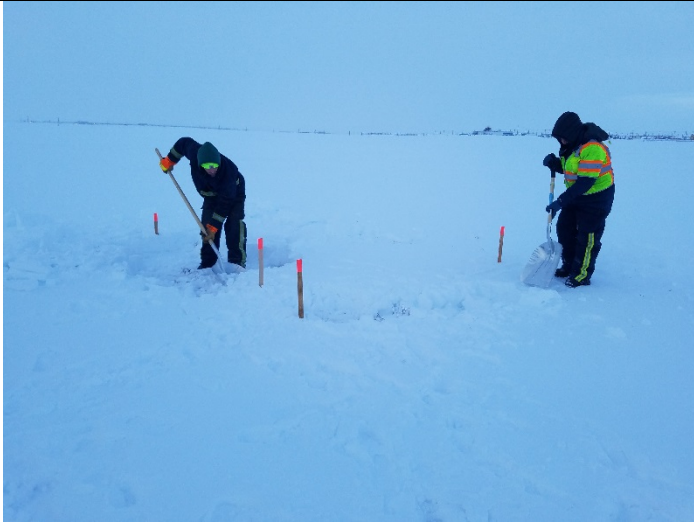
Clearing snow at Location 4 (Looking Northwest)
07 March 2018

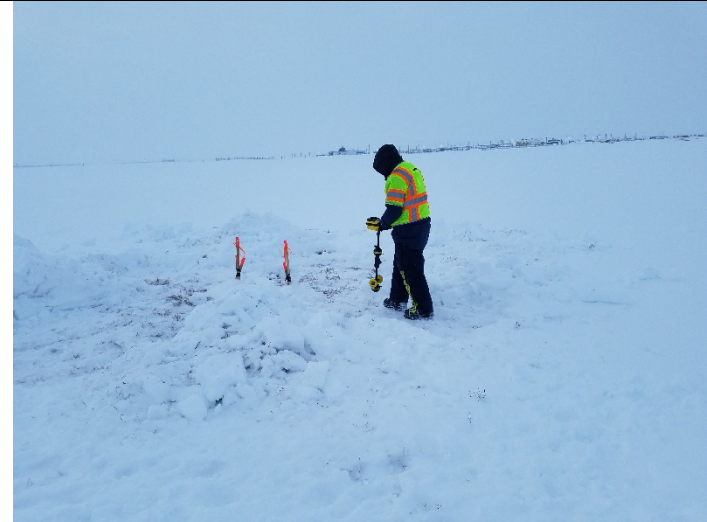
Using Utility Locator at Location 4 (Looking Northwest)
07 March 2018

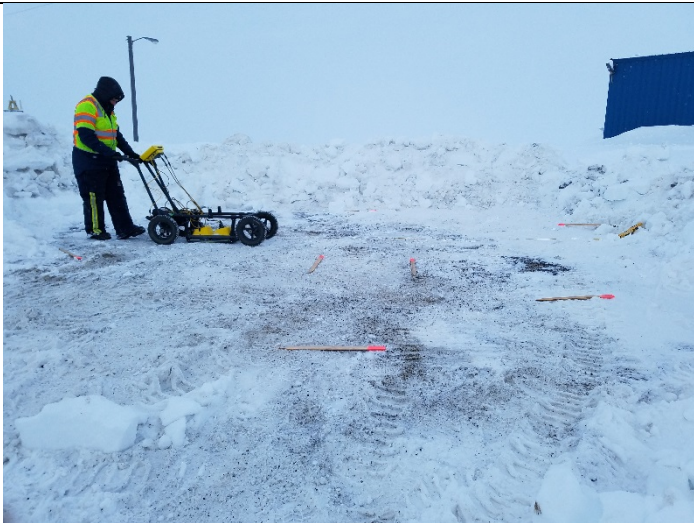
Performing GPR after clearing snow at Location 3 (Looking North)
08 March 2018

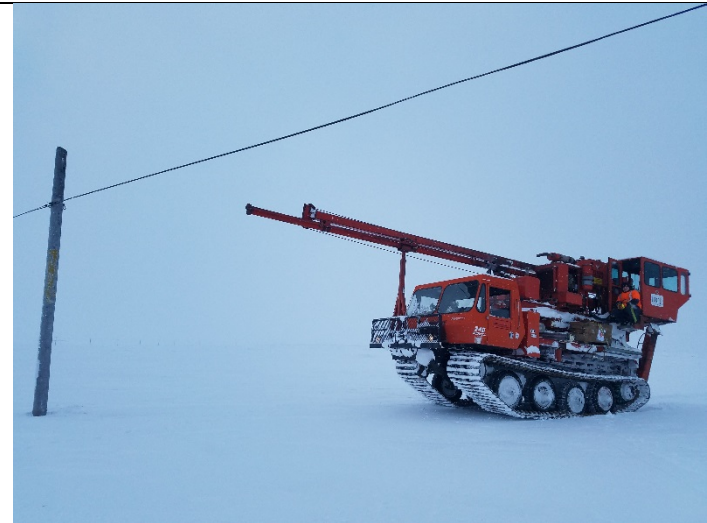
Nodwell rig, stopped by insufficient clearance under overhead power lines along original track to
Location 5 (Looking Southwest)
13 March 2018

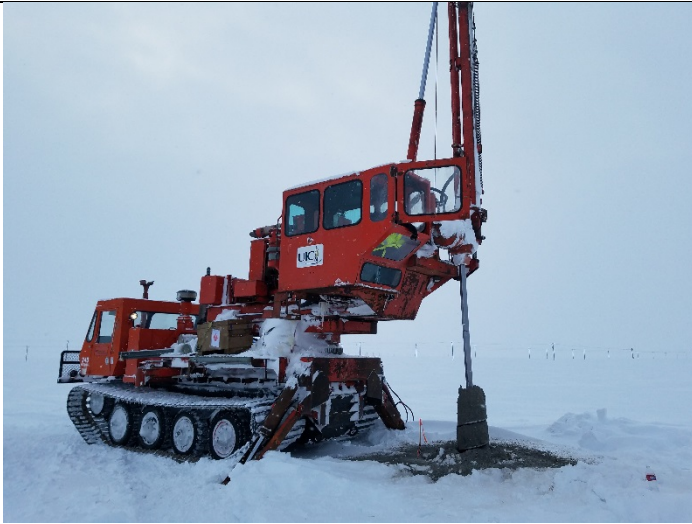
Drill rig pulling up soil core at Location 5 (Looking West)
13 March 2018

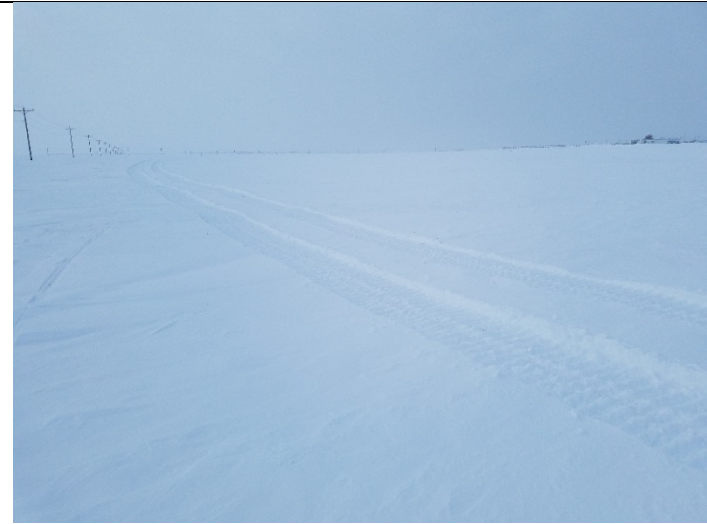
Drill rig tracks across tundra between locations 5 and 4 (Looking West)
13 March 2018

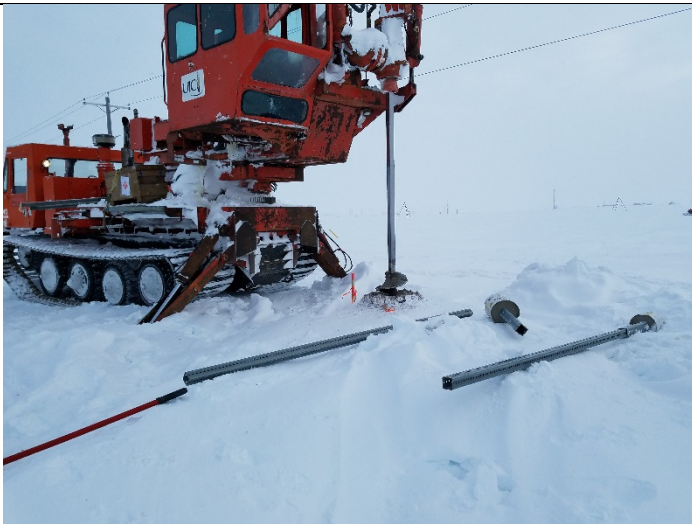
Drilling at Location 4 (Looking Southwest)
13 March 2018

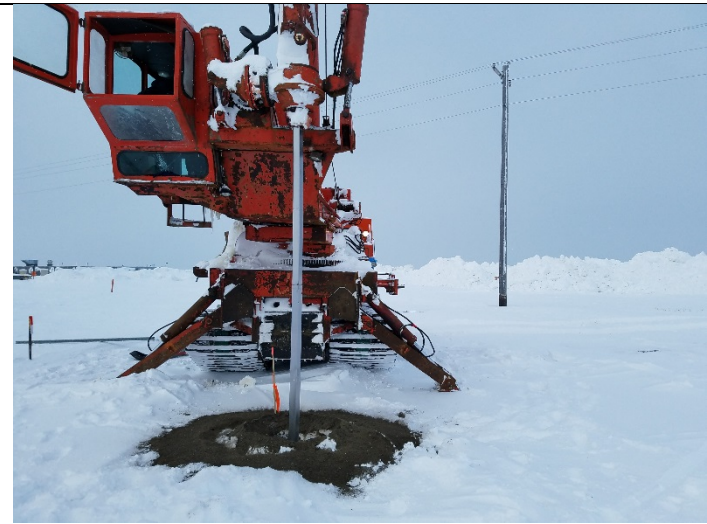
Drilling at Location 2b (Looking Northwest)
13 March 2018

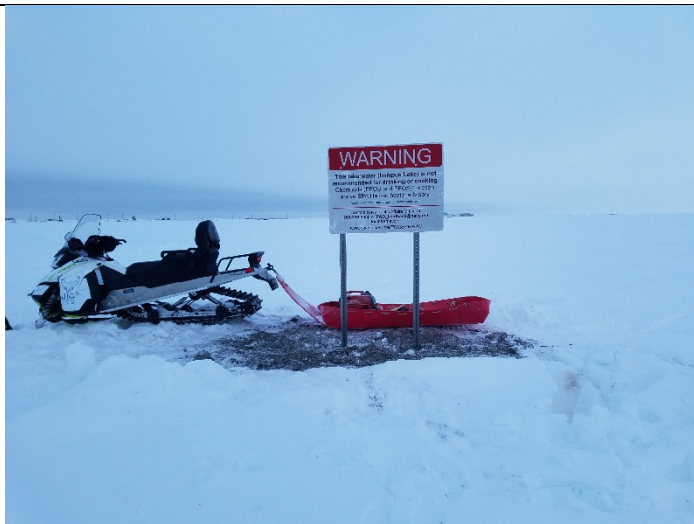
Location 5 after sign installation (Looking Northeast)
14 March 2018
