**Preliminary Assessment for
Per- and Polyfluoroalkyl Substances (PFAS) Ault Field**

Naval Air Station Whidbey Island
Oak Harbor, Washington

November 2018

Prepared for NAVFAC Northwest
by CH2M HILL, Inc.
Bellevue, Washington
Contract N62470-16-D-9000
CTO 4041

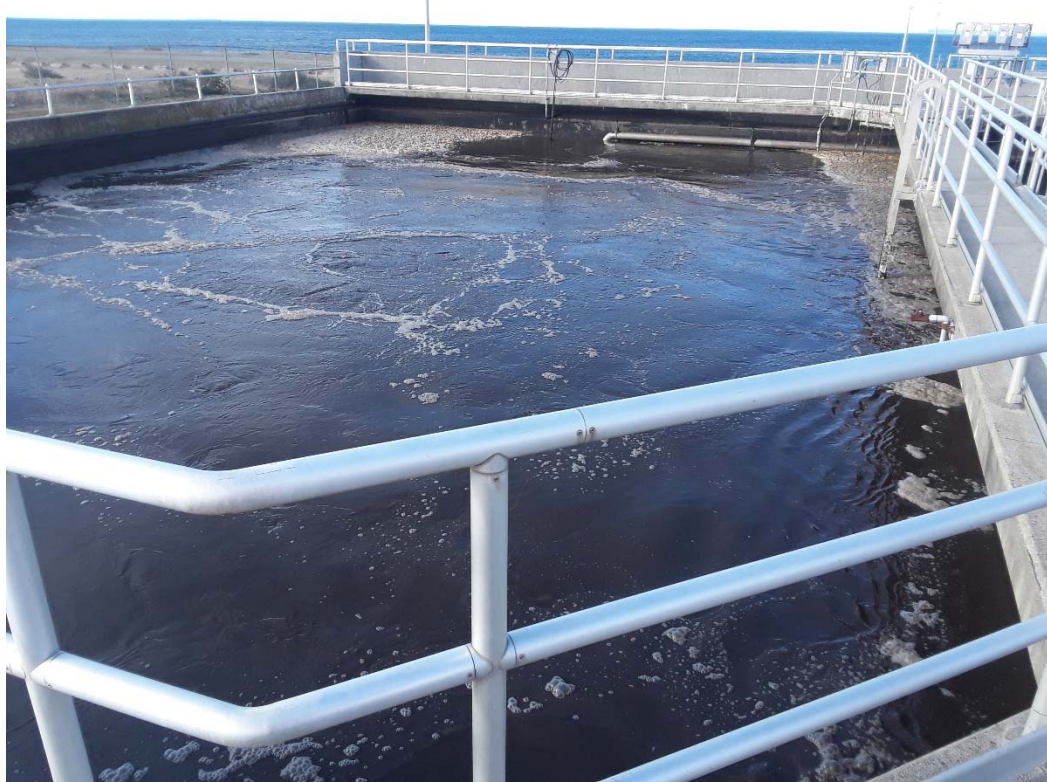
-Wastewater treatment pond (facing west)

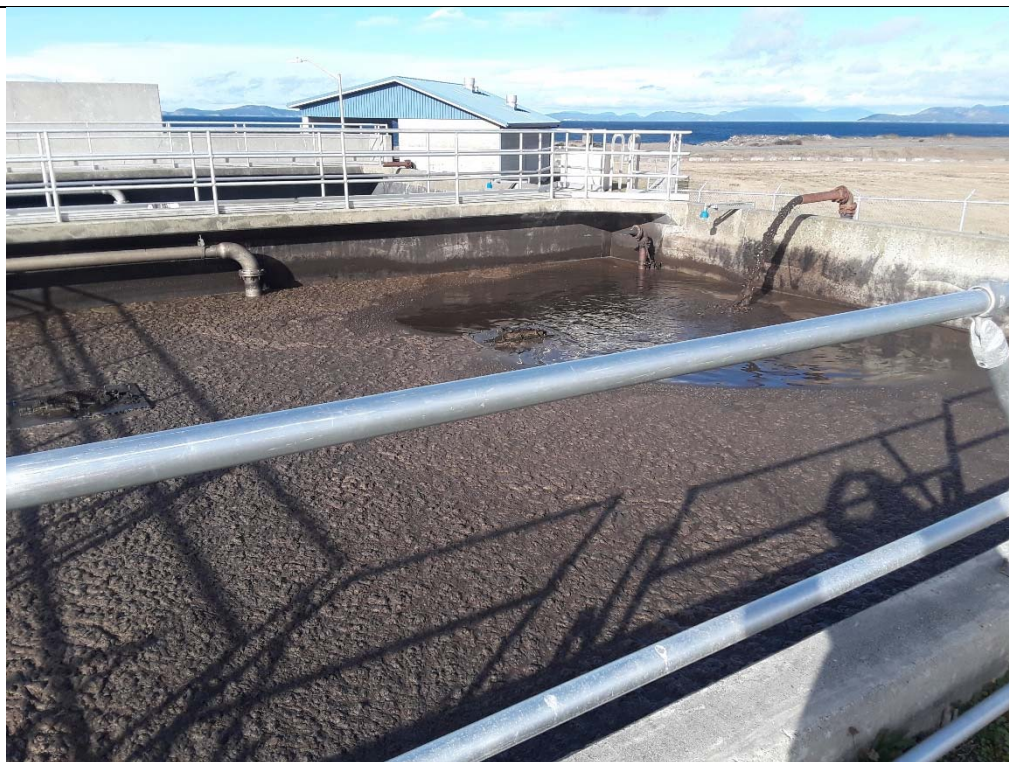
-Treatment pond (facing northwest)

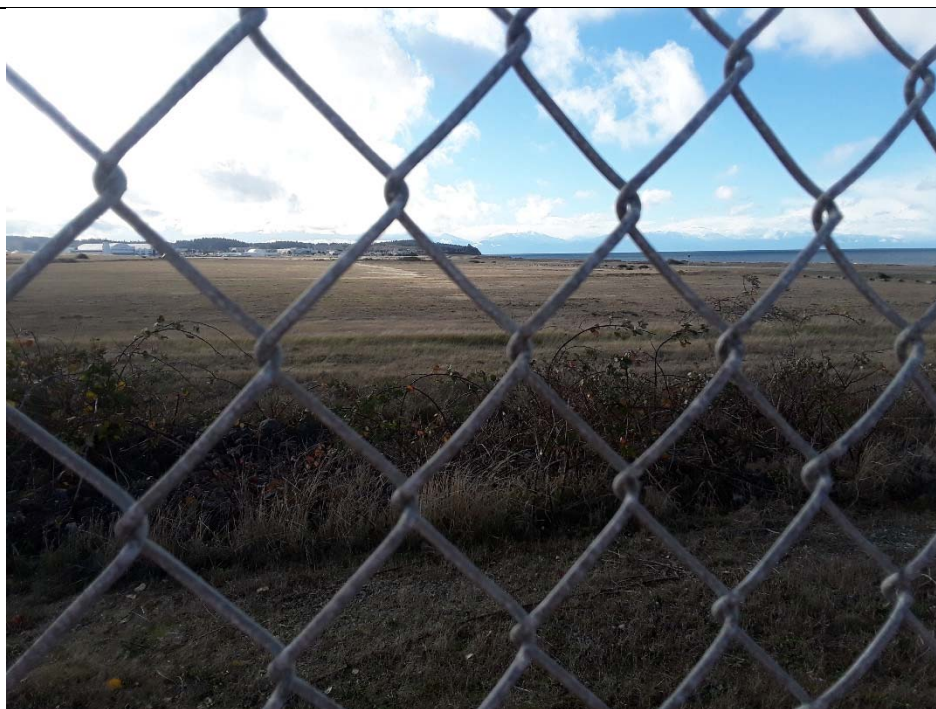
-Looking through fence at Former Sewage lagoons, couldn't get on other side of fence since it is too close to flight line (facing southwest). Extent of former ponds is visible through abrupt elevation changes around the edges.

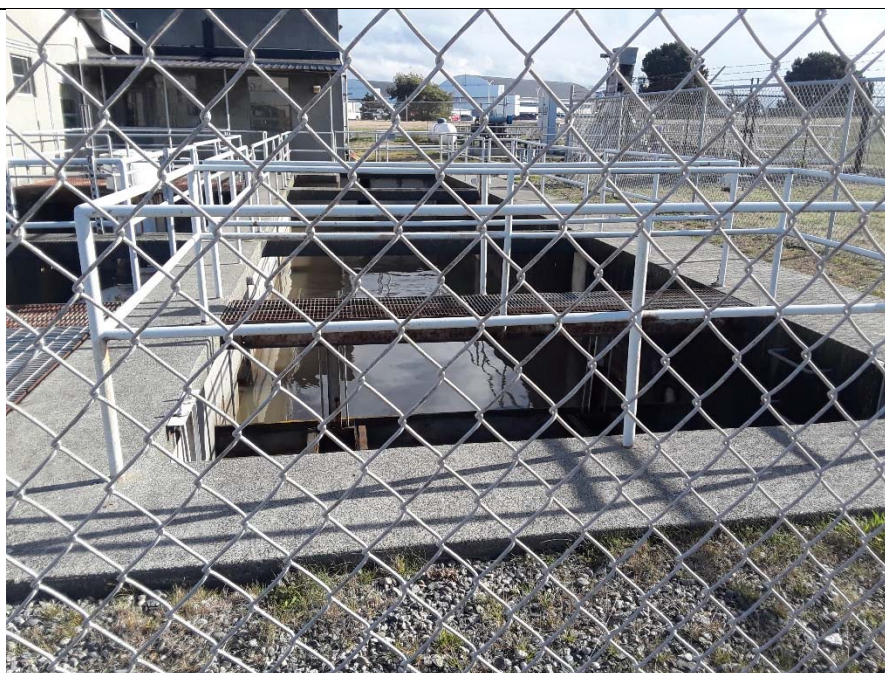
-Confirmed this to be one of the two clarifier tanks holding AFFF-contaminated water (approximately 60,000 gallons in this tank-Scott Lenke) (facing east)

- Mr. Lenke estimated 80,000 gallons of AFFF-contaminated water transferred from Hangar 7 in June 2017 timeframe. Transferred via pump truck, supposed to be removed/taken away within next 2 months.

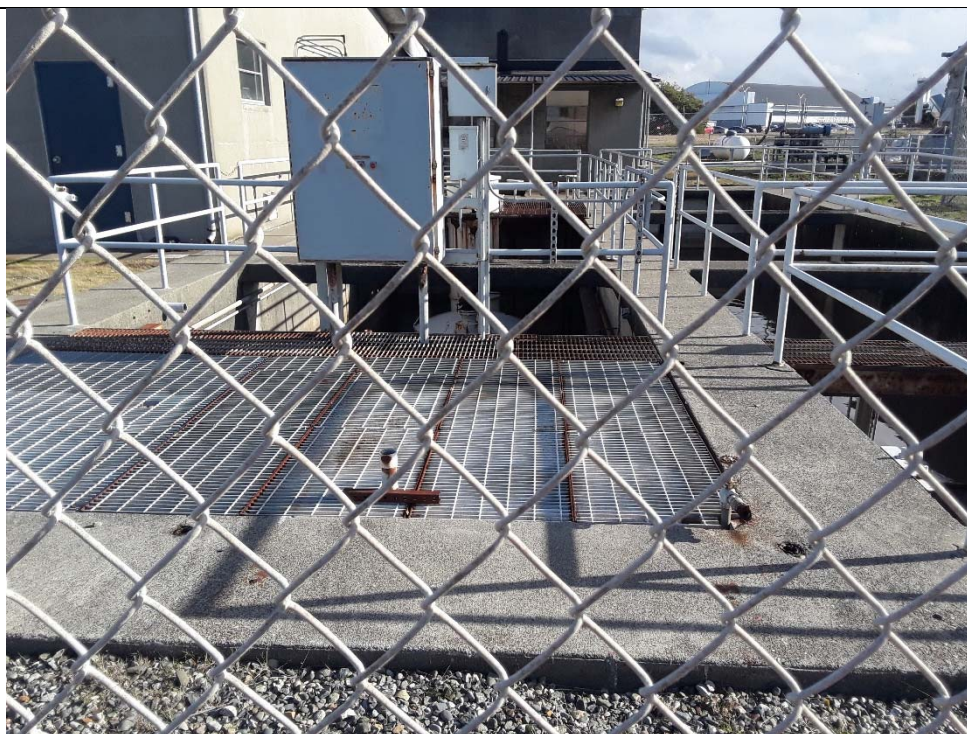
-Confirmed to be the second clarifier tank holding AFFF-contaminated water (approximately 20,000 gallons-Scott Lenke)

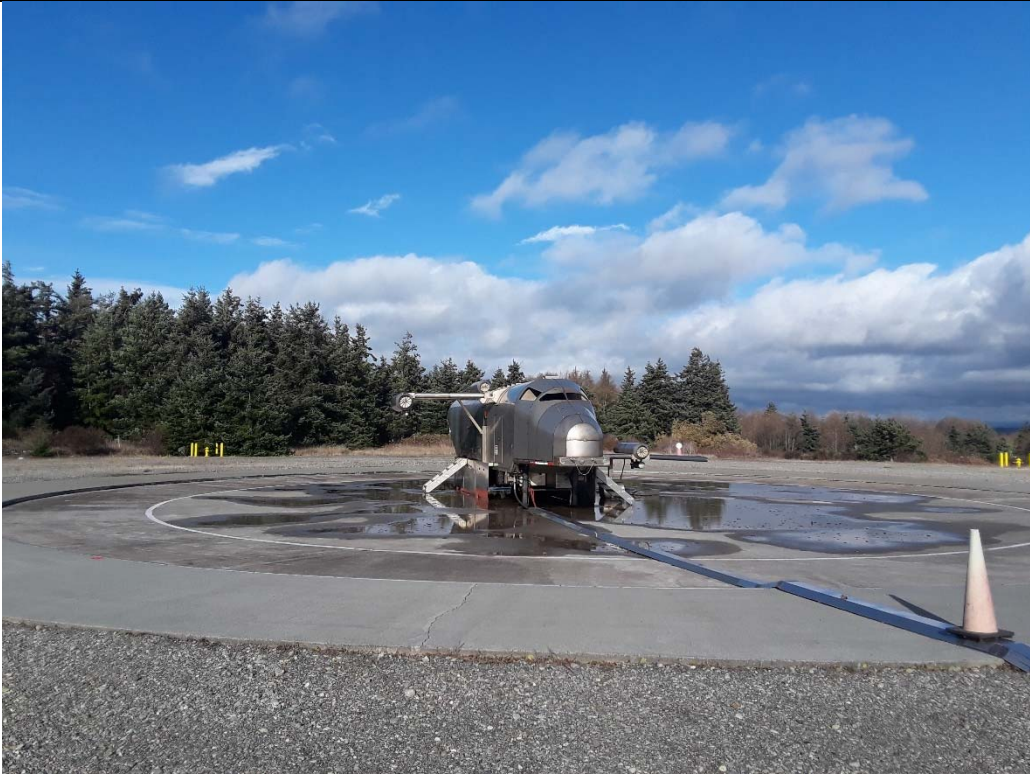
<p>-Current fire training pit and mock aircraft (facing northwest)</p>

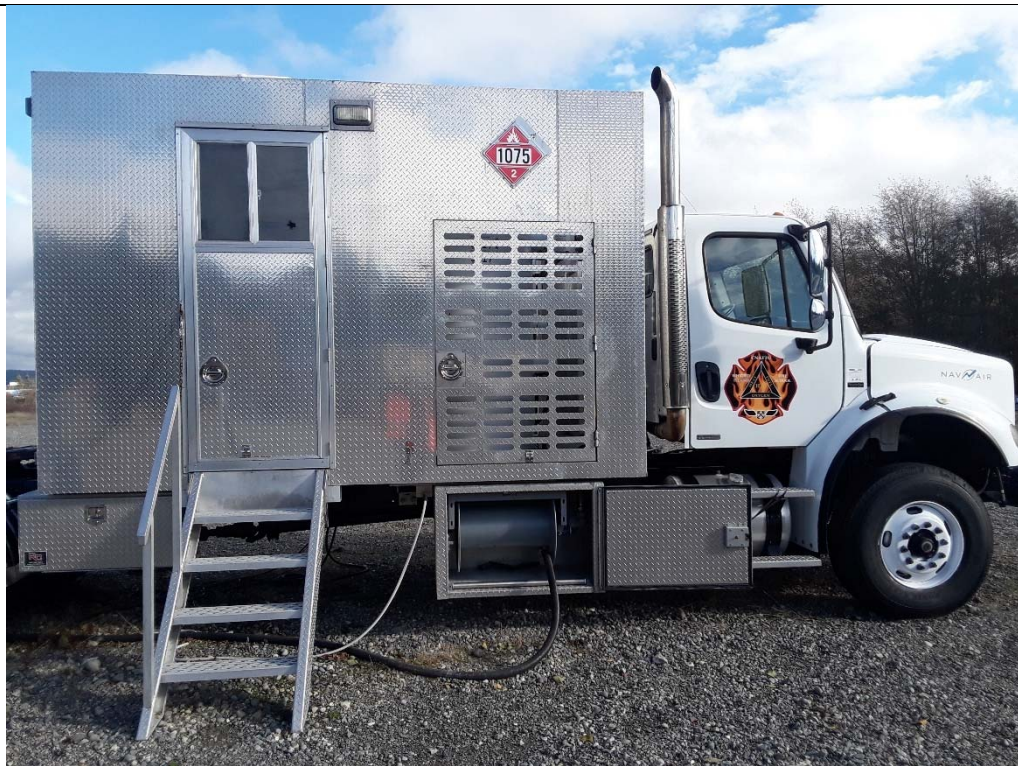
-Propane truck connected to mock aircraft (propane used since 2007)(facing east)

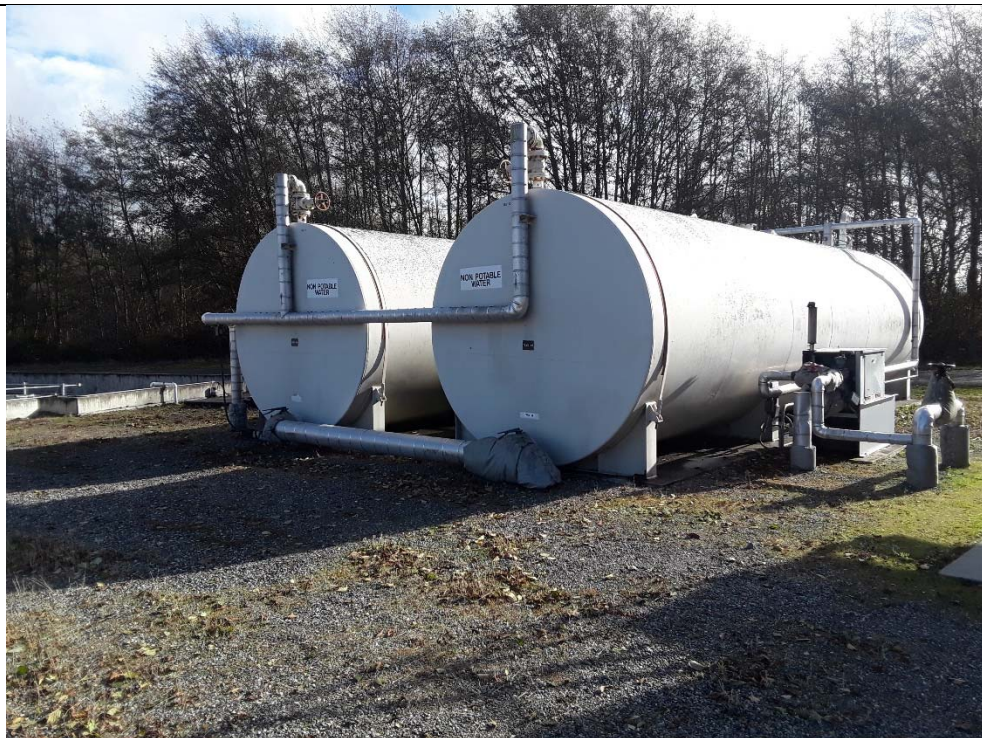
-Water storage tanks (all water used onsite is stored and recycled) (facing southeast)

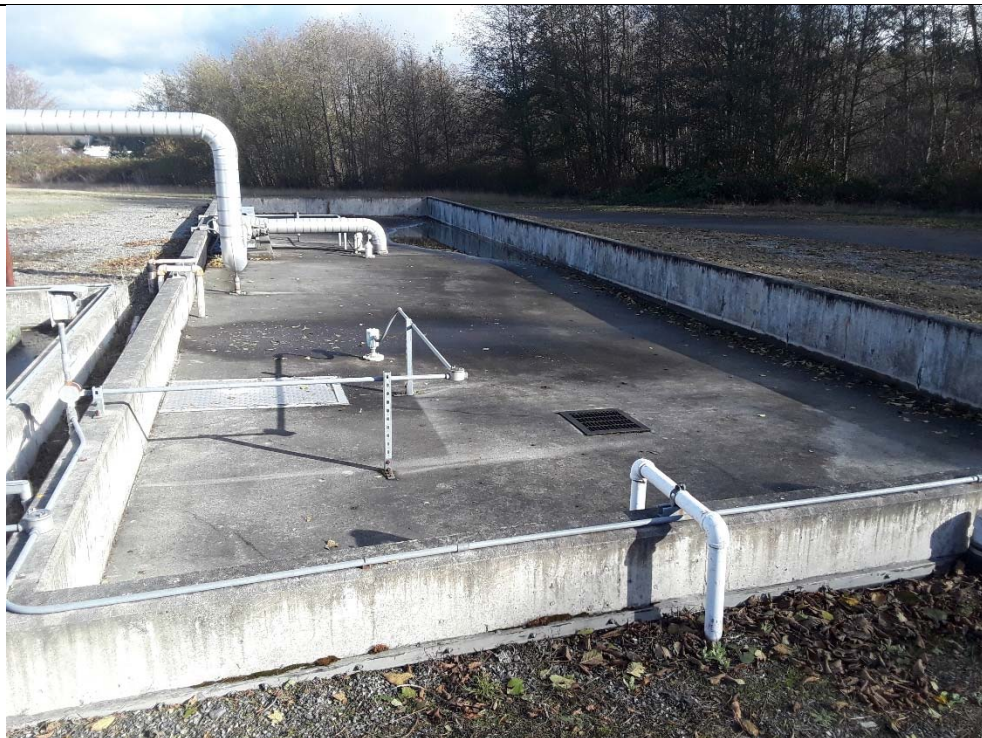
-Detention pond – water was stored here prior to entering oil/water separator (facing east)
