## TECHNICAL MEMORANDUM

**SUBJECT:** Final Technical Memorandum: 2023 Naval Base Kitsap Keyport Institutional Controls Inspection and Vapor Intrusion Monitoring Results, Naval Base Kitsap, Keyport, Washington  
Contract No. N4425520D60006  
DCIN: EA-LTM/OM-6006-24-0040

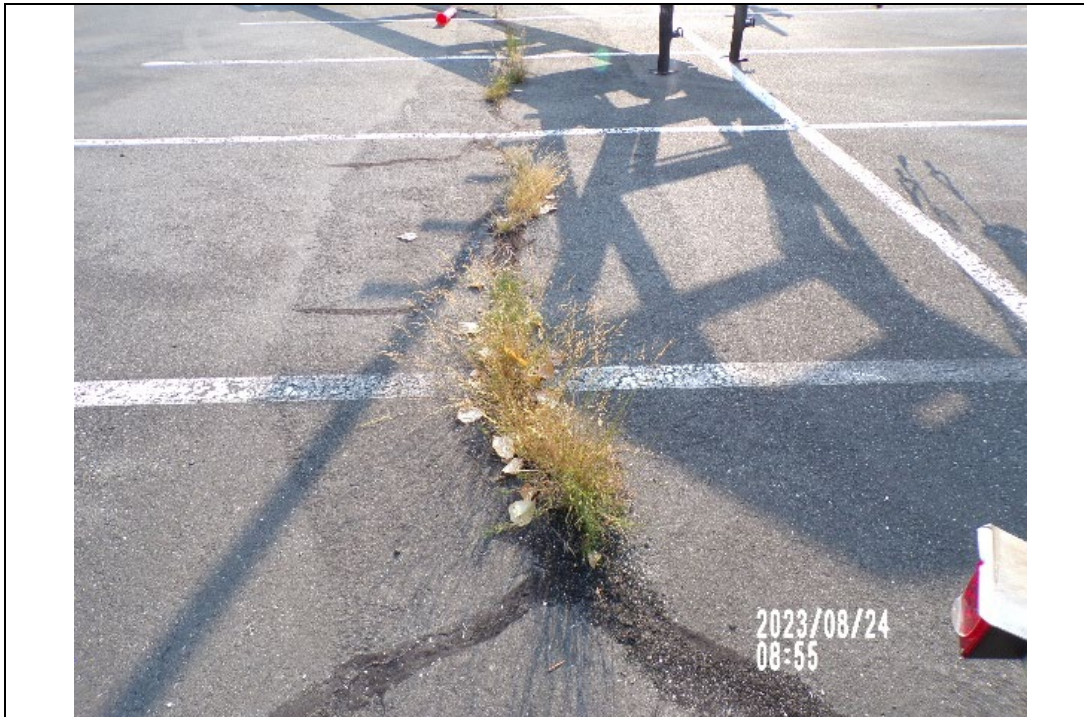
The asphalt surface covering the former landfill at OU 1 Area 1 is generally intact and is functioning as intended by the OU 1 Record of Decision (DON, Environmental Protection Agency [EPA], and Ecology 1998). Cracks up to 1-inch wide from general wear, root damage, and alligating were noted in various parts of the asphalt cover in Area 1. However, the cracks appeared to be surficial only with no underlying soil or waste body observed through the cracks.

<b>Photograph 1.</b> August 2023	View of the site facing north pavement crack OU1 Area D.
-------------------------------------	--

Additional investigations are ongoing at Area 1 which may result in changes to the remedy at OU 1. The need for replacement/repair of the asphalt cover will be evaluated once changes to the remedy are decided. However, if the asphalt is damaged to the point of potential exposure to waste or subsurface soils, or begins to allow significant infiltration of stormwater, it will be addressed as soon as possible. Additionally, the open soil understory of the plantations at Area 1 allows for potential infiltration of precipitation to the waste body, which should be considered in the future Focused Feasibility Study (FFS). No other corrective actions were identified or completed in 2023.

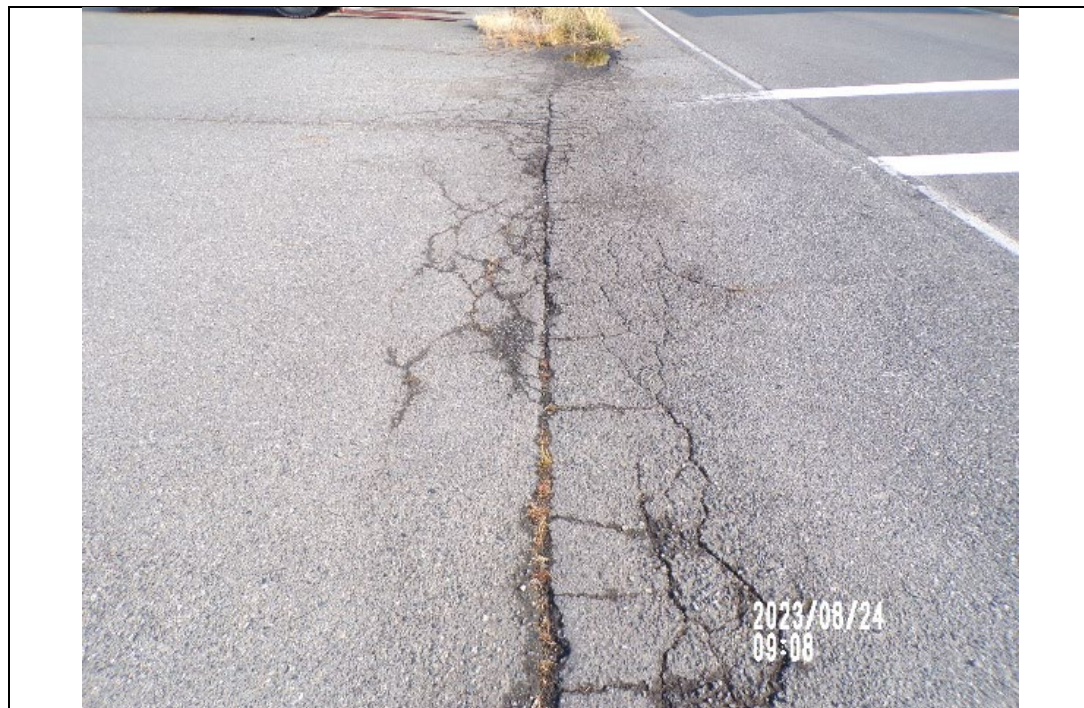
<b>Photograph 2.</b> August 2023	View facing north, alligating on east edge of OU1.
-------------------------------------	--

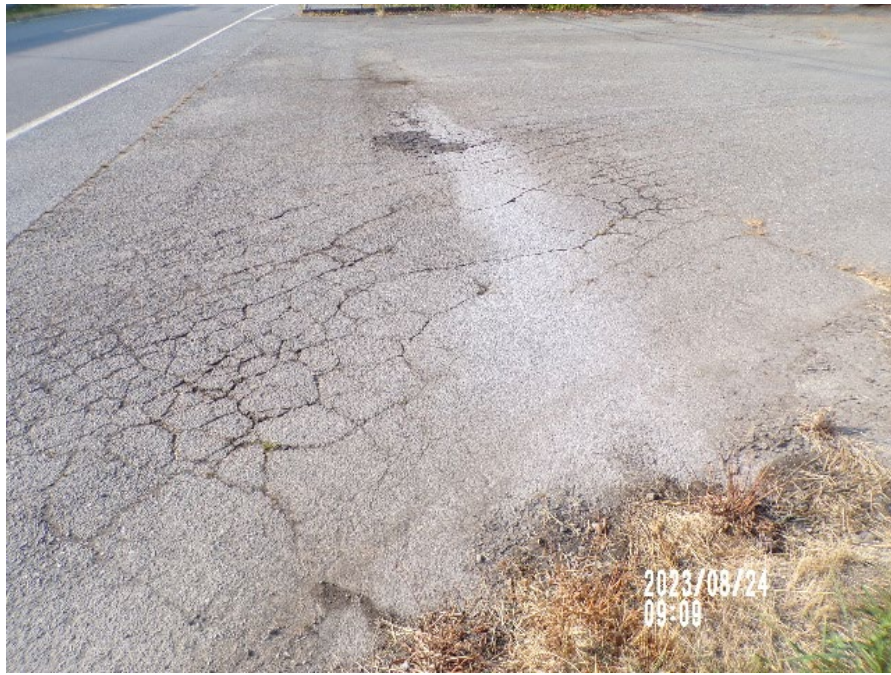
<b>Photograph 3.</b> August 2023	View facing south, alligating on east side of OU1
-------------------------------------	---

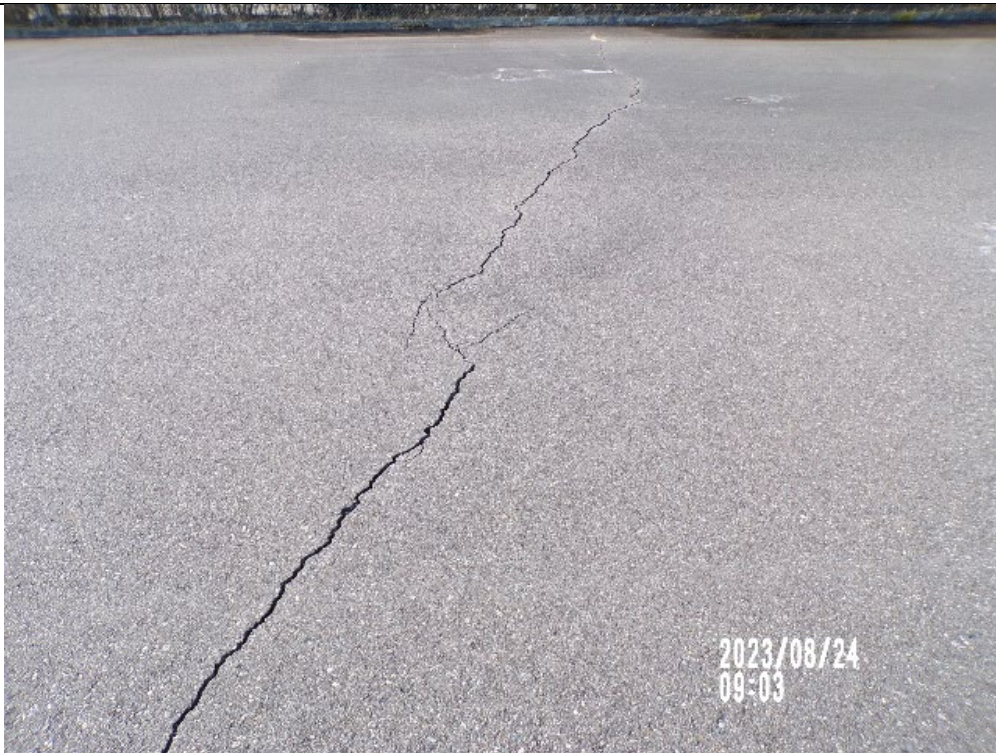
<b>Photograph 4.</b> August 2023	View facing south, pavement cracking near storage shed.
-------------------------------------	---

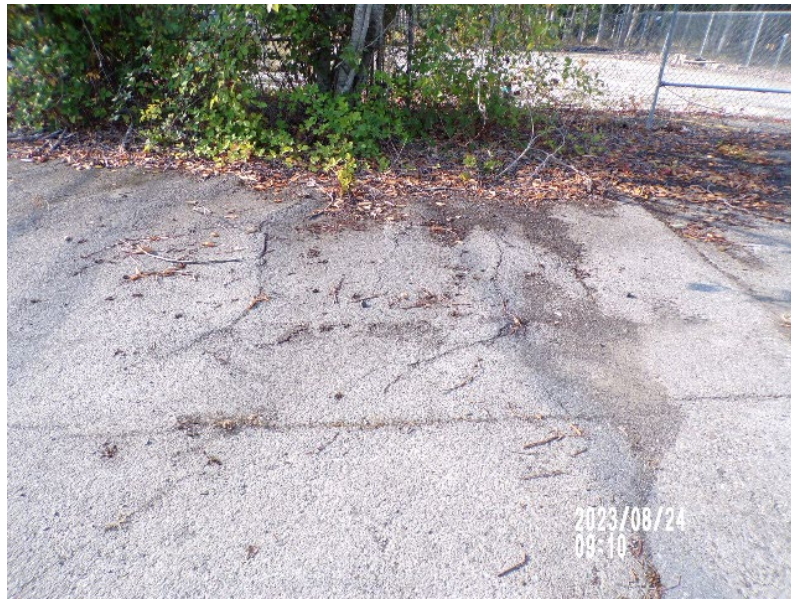
<b>Photograph 5.</b>	View facing south, pavement cracking near southern plantation.
August 2023

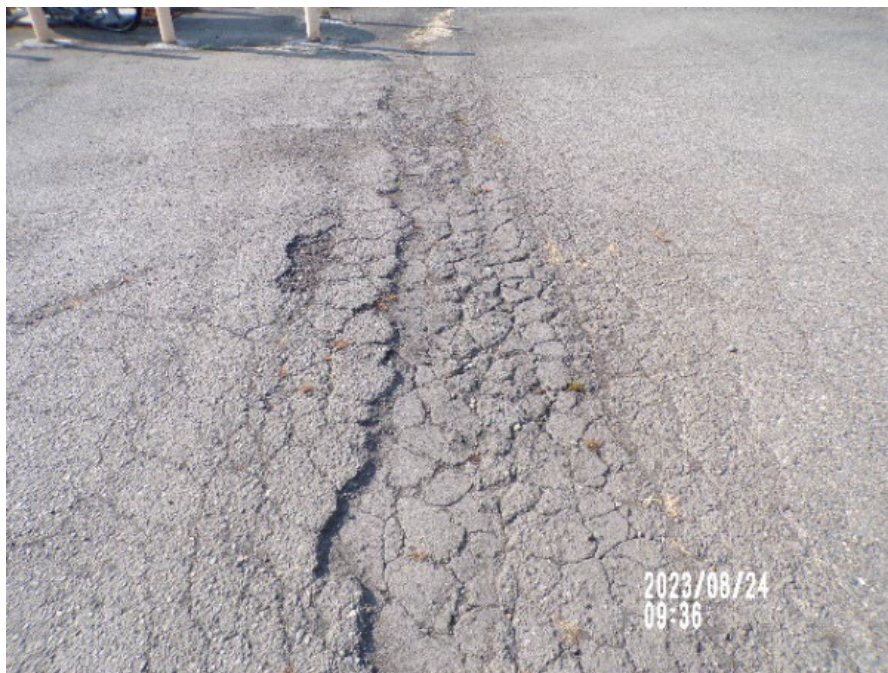
No indications of current or recent excavations were observed at the site during the inspection. Based on interviews, the excavation permit process is in place and effective in control of site excavations. Several potholes, alligatoring, and cracks were noted throughout the asphalt cover in Area 22. However, the cracks appeared to be surficial only with no underlying soil observed through the cracks.

<b>Photograph 6.</b>	View facing south, alligating at OU1 Area 22 near 4th Street parking area.
August 2023

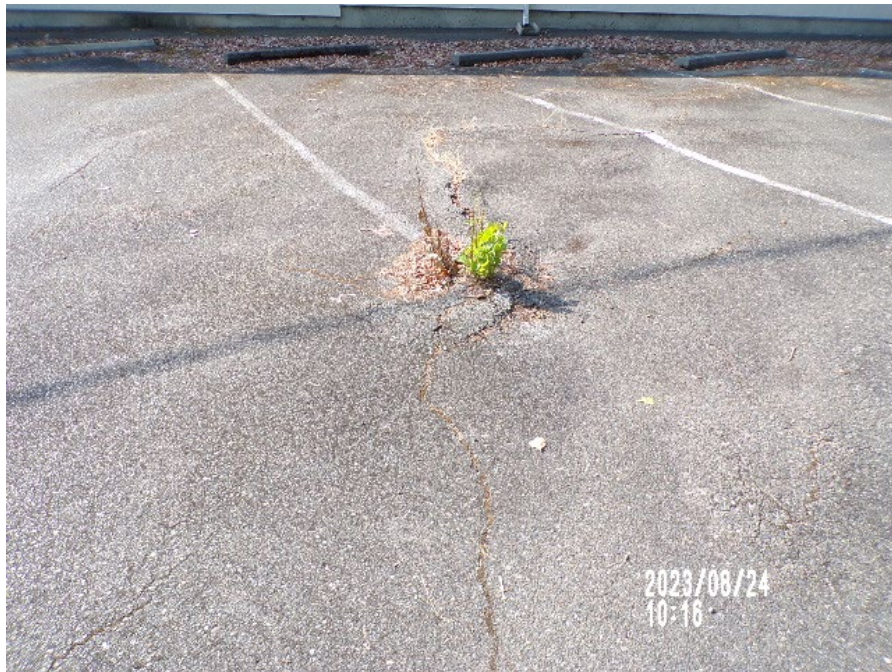
<b>Photograph 7.</b> August 2023	View facing south, root damage to asphalt at OU2 Area 2.
-------------------------------------	--

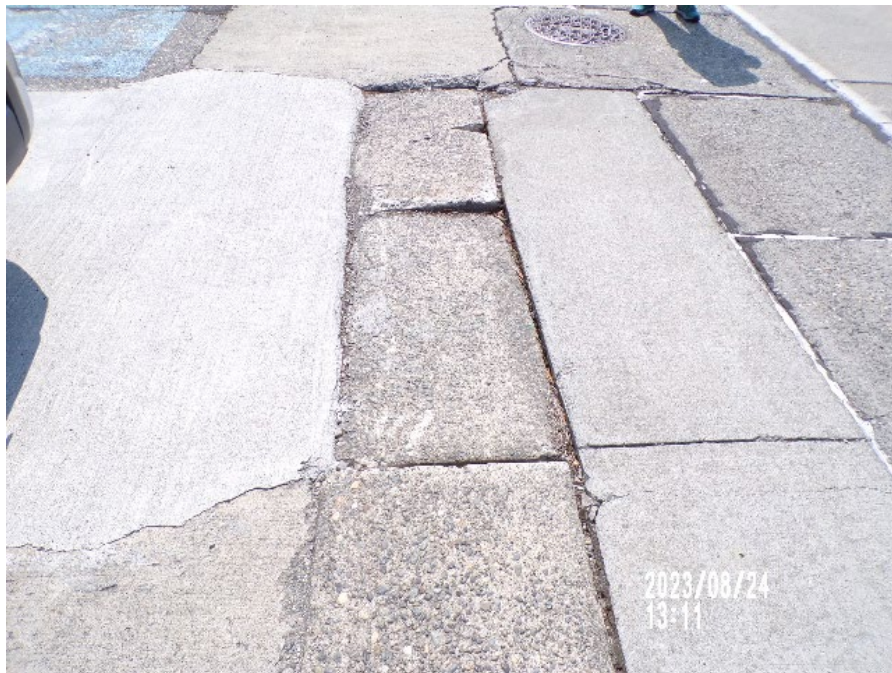
No indications of current or recent excavations were observed at the site. Based on interviews, there has been construction involving excavation and installation of groundwater monitoring wells at Area 7. However, excavation permits were obtained in both cases. Base Environmental is heavily involved in the planning and execution of all excavation activities and the excavation permit process is in place and effective in control of site excavations. Minor root damage to the asphalt cover was noted throughout portions of Area 7. However, the cracks appeared to be surficial only with no underlying soil observed through the cracks.

<b>Photograph 8.</b> August 2023	View facing south, cracked pavement in front of Building 15, OU2 Area 7.
-------------------------------------	--

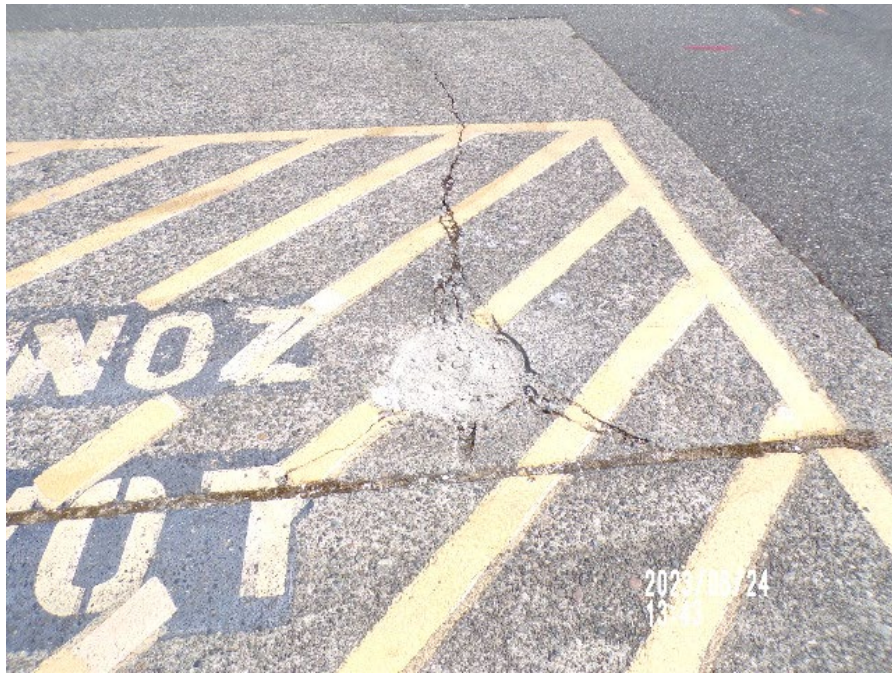
**Photograph 9.** View facing east, damaged pavement at loading zone OU2 Area 7.  
August 2023

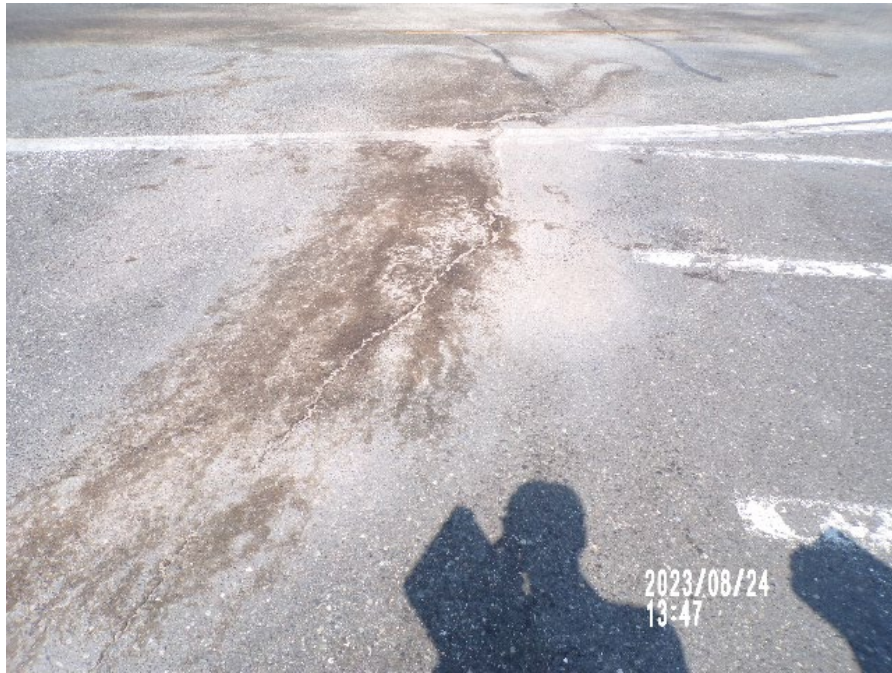
**Photograph 10.** View facing north, cracked pavement at OU2 Area 2.  
August 2023
