First Five-Year Review of Record of Decision

Final

Jackson Park Housing Complex/ Naval Hospital Bremerton

Bremerton, Washington

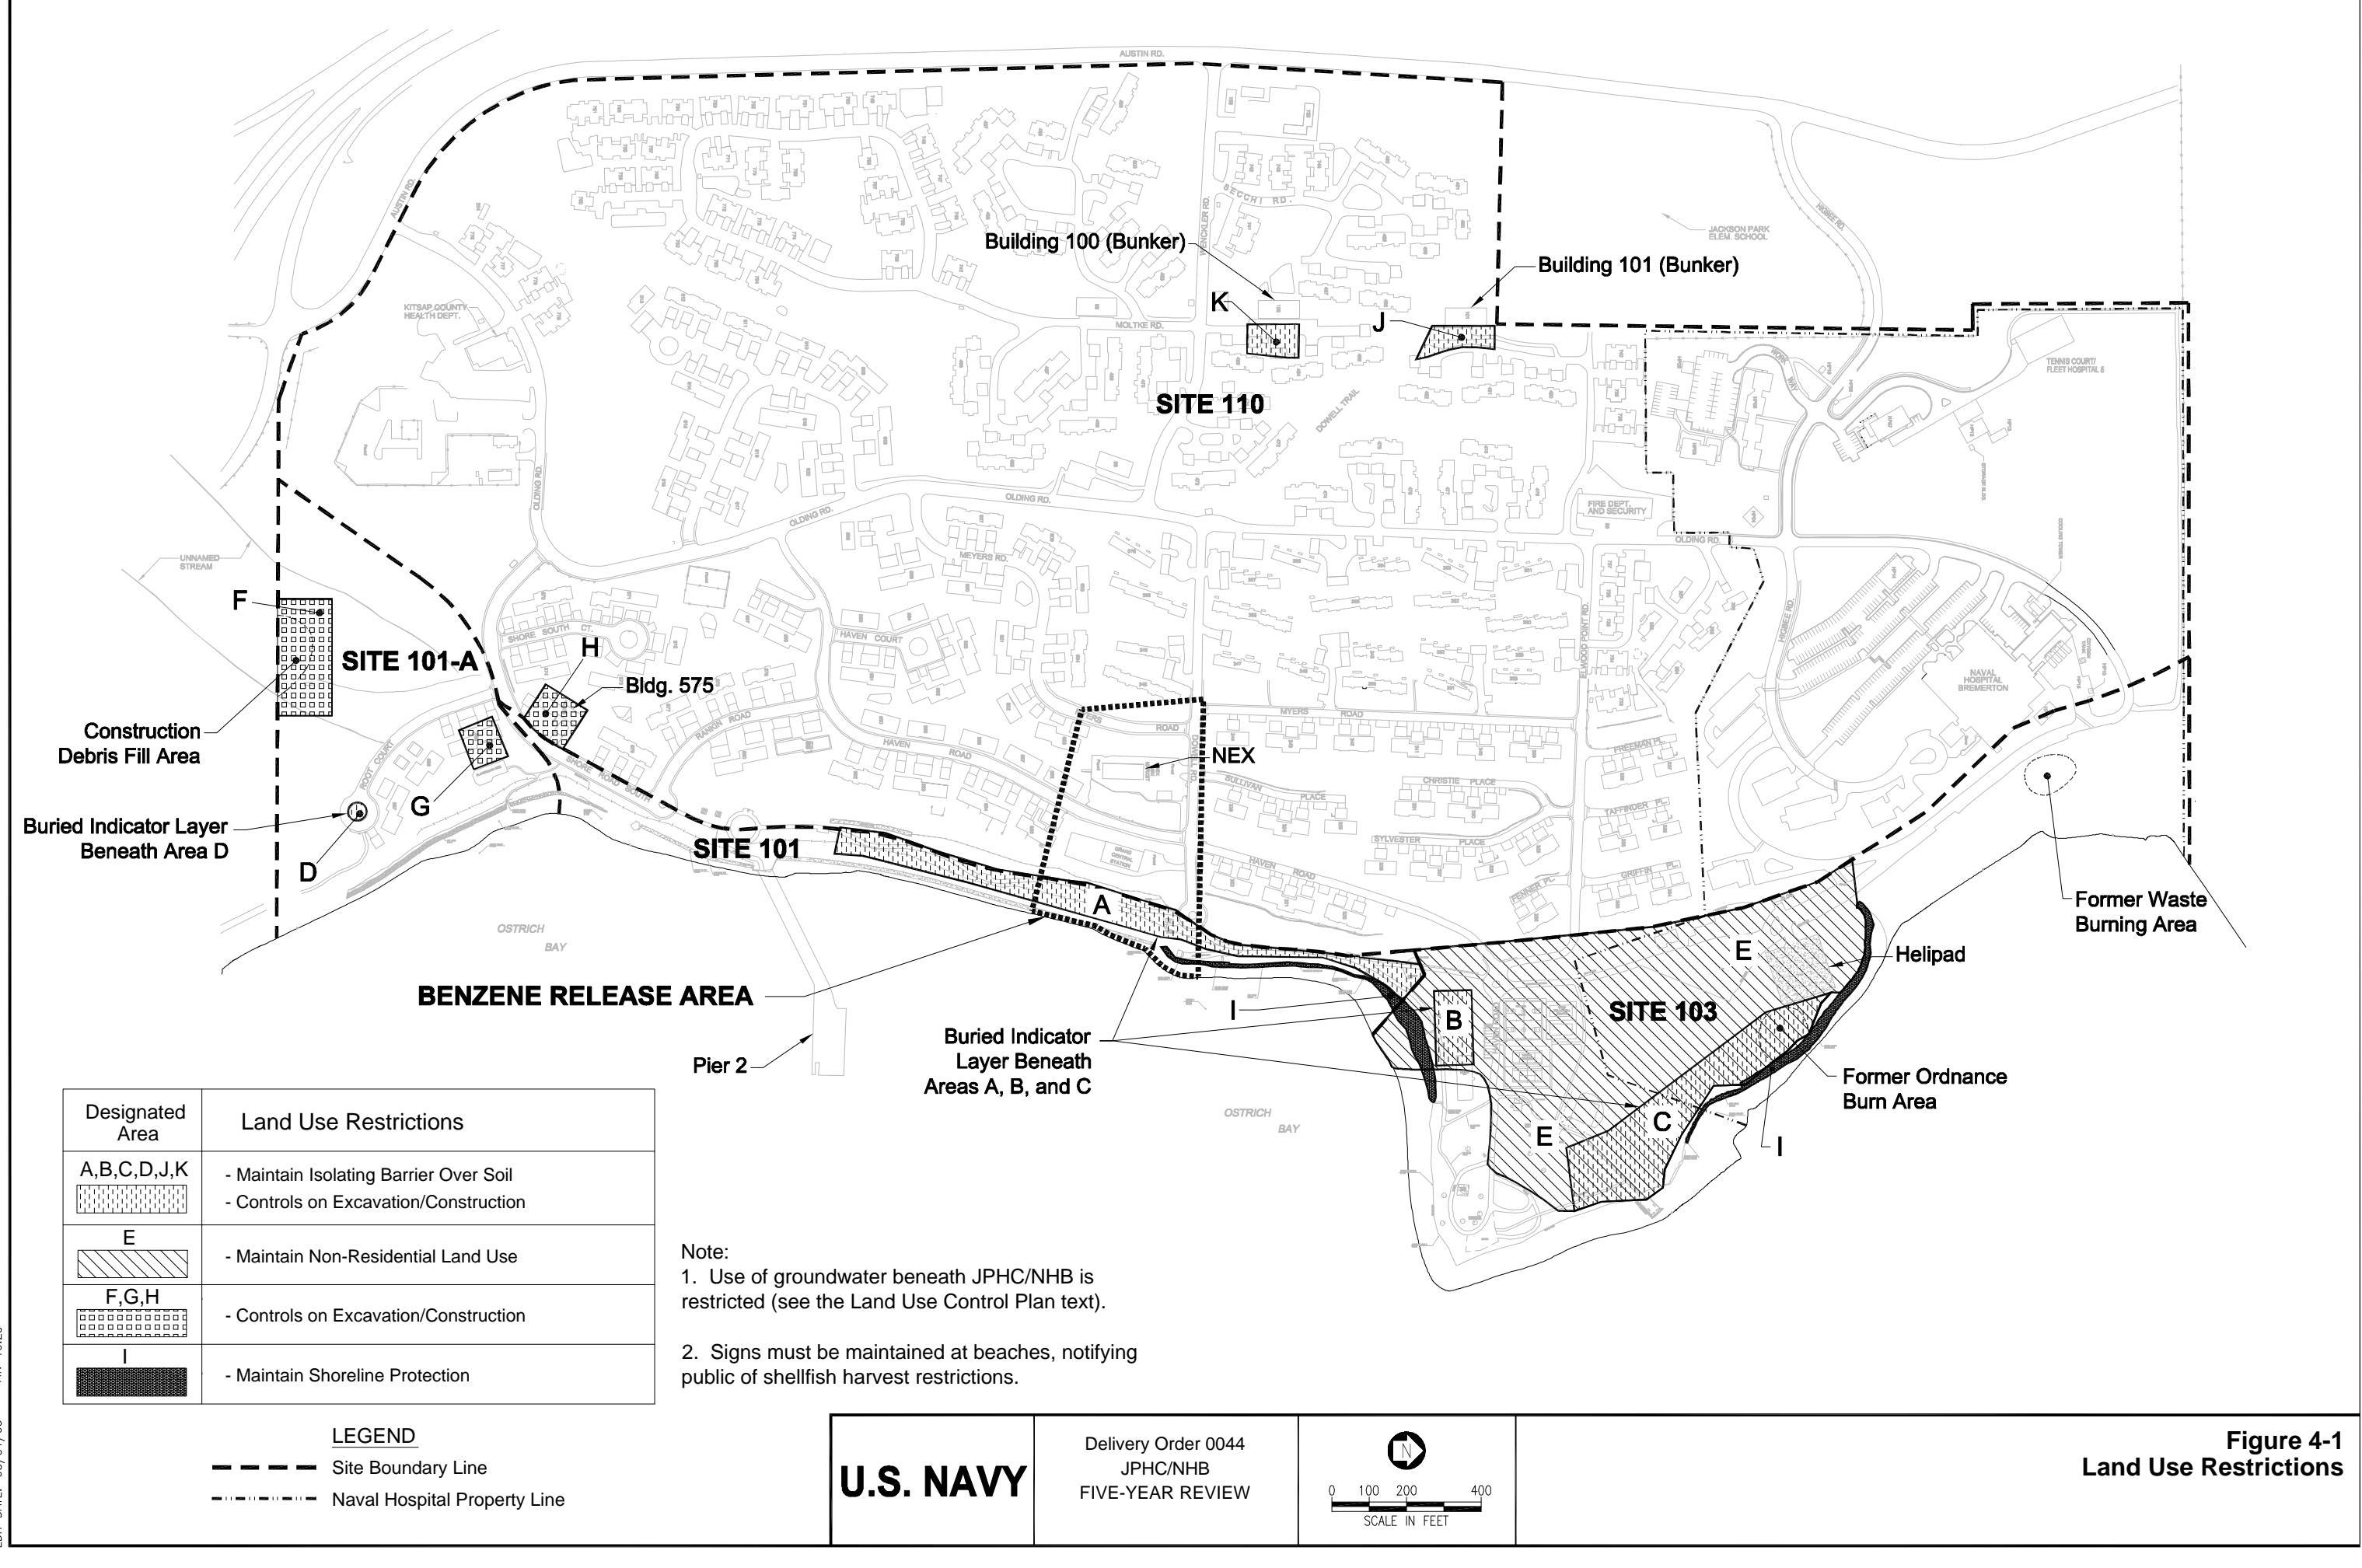
- Maintenance of the asphalt cover in front of Buildings 100 and 101 (Site 110)
- No observed digging/excavation in any of the areas where disturbance is prohibited without a dig permit (see Figure 4-2)

- Prevention of erosion for all the areas with digging/excavation restrictions (all areas noted on Figure 4-2)
- Shellfish harvesting prohibition signs at all the shoreline areas (Sites 101, 101-A, and 103)
- Maintenance of nonresidential land use for Site 103
- Maintenance of the shoreline stabilization measures—specifically, rock shelves and stairways, seawall, and armor revetment require maintenance to prevent erosion of impacted soils into Ostrich Bay.

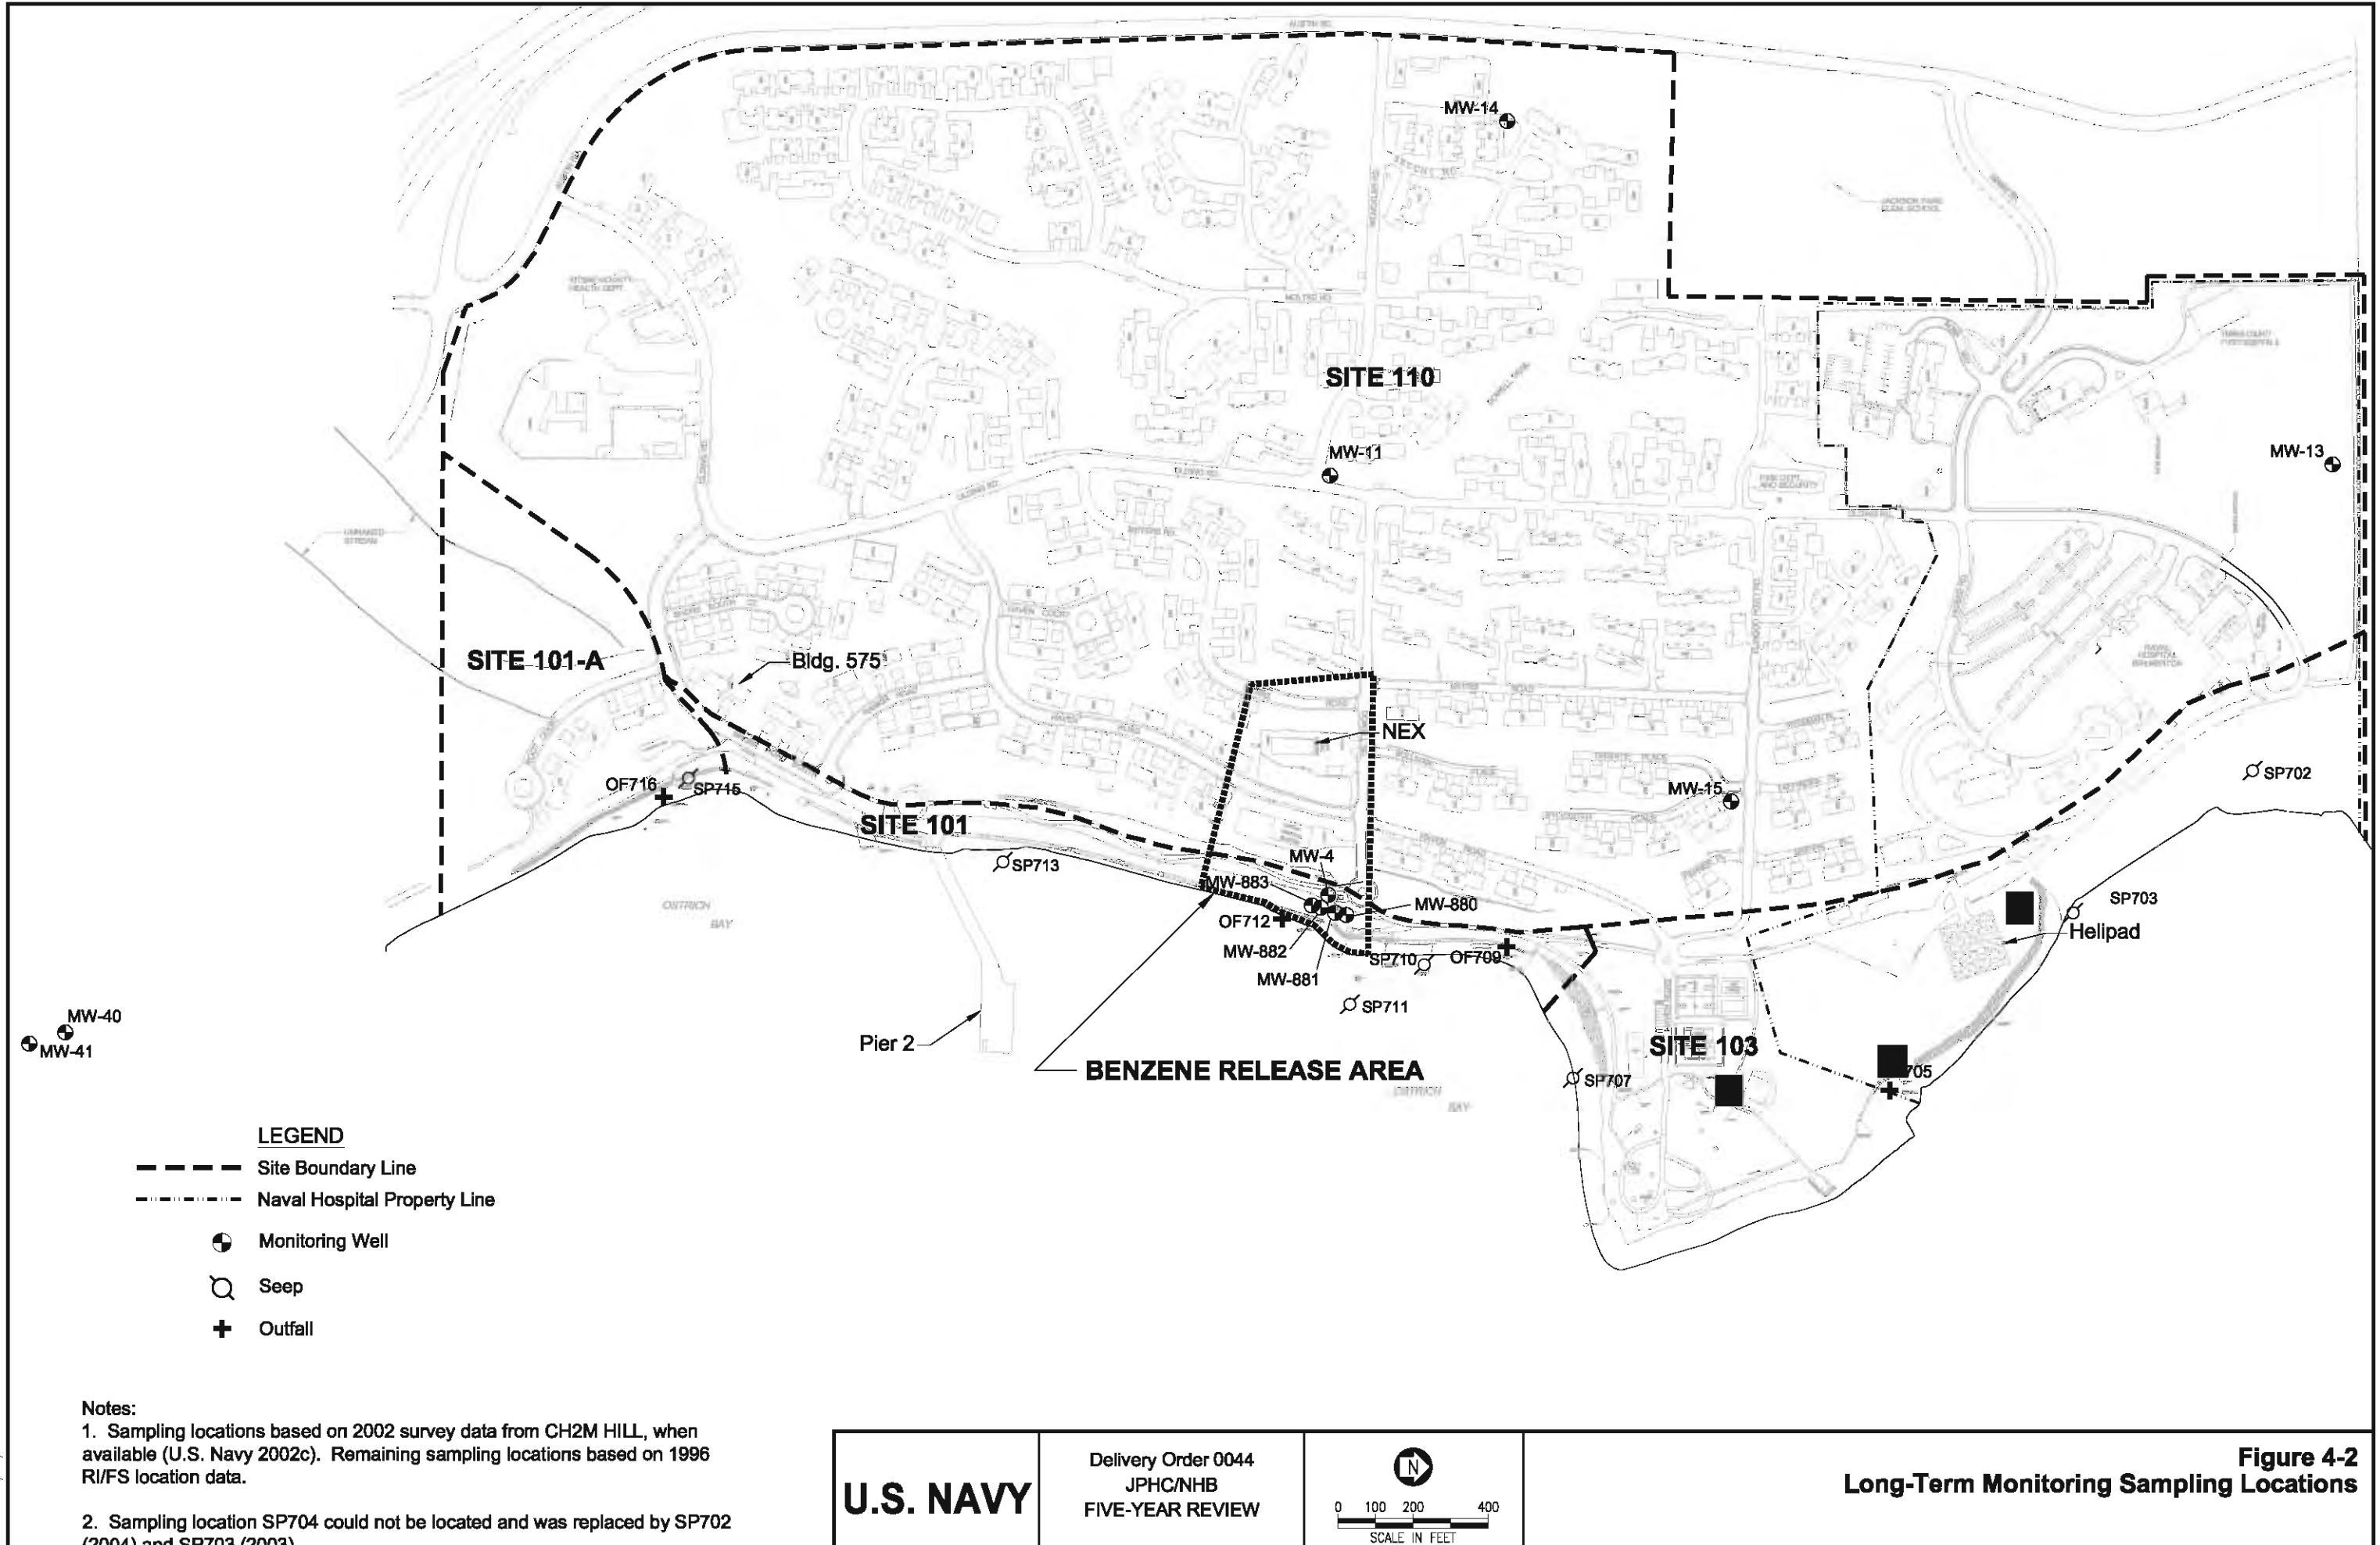
2. Sampling location SP704 could not be located and was replaced by SP702 (2004) and SP703 (2003).

Two seeps (SP-707 and SP-704) and one outfall (OF-705) were selected to be sampled at Site 103 (Figure 4-1). SP-704 could not be located, and no other seeps were found during the first two rounds of monitoring. However, a north-side seep was located during the second round of monitoring (SP-703) and was selected as a replacement for SP-704 in the 2003 monitoring. Another substitute seep (SP-702) was sampled in 2004. Data are available for four rounds of sampling since the signing of the ROD. Four chemicals (arsenic, beryllium, cyanide, and mercury) have been detected at least once above the RGs or background concentrations established for the site Table 6-3. TCE was detected in the outfall sample on the north side of Elwood Point (OF-705) in 2003 and 2004 at concentrations below the ROD RG. (VOCs were not analyzed in earlier rounds of sampling at this location.)
