May 3, 2013

# Preliminary Assessment Report for Naval Defensive Sea Area

## **Unalaska Island Alaska**

**Department of the Navy  
Naval Facilities Engineering Command Northwest**  
1101 Tautog Circle  
Silverdale, WA 98315

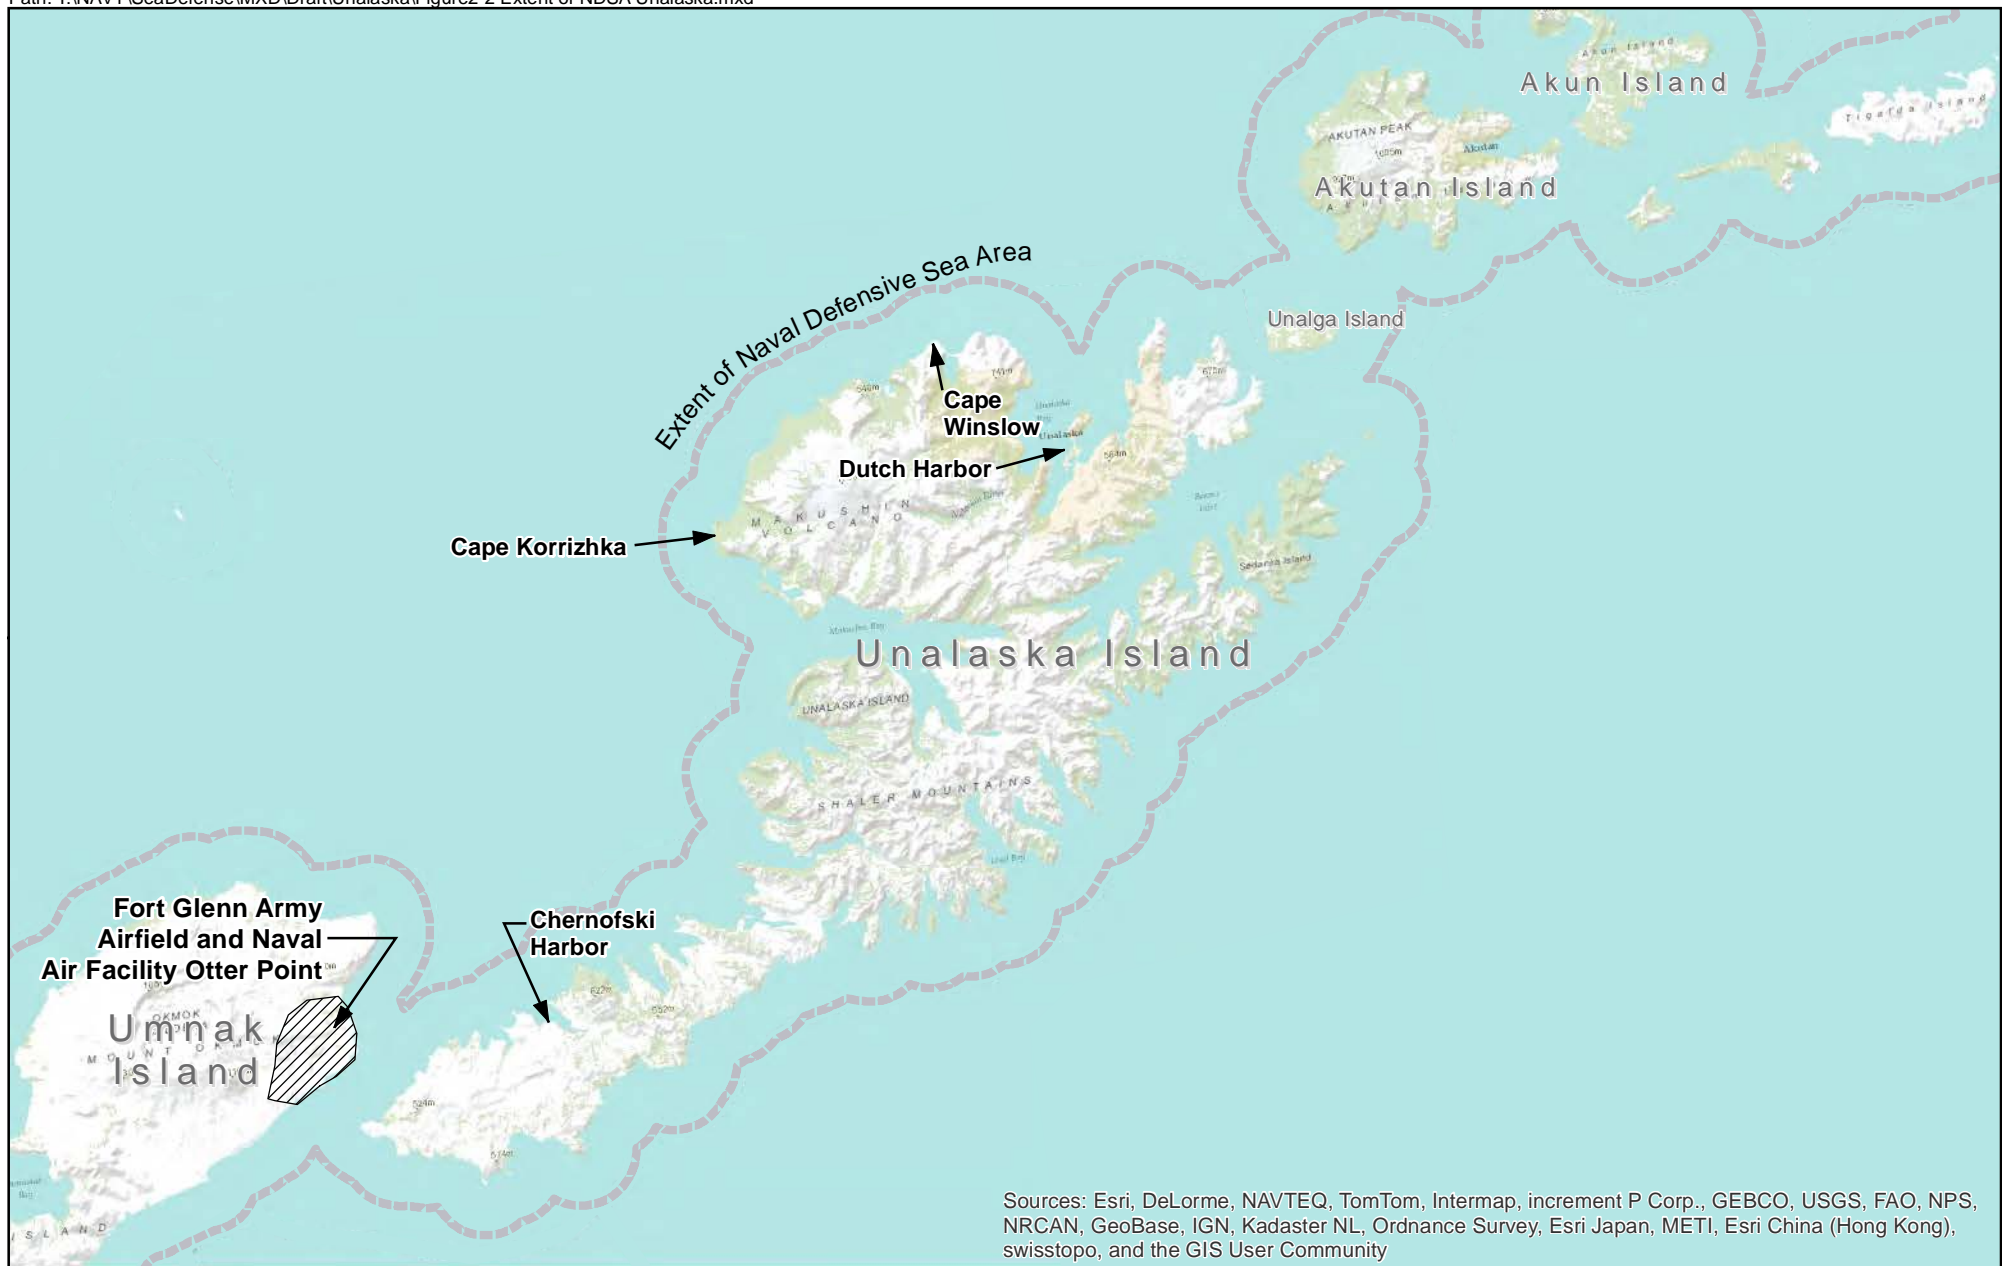
<p>U.S. NAVY</p>	<p>Delivery Order 0040 Naval Defensive Sea Area Unalaska Island, Alaska</p>	<p>Scale in Miles</p>	<p><b>Figure 2-2</b> <b>Extent of the Naval Defensive Sea Area</b> <b>Surrounding Unalaska Island</b></p>
------------------	---	-----------------------	---

The study area for this PA consists of the known in-water range areas established for target firing of the costal artillery and AA batteries installed on Unalaska Island, on-water ordnance handling locations, and documented ordnance disposal areas within the 3-mile limit of the Unalaska NDSA. Figure 2-2 shows the extent of the NDSA surrounding Unalaska Island.

As described in Executive Order 8680, the Unalaska Island NDSA includes the territorial waters between the extreme high-water marks and the 3-mile marine boundaries (Appendix A). Typical maximum water depths in this area reach approximately 40 to 80 fathoms (240 to 480 feet), but exceed 400 fathoms (2,400 feet) in the area between Cape Winslow and Cape Kovrizhka, located northwest of Unalaska Bay (Figure 2-2).

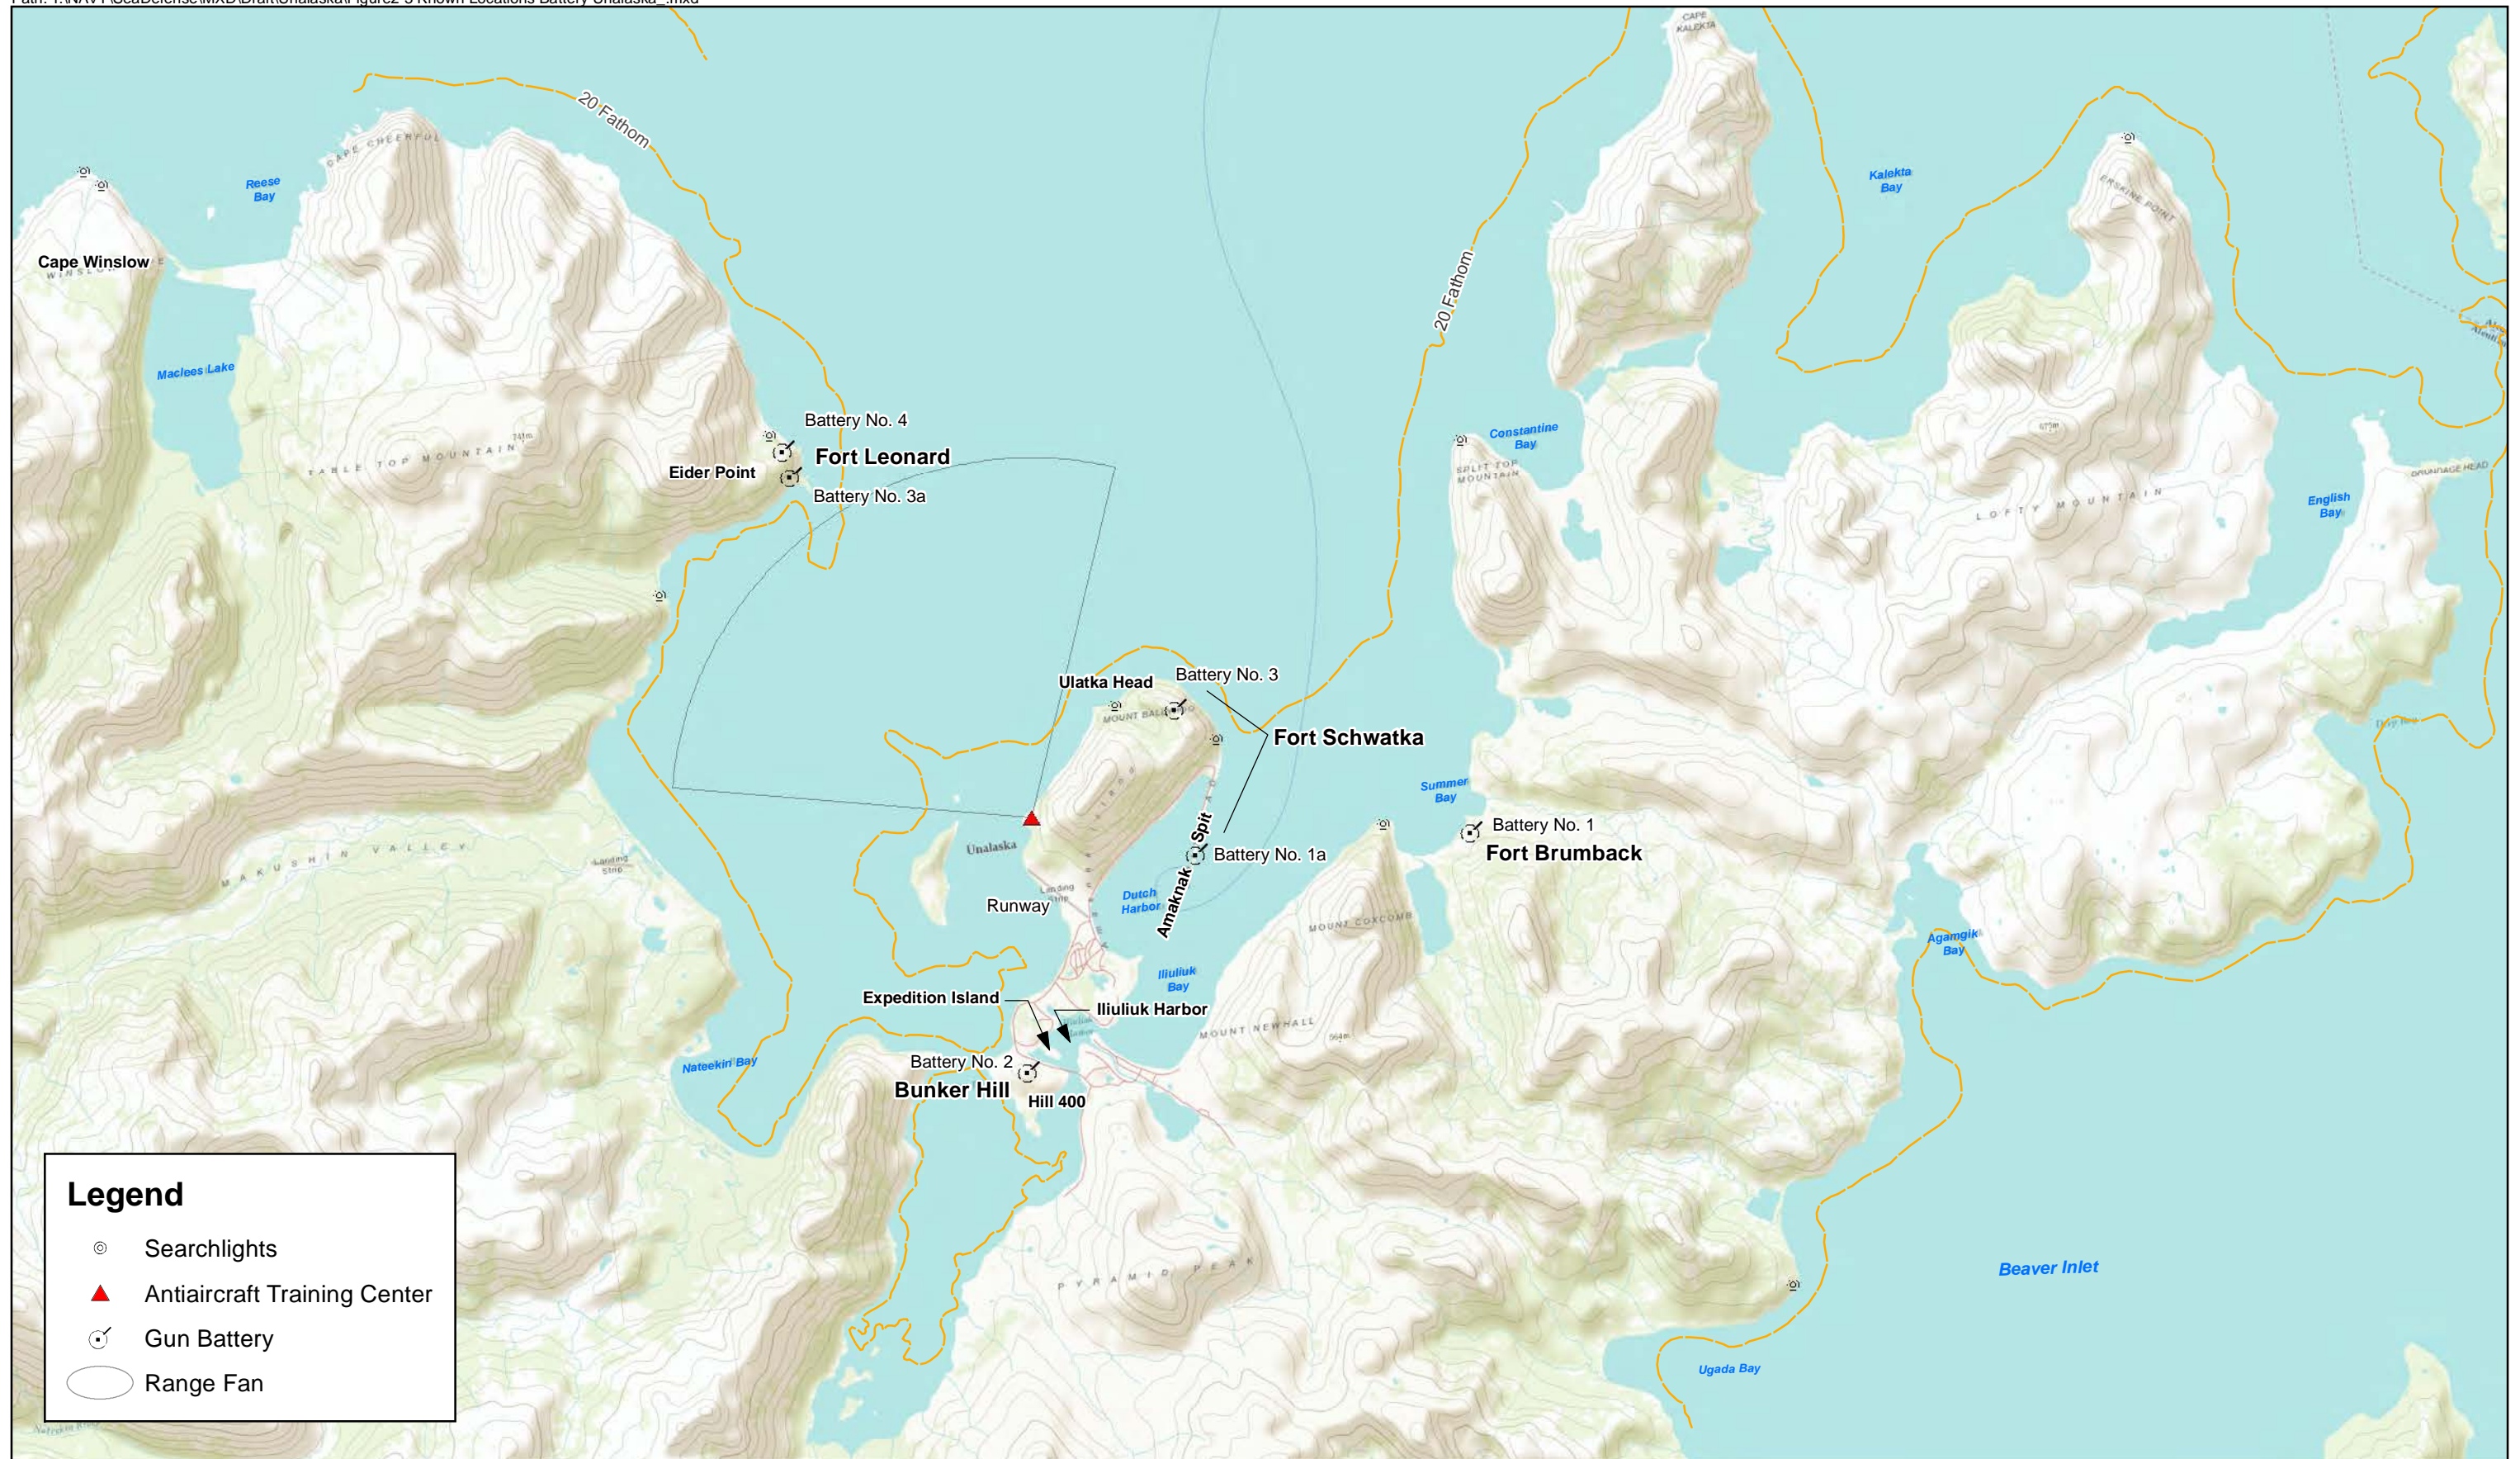
**Figure 2-3**  
**Known Locations of U.S. Gun Batteries, Searchlights**  
**and an Anti-aircraft Training Center in the Vicinity of**  
**Dutch Harbor, Unalaska Island**

The Unalaska NOB also contained an AATC where active firing was conducted using an unspecified number of .30-caliber machine guns, two .50-caliber machine guns, five 20-mm AA guns, and one 40-mm AA gun. It was located at the northwest base of Mount Ballyhoo on Amaknak Island. The facility was sized to handle 60 men a day, 30 men in the morning and 30 in the afternoon. Firing was directed into Unalaska Bay with a presumed 100-degree danger area extending 6,000 yards seaward. The location of this AATC and the presumed danger area (range fan) is shown on Figure 2-3.

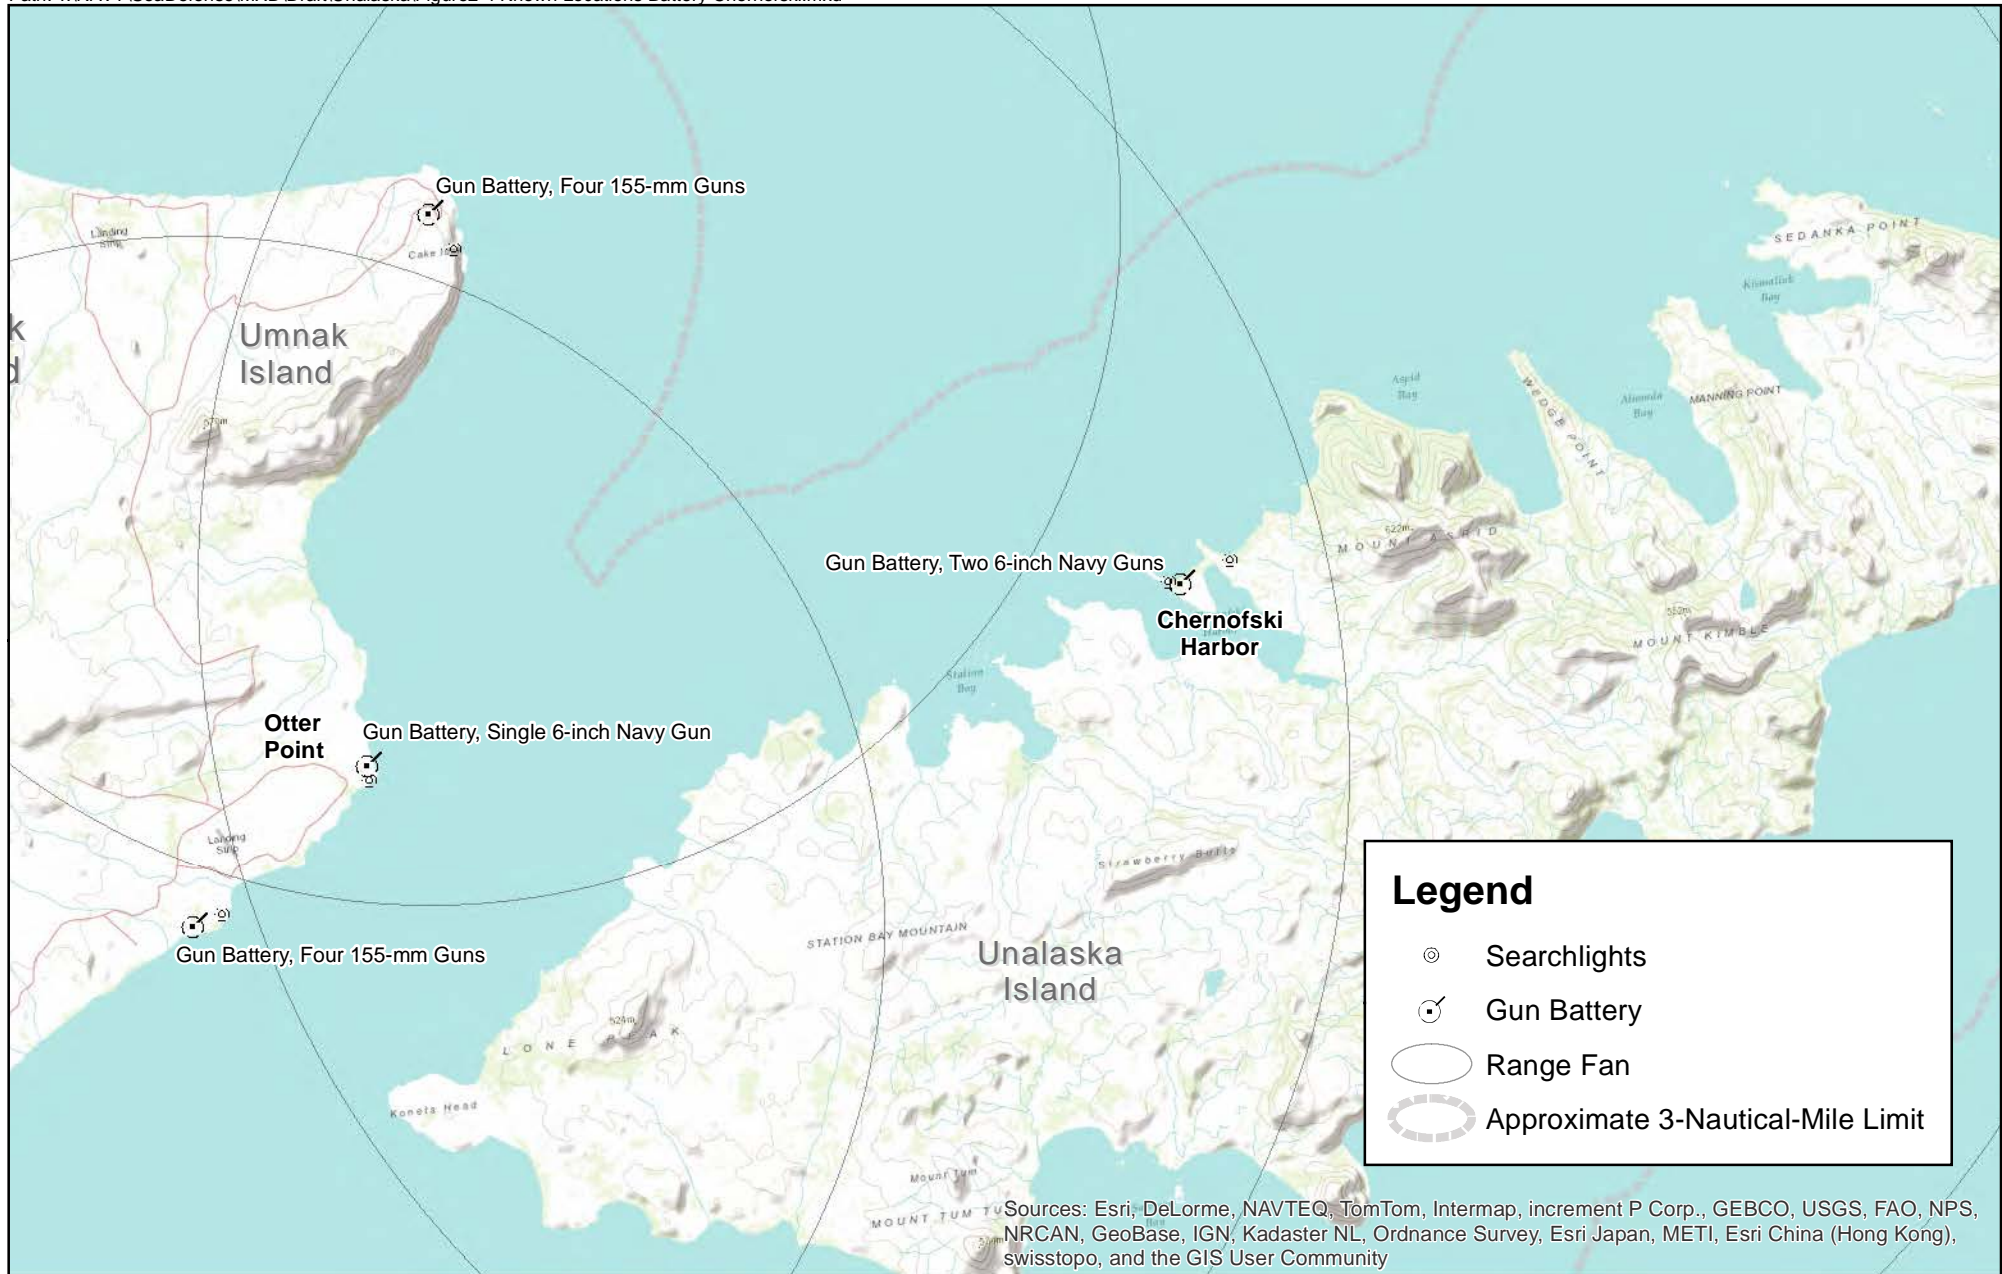
Known locations of the U.S. gun batteries and searchlights in the vicinity of Unalaska Bay are shown on Figure 2-3. Temporary AA gun batteries are not shown in the figure because they were not stationary.

However, the AATC facility at NOB Dutch Harbor was used extensively during World War II for the training of both Army and Navy personnel. The archive search for this project produced monthly reports to the Commandant of the Seventeenth Naval District indicating that thousands of men were trained at this AATC by firing at targets over Unalaska Bay. The War Diary for NOB Dutch Harbor indicates that during 1944 the AATC trained 4,860 men, while between January and August 1945 an additional 1,635 men received training (War Diary n.d.). Figure 2-3 shows the presumed danger area (range fan) associated with the AATC.

One AATC was operated on Amaknak Island (Dutch Harbor) during World War II. This was located at the northwestern base of Mount Ballyhoo where 40-mm, 20-mm, .50-caliber, and .30-caliber guns fired north-northwest over Unalaska Bay. The presumed danger area (range fan) for this AATC is shown on Figure 2-3.

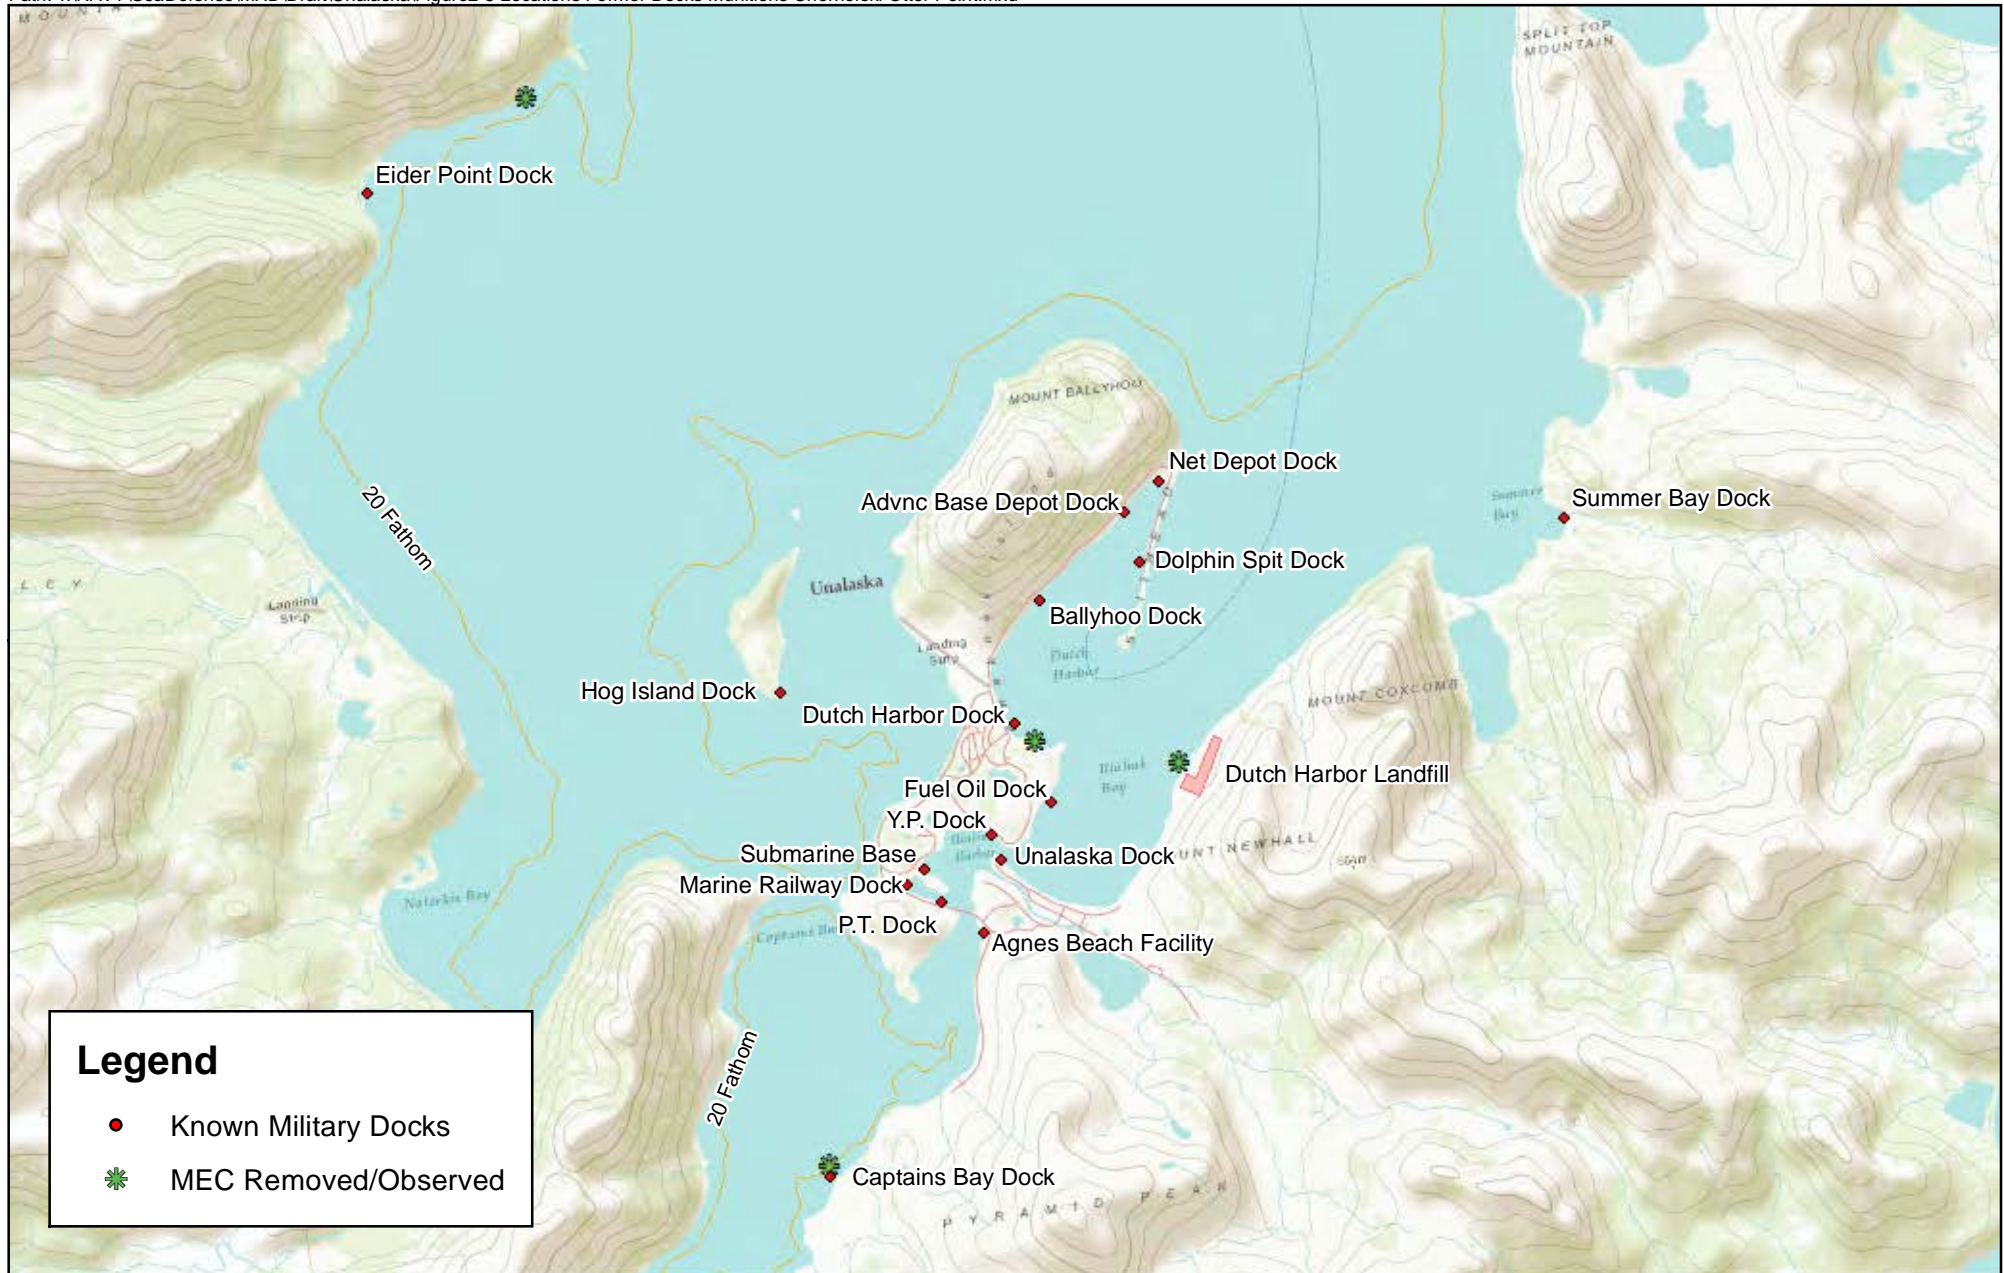
**Figure 2-5**  
**Locations of Former Military Docks and Discarded**  
**Military Munitions on the Seafloor in the Vicinity of**  
**Dutch Harbor, Unalaska Island**

The photointerpretation identified several docks where ships may have unloaded cargo. Many of the docks identified in the photointerpretation coincide with the docks identified in the historical military records. Aero-Data identified two small docks that appear to have been military docks where the seafloor could potentially contain MEC. Although there were no related historical records found during the literature search for this project, they were present near points of previous military activity and are seen on 1950 and 1951 aerial photographs. One dock is located near the south end of the spit on the east side of Mount Ballyhoo, and the other located at Eider Point (unnamed small docks on Figure 2-5).

Figure 2-5 shows the approximate locations within the Unalaska Bay area where DMM or UXO have been observed within the marine environment or removed from the seafloor and disposed of.

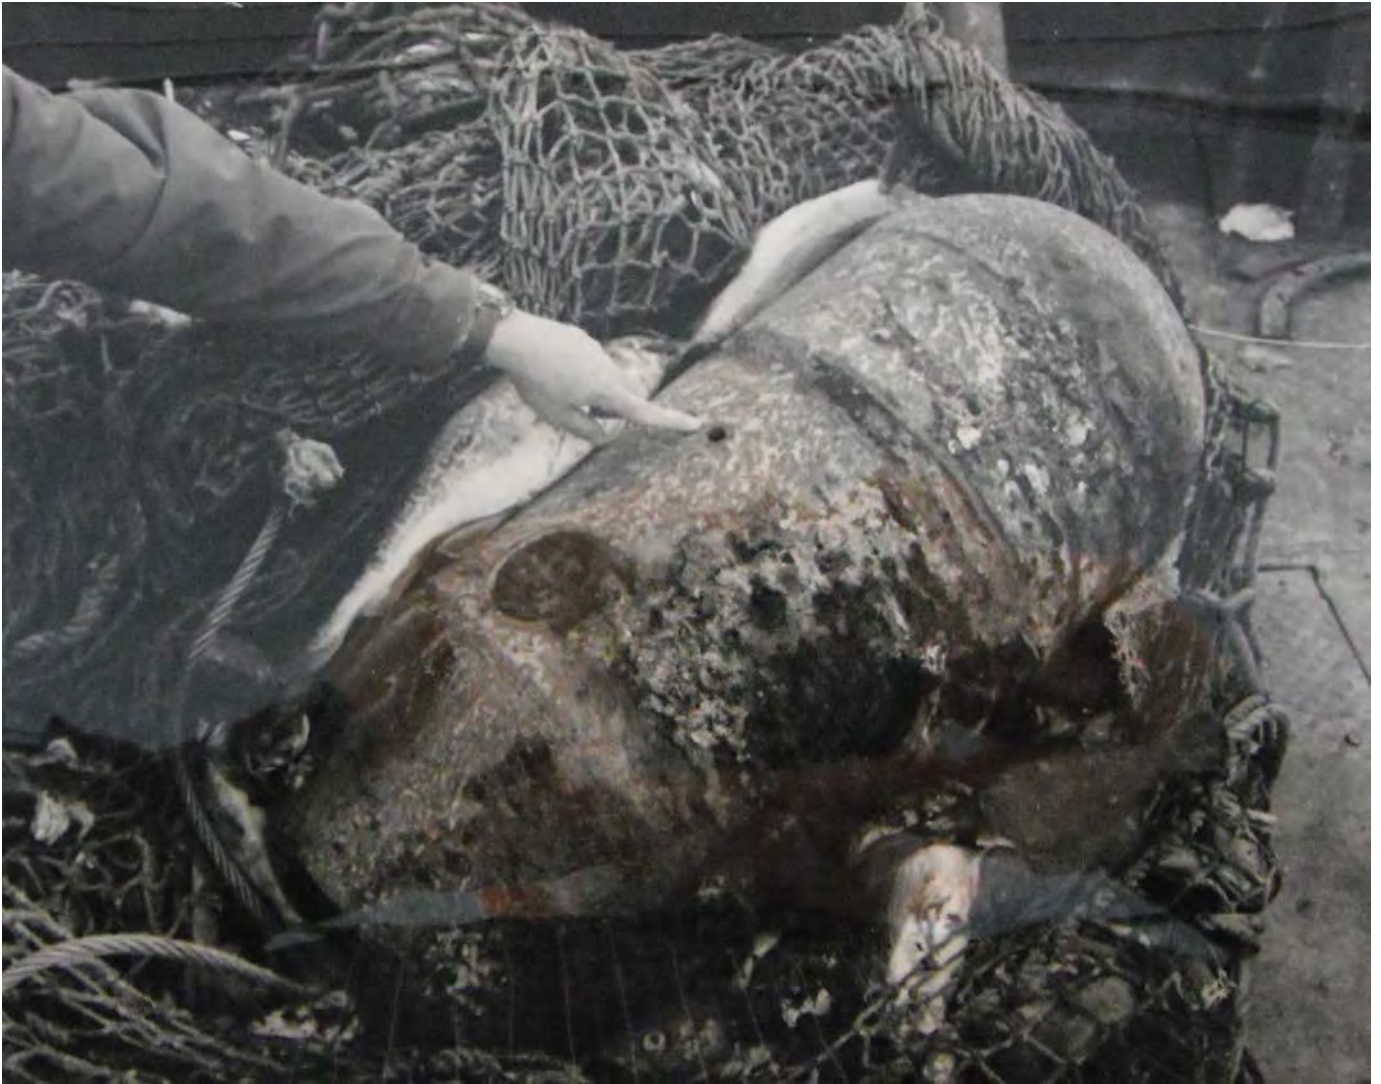
**Figure 3-1**  
**650-Pound Mk 29 Depth Bomb**  
**Snagged in a Fishing Net Off Kodiak Island, 1974**

Although no empirical evidence exists regarding the rate of corrosion or encrustation acting on MEC in the marine environment at Unalaska Island, a photograph was taken of an unexploded depth bomb that was snagged in a net by fishers near Kodiak Island during 1974. The photograph shows very little corrosion and/or encrustation of this ordnance item after approximately 30 years in the marine environment (Figure 3-1).

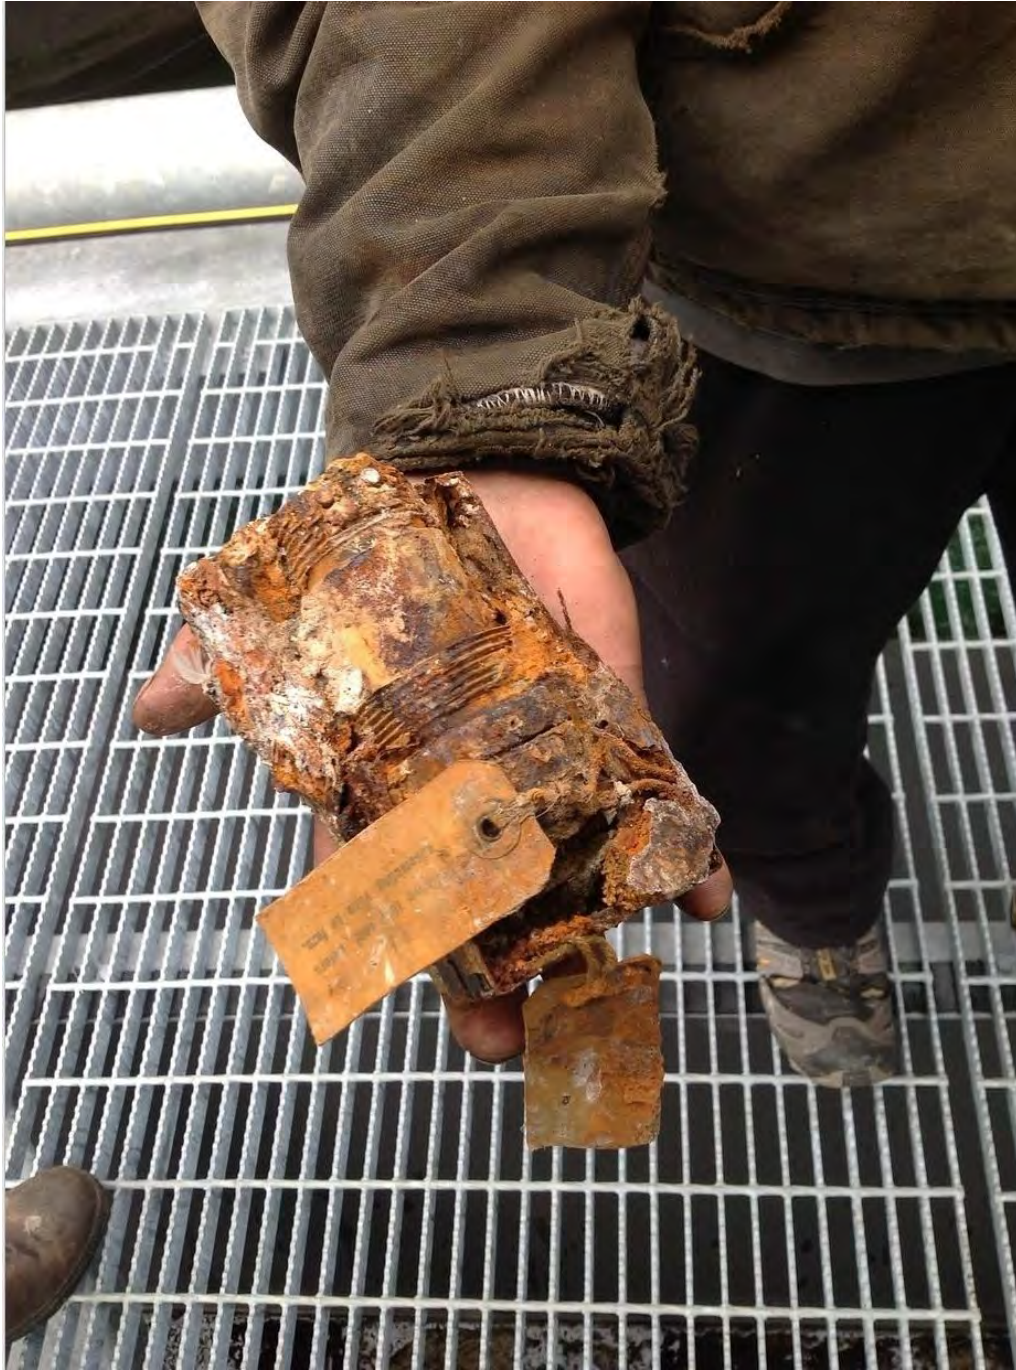
**Figure 3-2**  
**Land Mine Pulled Up from the Seafloor**  
**During Deep-Water Fishing Off Dutch Harbor in June 2012**

During fishing operations, MEC have been pulled up in fishing equipment at depths greater than 20 fathoms (120 feet). The skipper of the *Aleutian Sable* said that he has found ordnance on several occasions, as recently as June 2012, near the Chelan Bank where he fishes (Hebert 2012). The *Aleutian Sable* typically fishes for sablefish in water that is 250 to 450 fathoms (1,500 to 2,700 feet), but has fished as deep as 650 fathoms (3,900 feet) (see Figures 3-2 and 3-3). This area is much deeper than the 20-fathom limit (120-foot) specified in the Navy MRP and should be reason for concern, because a complete pathway of exposure to MEC exists.

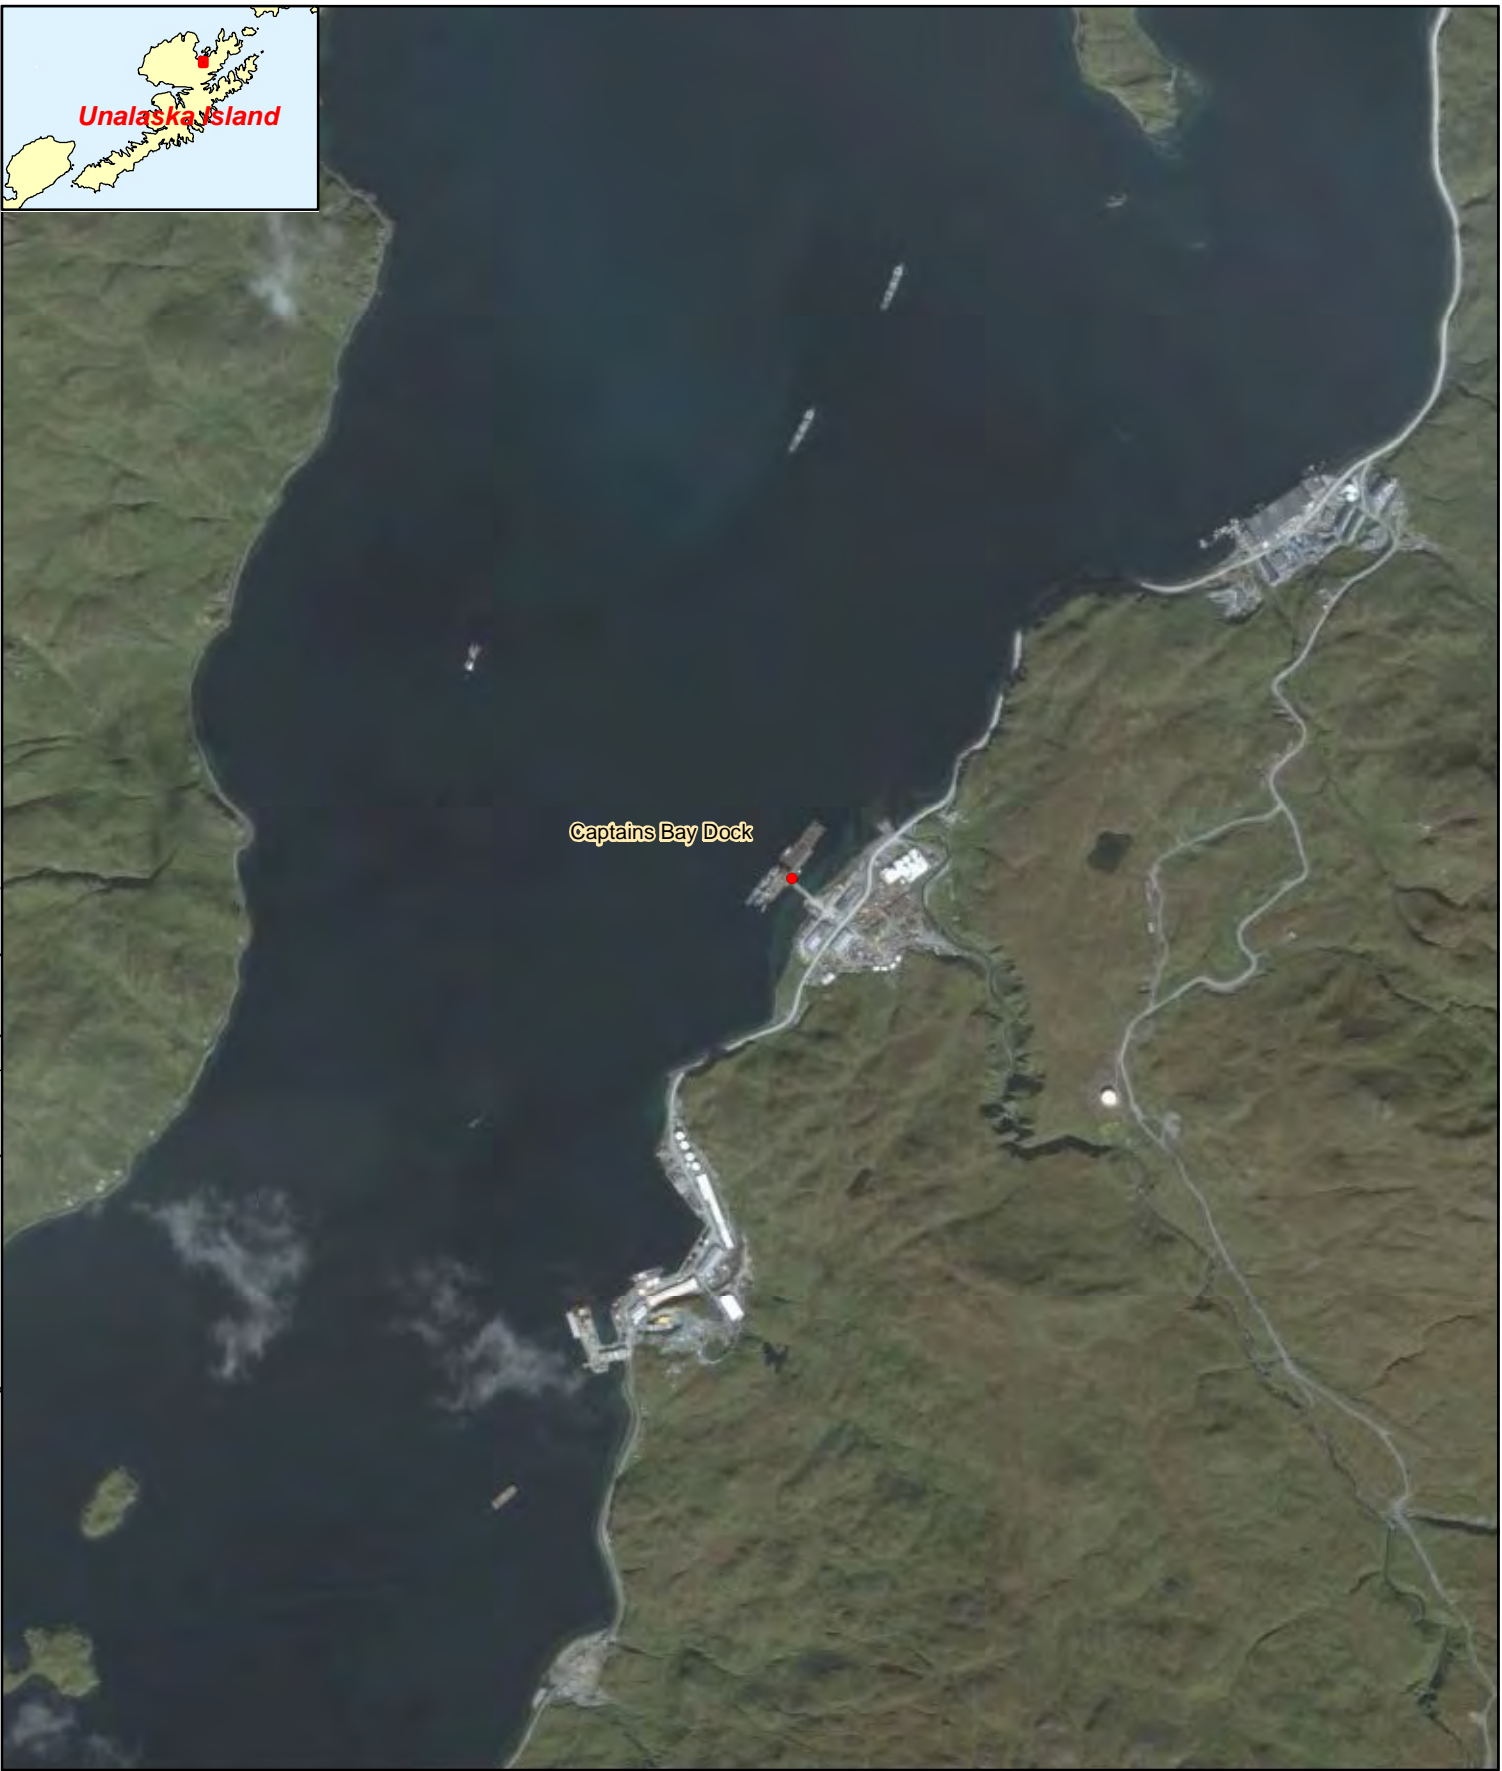
<p>0 750 1,500 Scale In Feet</p>	<p><b>Figure 4-3</b> <b>Location of Former Military Dock</b> <b>Within Captains Bay Where</b> <b>the Seafloor Could Potentially</b> <b>Contain MEC, Unalaska Island</b></p>
------------------	---	--	---

- Areas of the seafloor surrounding the former Navy dock in Captains Bay, as shown on Figure 4-3: This dock was also heavily used during World War II as a transshipment point for ordnance and other supplies destined for Aleutian bases farther west.
