May 3, 2013

# Preliminary Assessment Report for Naval Defensive Sea Area

## **Unalaska Island Alaska**

**Department of the Navy  
Naval Facilities Engineering Command Northwest**  
1101 Tautog Circle  
Silverdale, WA 98315

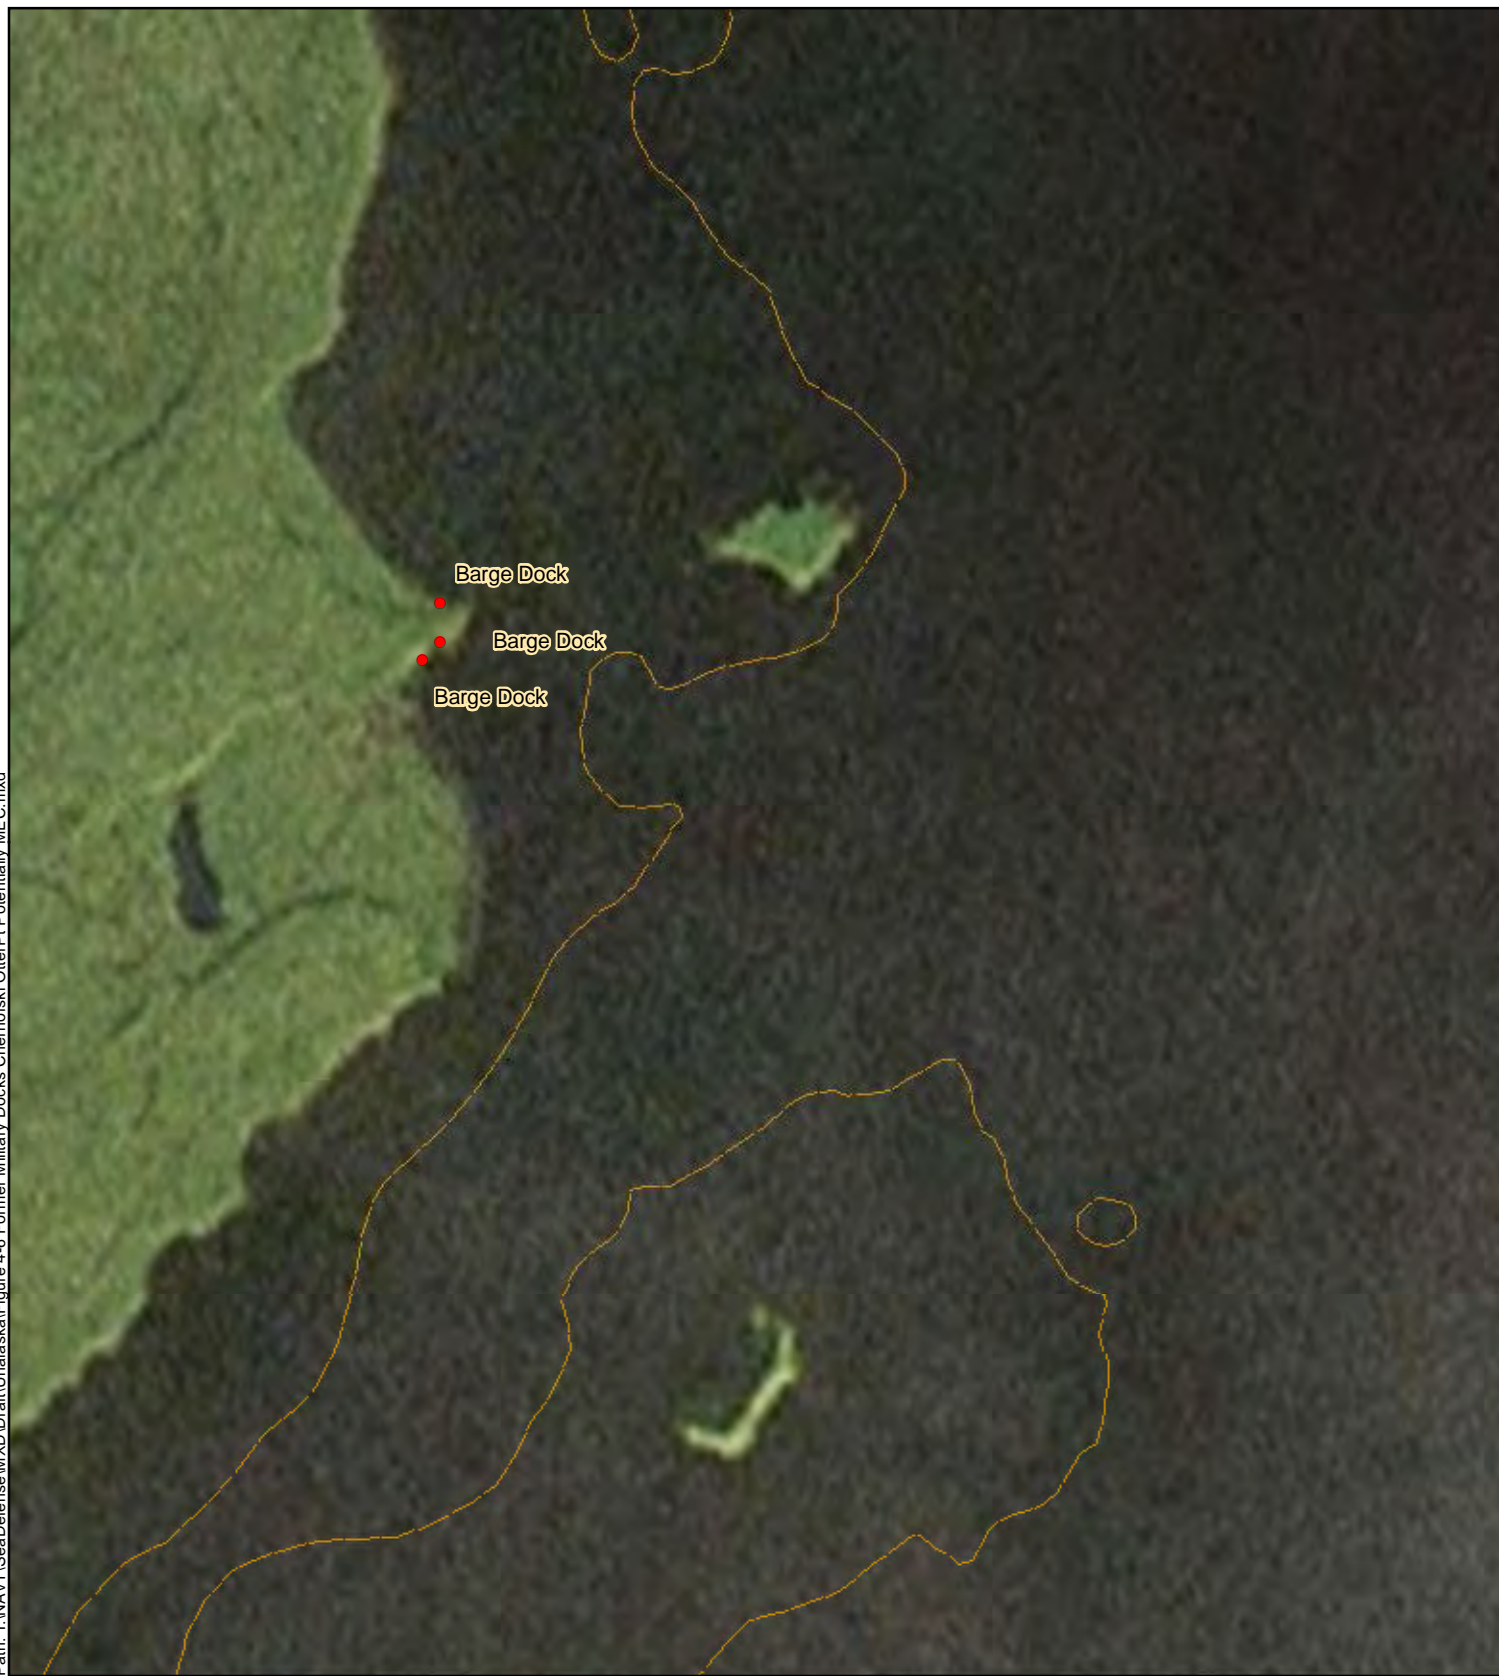
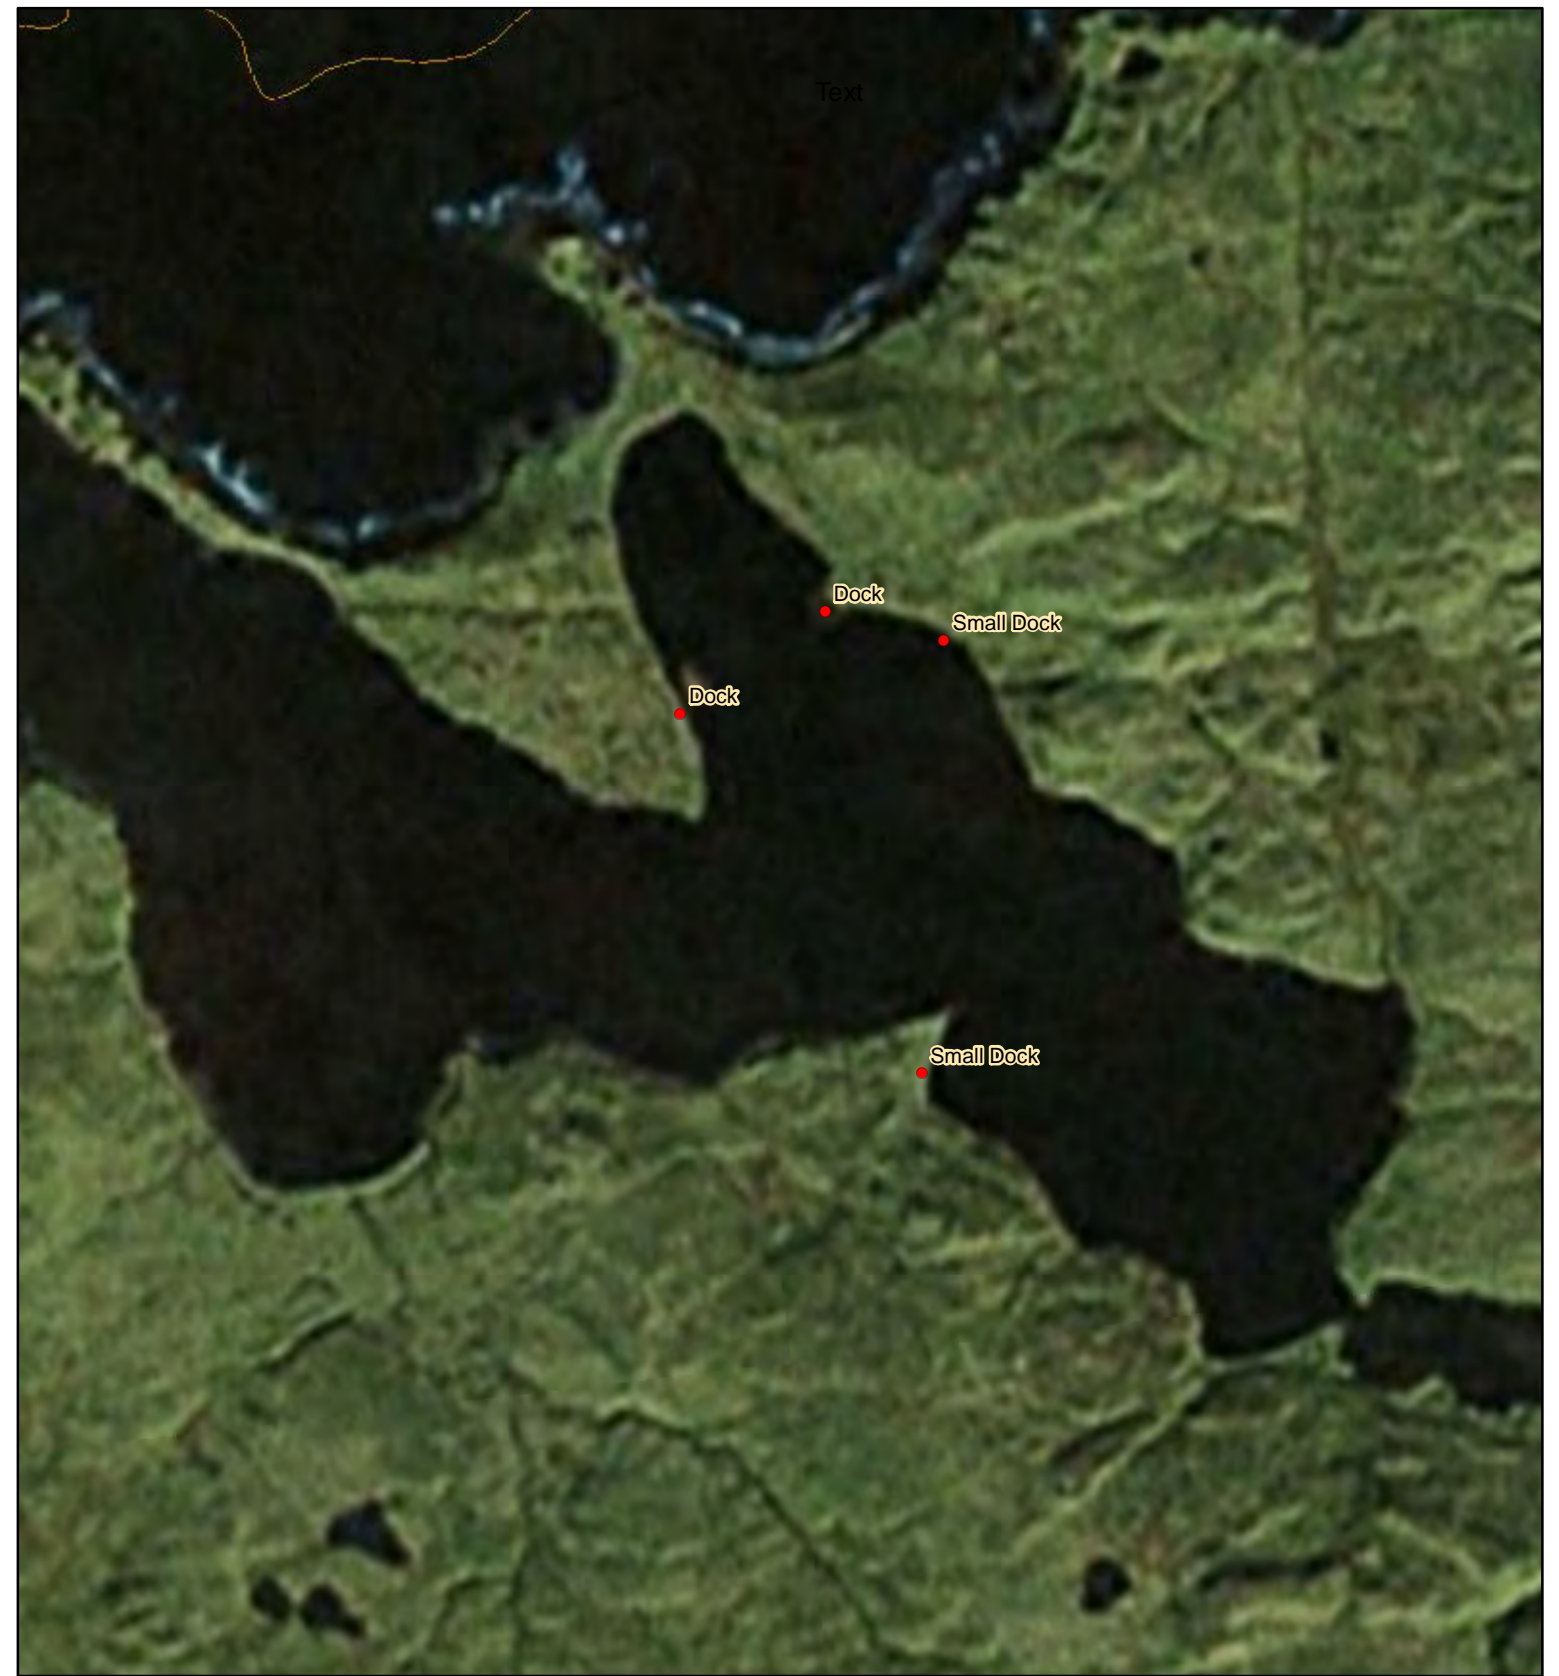
<p><i>Unalaska Island</i></p>	<p><b>Legend</b></p> <p>— 20 Fathom Contour</p>	<p><b>Figure 4-6</b> <b>Locations of Former Military Docks Within Chernofski Harbor and at Otter Point Where the Seafloor Could Potentially Contain MEC, Unalaska Island</b></p>
------------------	---	---	---	---	--

The locations of known docks in the Chernofski Harbor and Otter Point area are shown on Figure 2-6. Chernofski Harbor included a main pier that measured 72 by 402 feet, three barge docks, and a separate repair dock; however, the locations of four of these docks could be identified in Figure 2-6. Three barge docks were also constructed at Otter Point (Fort Glenn) at the following locations:

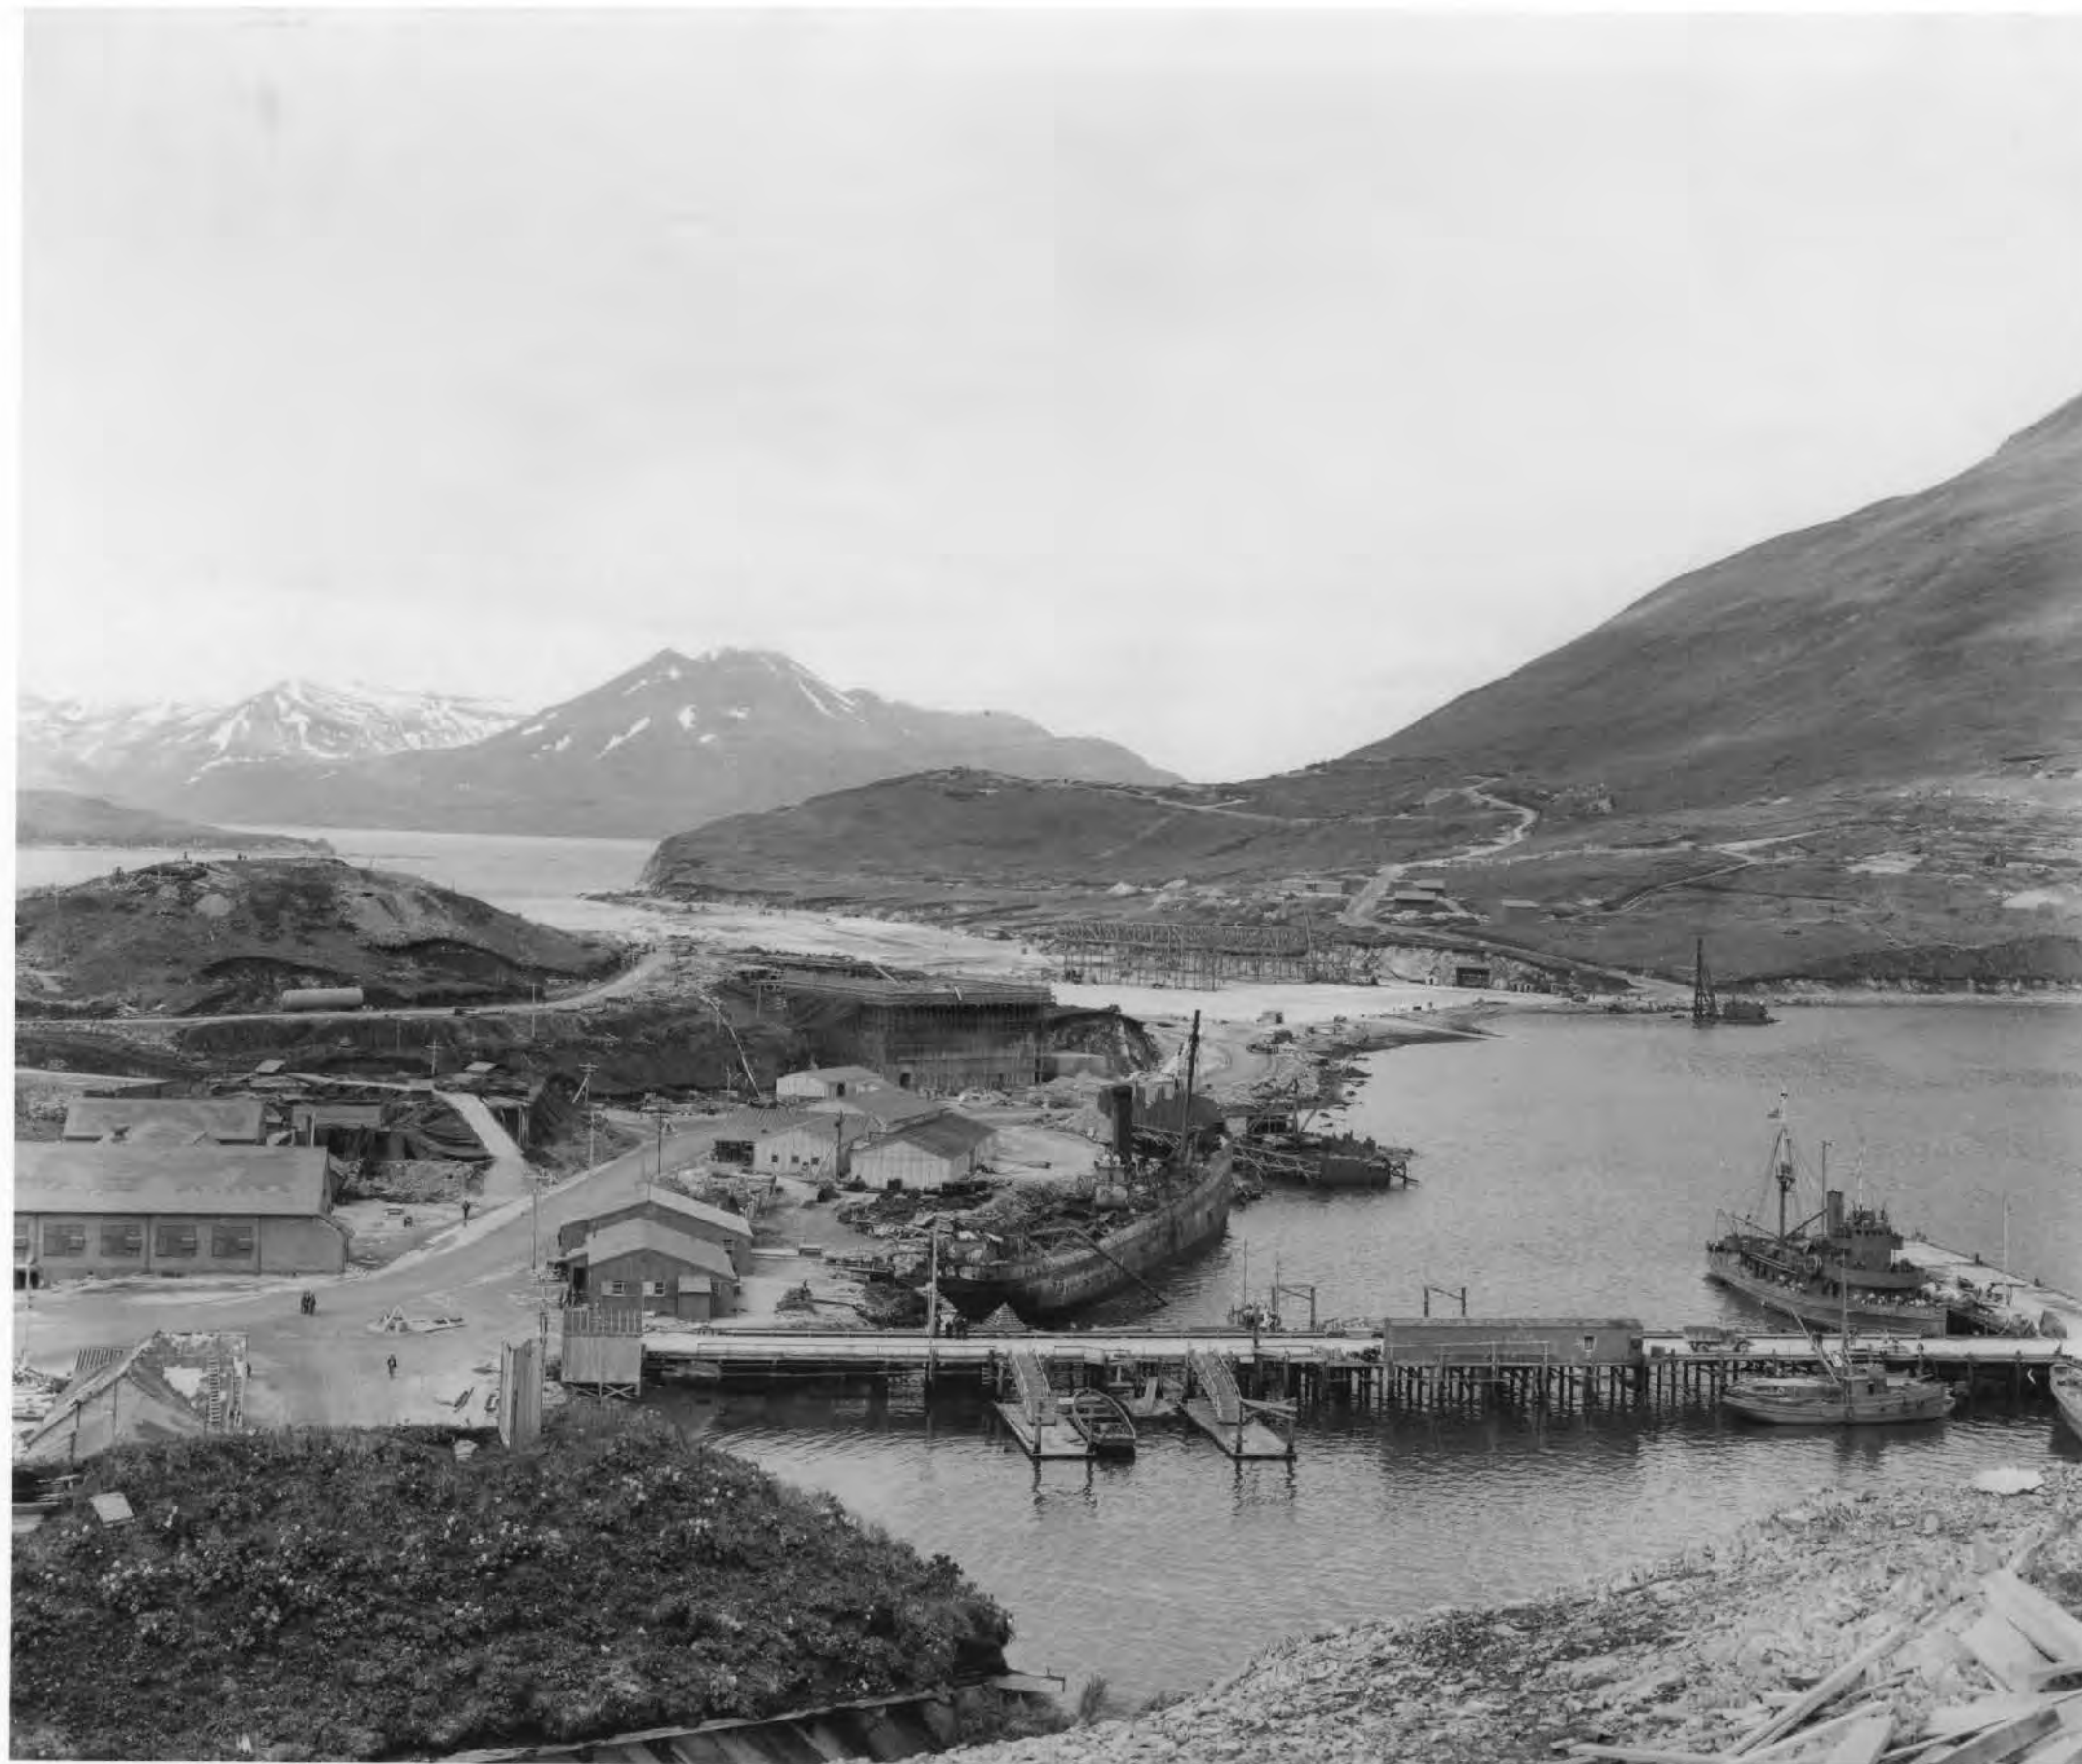
**Exhibit 15 - Unalaska**  
**Dutch Harbor**  
**6/27/1942**

VIEW OF THE DUTCH HARBOR NAVAL AIR STATION, ON 27 JUNE 1942. THE BURNED OUT S.S. NORTHWESTERN IS AT CENTER. SHE HAD BEEN HIT IN THE JAPANESE AIR RAID ON 4 JUNE 1942.

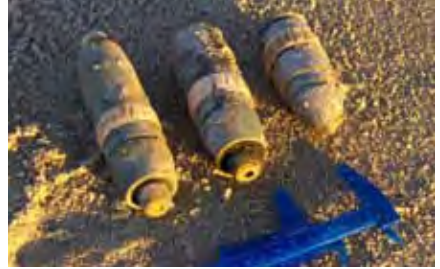
*Unexploded Ordnance Recovered During Dredging*

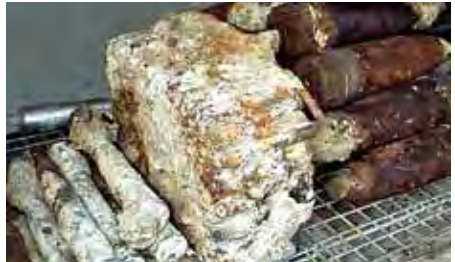
*Various Recovered Projectiles*

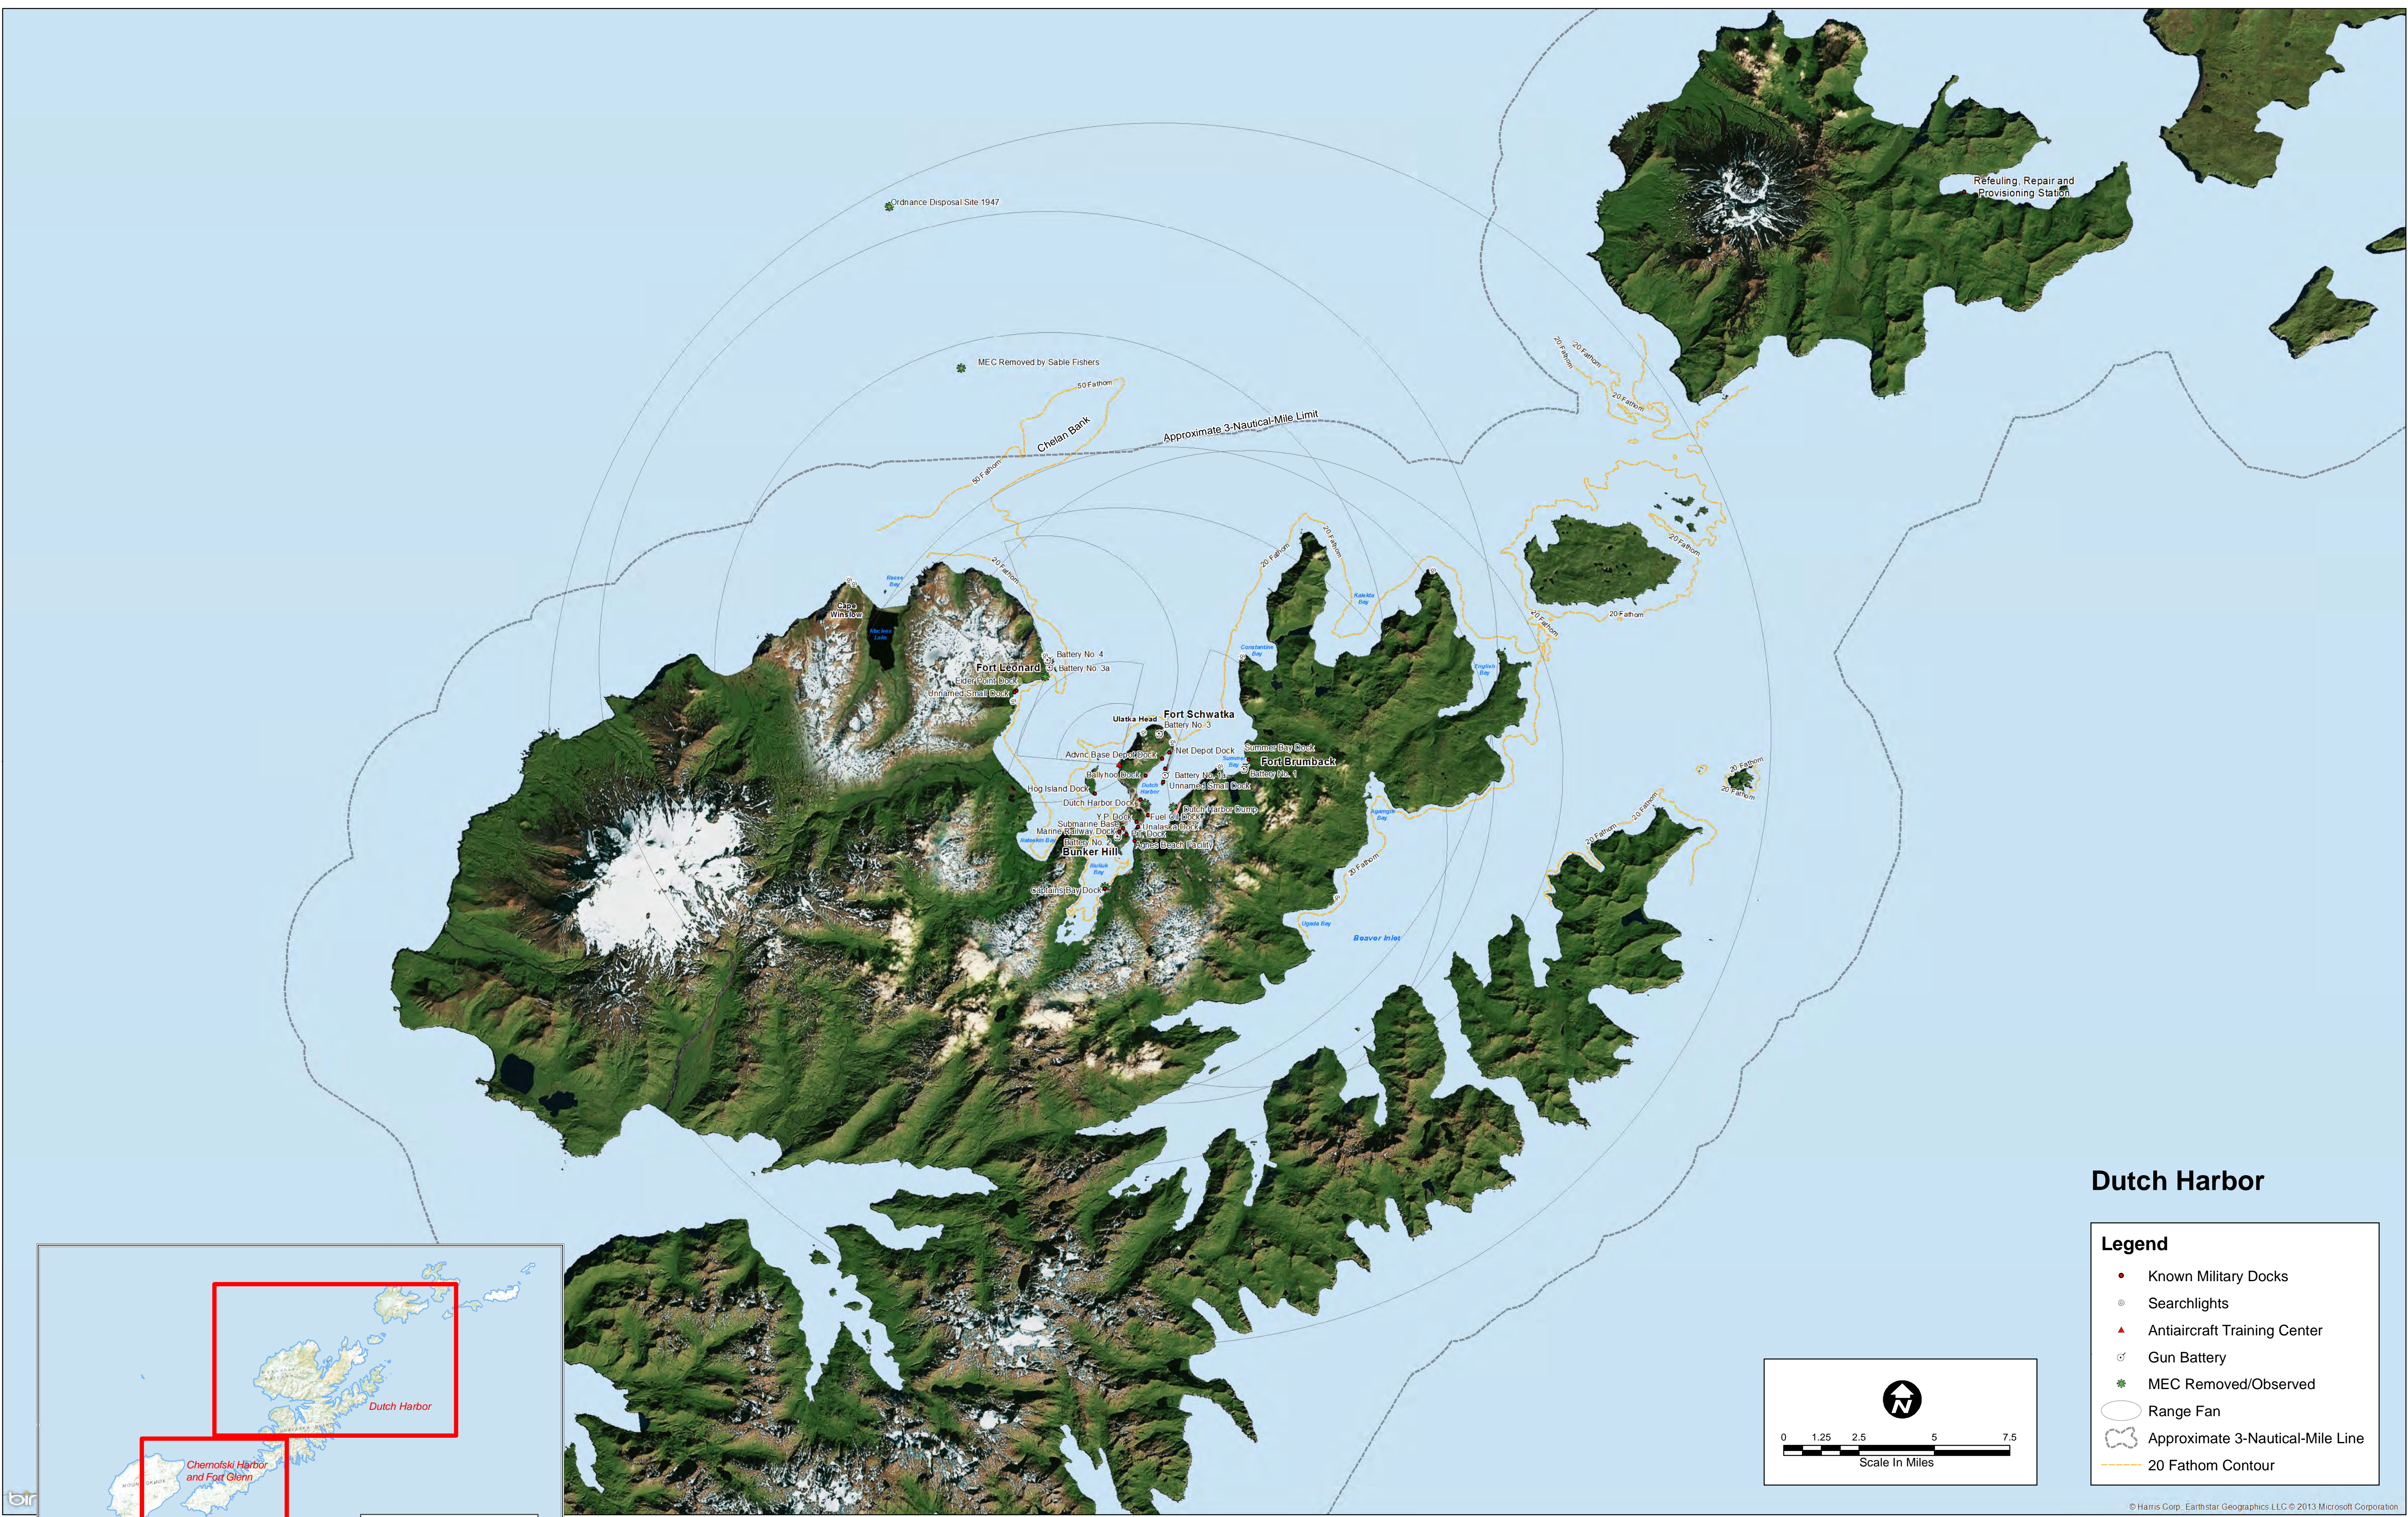
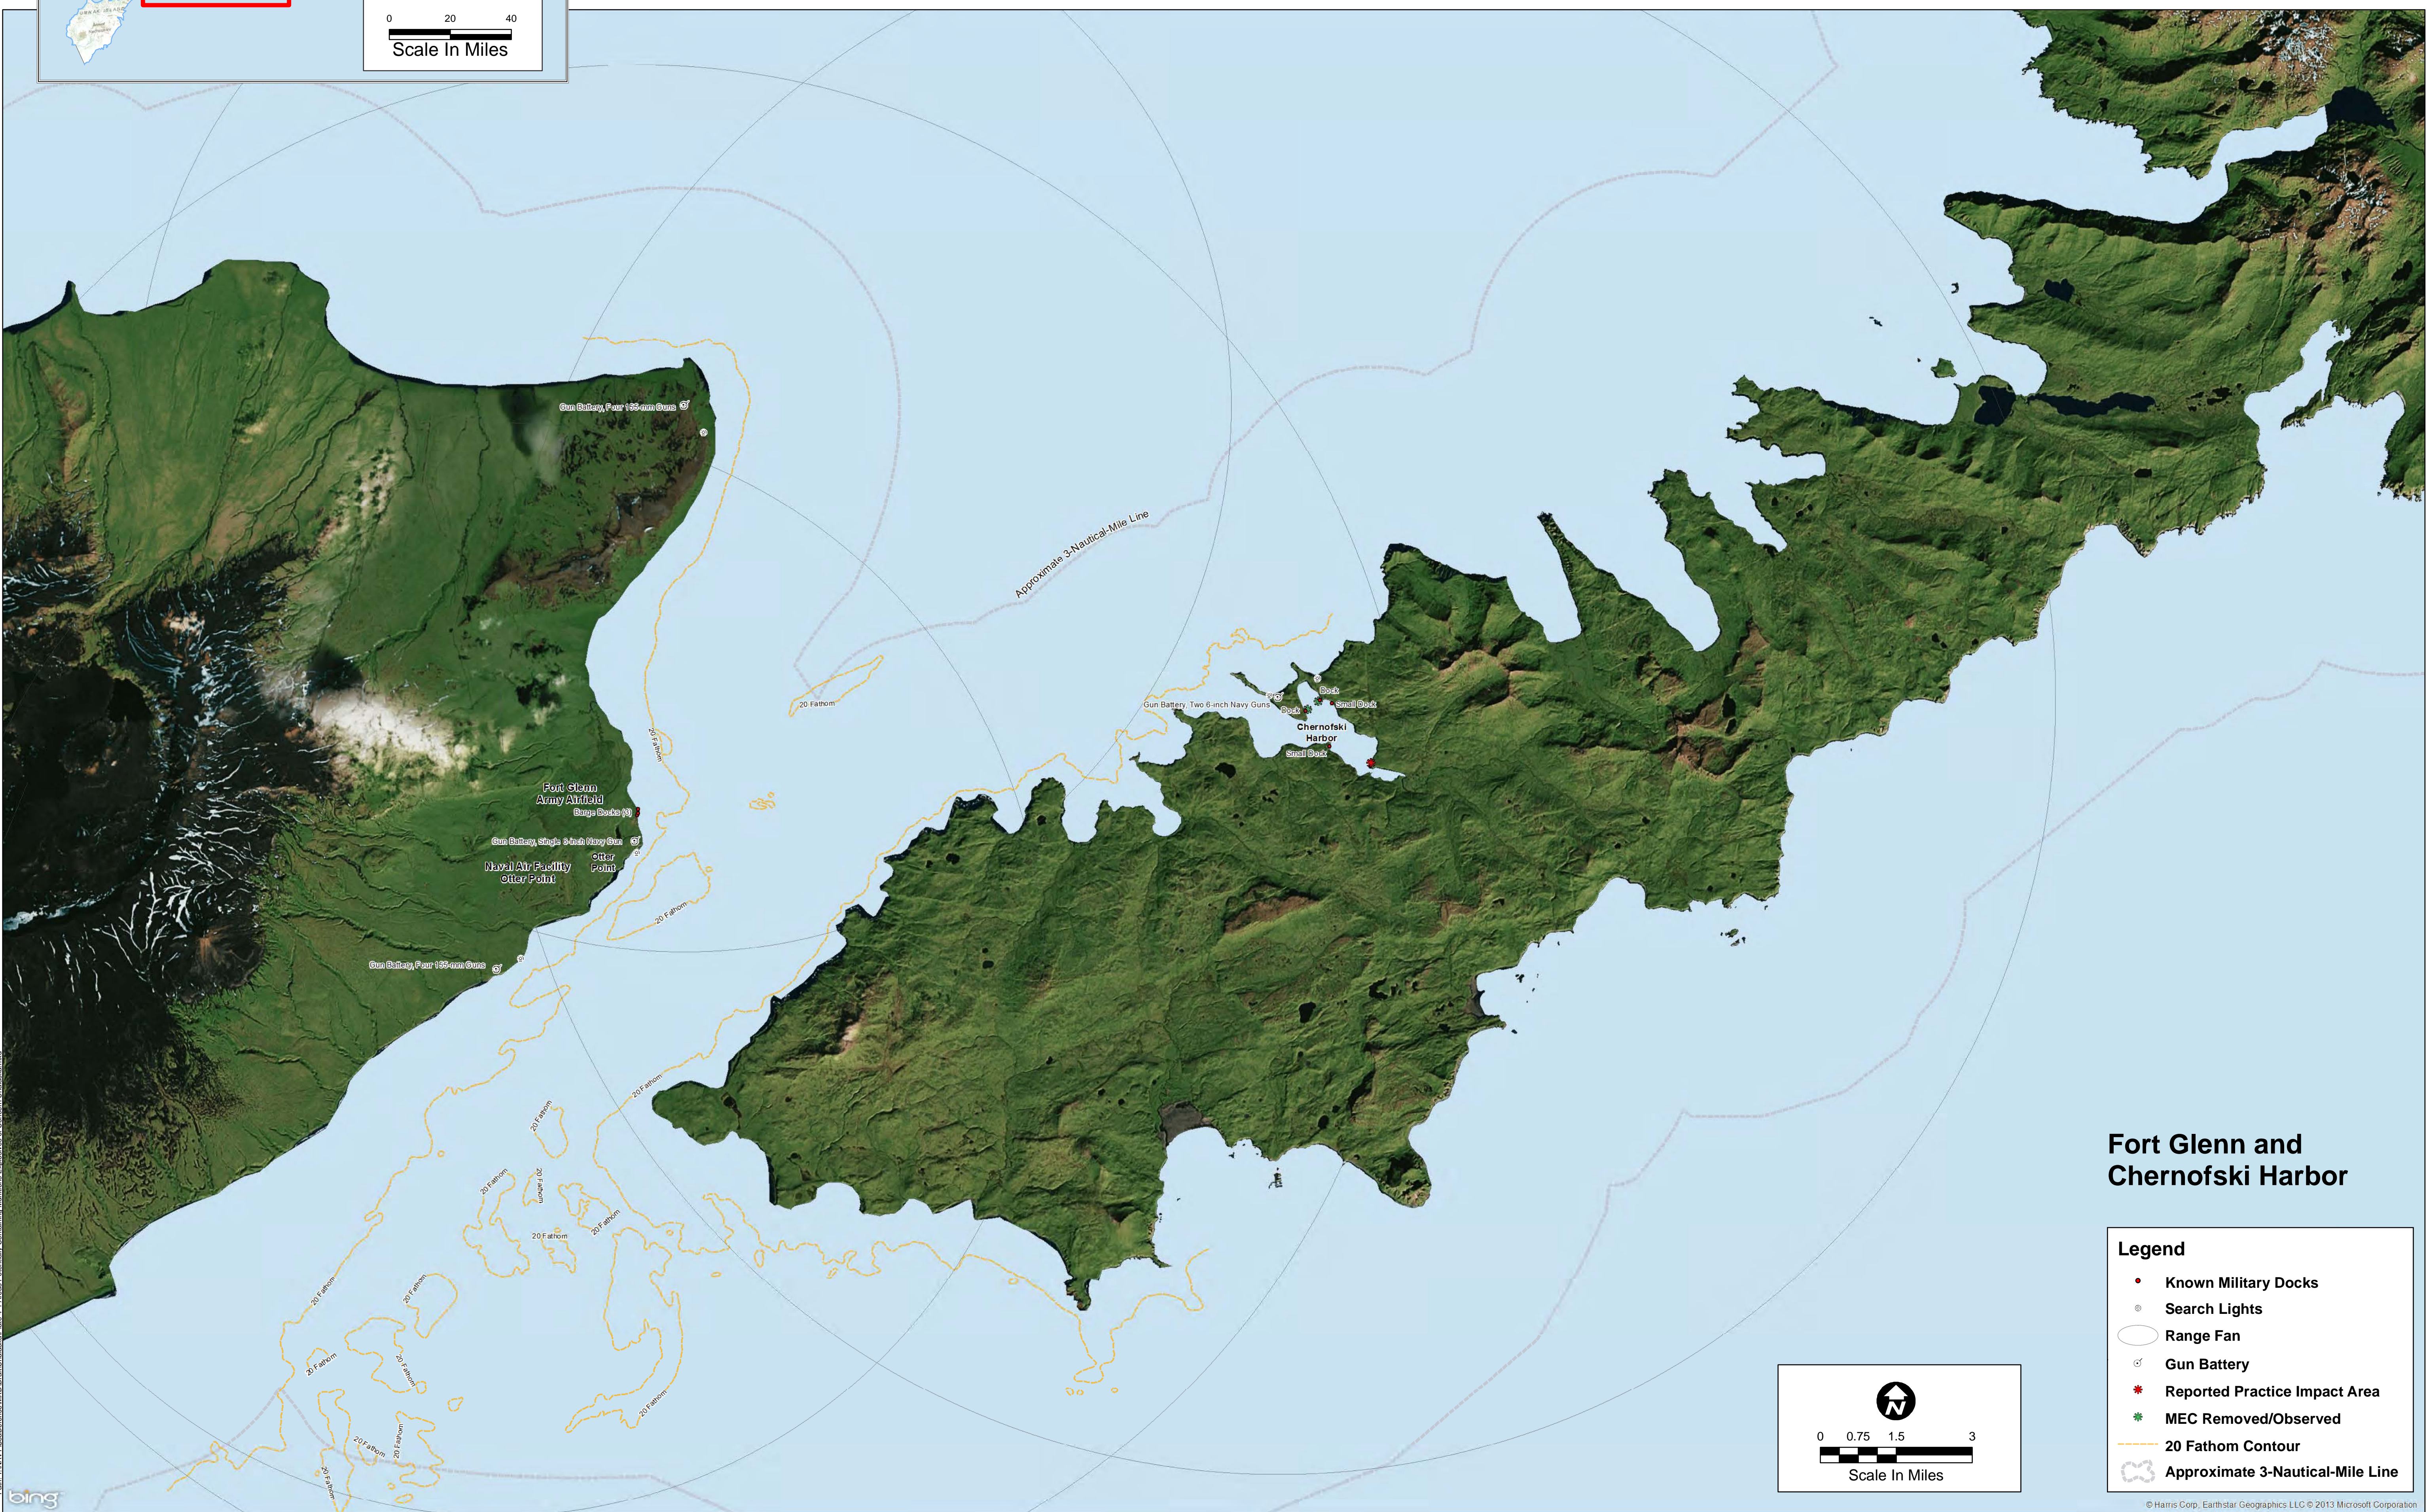
**Plate 4-1**

The sources of MEC released into the marine environment of the Unalaska Island NDSA by U.S. forces consist of CDA and AA gun batteries, an AATC, on-water ordnance transfer operations, and ordnance disposal following the war. Locations identified by this PA where these actions occurred are shown on Plate 4-1. This plate also shows the ranges of CDA guns which are represented by the gray circles and arcs.

**Locations of Areas Potentially Containing Munitions and Explosives of  
Concern within the Naval Defensive Sea Area at Unalaska Island**

Information reviewed for this PA report identified U.S. CDA and AA gun batteries on Unalaska Island consisting of two 8-inch CDA guns, two 6-inch CDA guns, eight 155-mm CDA guns, six 90-mm AMTB guns, twelve 3-inch AA guns, twenty-seven 37- or 40-mm AA guns, twenty-two 20-mm AA guns, twenty-eight .50-caliber machine guns associated with the gun batteries, and .30-caliber machine guns associated with several searchlight installations. The area covered by these gun batteries included a large expanse of ocean surrounding Unalaska Harbor (see Plate 4-1).

In addition, the following CDA, AA, or other large-caliber guns were identified in the Chernofski Harbor and Otter Point areas: three 6-inch CDA guns, eight 155-mm CDA guns, twelve 105-mm howitzers, sixteen 3-inch AA guns, thirty-two 37-mm AA guns, forty 20-mm AA guns, thirty-two .50-caliber machine guns, eighteen 60-mm mortars, and twelve 81-mm mortars. These gun batteries were concentrated in the Umnak Pass to Cape Idak to Chernofski Harbor area. The estimated area covered by these gun batteries is shown on Plate 4-1.
