**Preliminary Assessment for
Per- and Polyfluoroalkyl Substances (PFAS) Ault Field**

Naval Air Station Whidbey Island
Oak Harbor, Washington

November 2018

Prepared for NAVFAC Northwest
by CH2M HILL, Inc.
Bellevue, Washington
Contract N62470-16-D-9000
CTO 4041

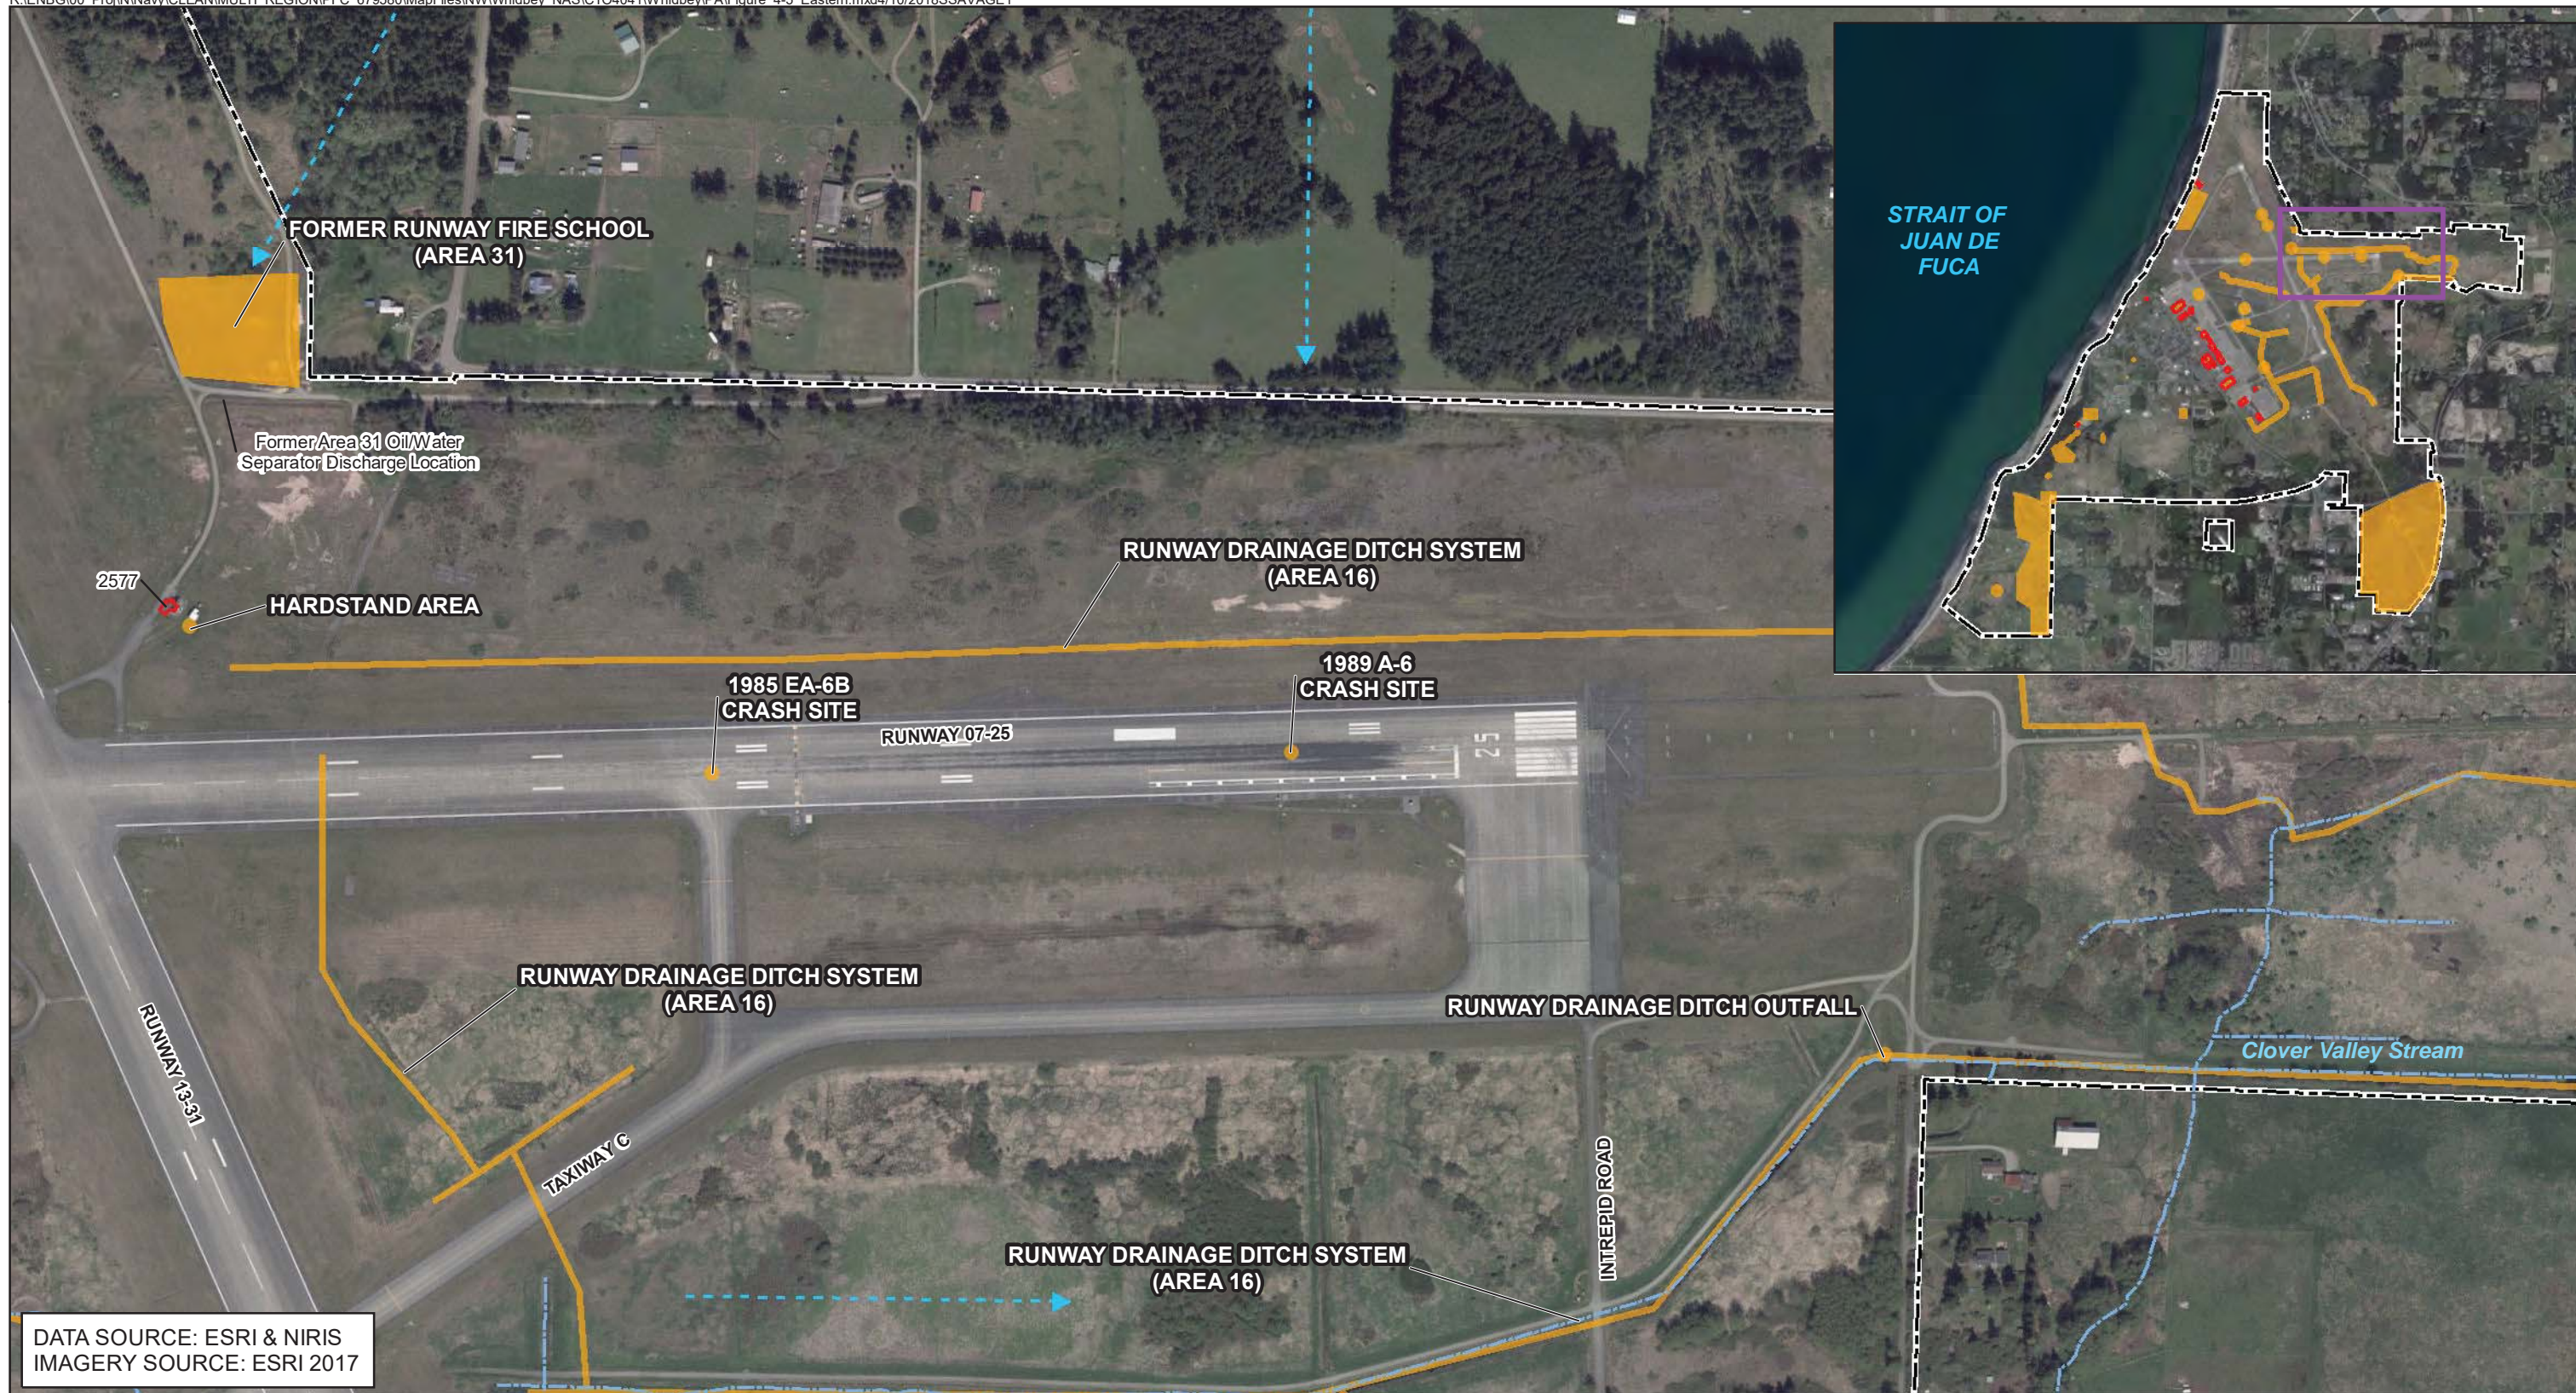
Figure 4-5
 Potential PFAS Release Areas - East
 Naval Air Station Whidbey Island
 Oak Harbor, Washington

The Hardstand Area is located in the northeastern portion of Ault Field directly south of the Former Runway Fire School (Area 31), adjacent to Building 2577 (**Figure 4-5**). The Hardstand Area is along an unnamed road leading to the Former Runway Fire School and is surrounded by grass-covered areas. The approximate geographic coordinates for the Hardstand Area are 48°21'14.360"N and 122°39'12.058"W.

It is possible that minor amounts of AFFF or water could have leaked or spilled from the fire crash trucks as they were stationed here. Any AFFF would have flowed off the pavement to topographically low areas along the edge of the road and infiltrated to groundwater. Apparent groundwater flow near the Hardstand Area is generally to the south towards the runways (**Figure 4-5**). Depth to the surficial aquifer at this location is assumed to range from 5 to 8 feet bgs. Groundwater at Ault Field is not used as a drinking water source; therefore, there is no current exposure pathway for groundwater to on-Base residents or workers through drinking water. There are 630 private and/or community water wells within 4 miles, seven of which have concentrations of PFOS or PFOA above the LHA (**Section 2.3**). Two of the seven wells with exceedances are located 1.4 miles to the southeast and 2.5 miles to the southwest, while five of the wells are grouped in relatively small cluster 3.1 miles to the south. The groundwater flow direction between this location and the water wells is not entirely known, which presents a potential exposure pathway for off-Base residents (CH2M, 2017b).

Any AFFF or PFAS-contaminated water flowing through the Runway Drainage Ditch System could have leached into groundwater at this location. Groundwater flow direction in the vicinity of the Runway Drainage Ditch System is generally to the east towards Dugualla Bay (**Figure 4-5**). Depth to the surficial aquifer at this location is not known due to a lack of monitoring wells in the area. Groundwater at Ault Field is not used as a drinking water source; therefore, there is no current exposure pathway for groundwater to on-Base residents or workers through drinking water. There are 630 private and/or community water wells within 4 miles, seven of which have concentrations of PFOS or PFOA above the LHA (**Section 2.3**). Two of the seven wells with exceedances are located 0.6 mile to the southeast and 3.2 miles to the southwest, while five of the wells are grouped in relatively small cluster 2.9 miles to the south. The groundwater flow direction between this location and the water wells is not entirely known, which presents a potential exposure pathway for off-Base residents (CH2M, 2017b).

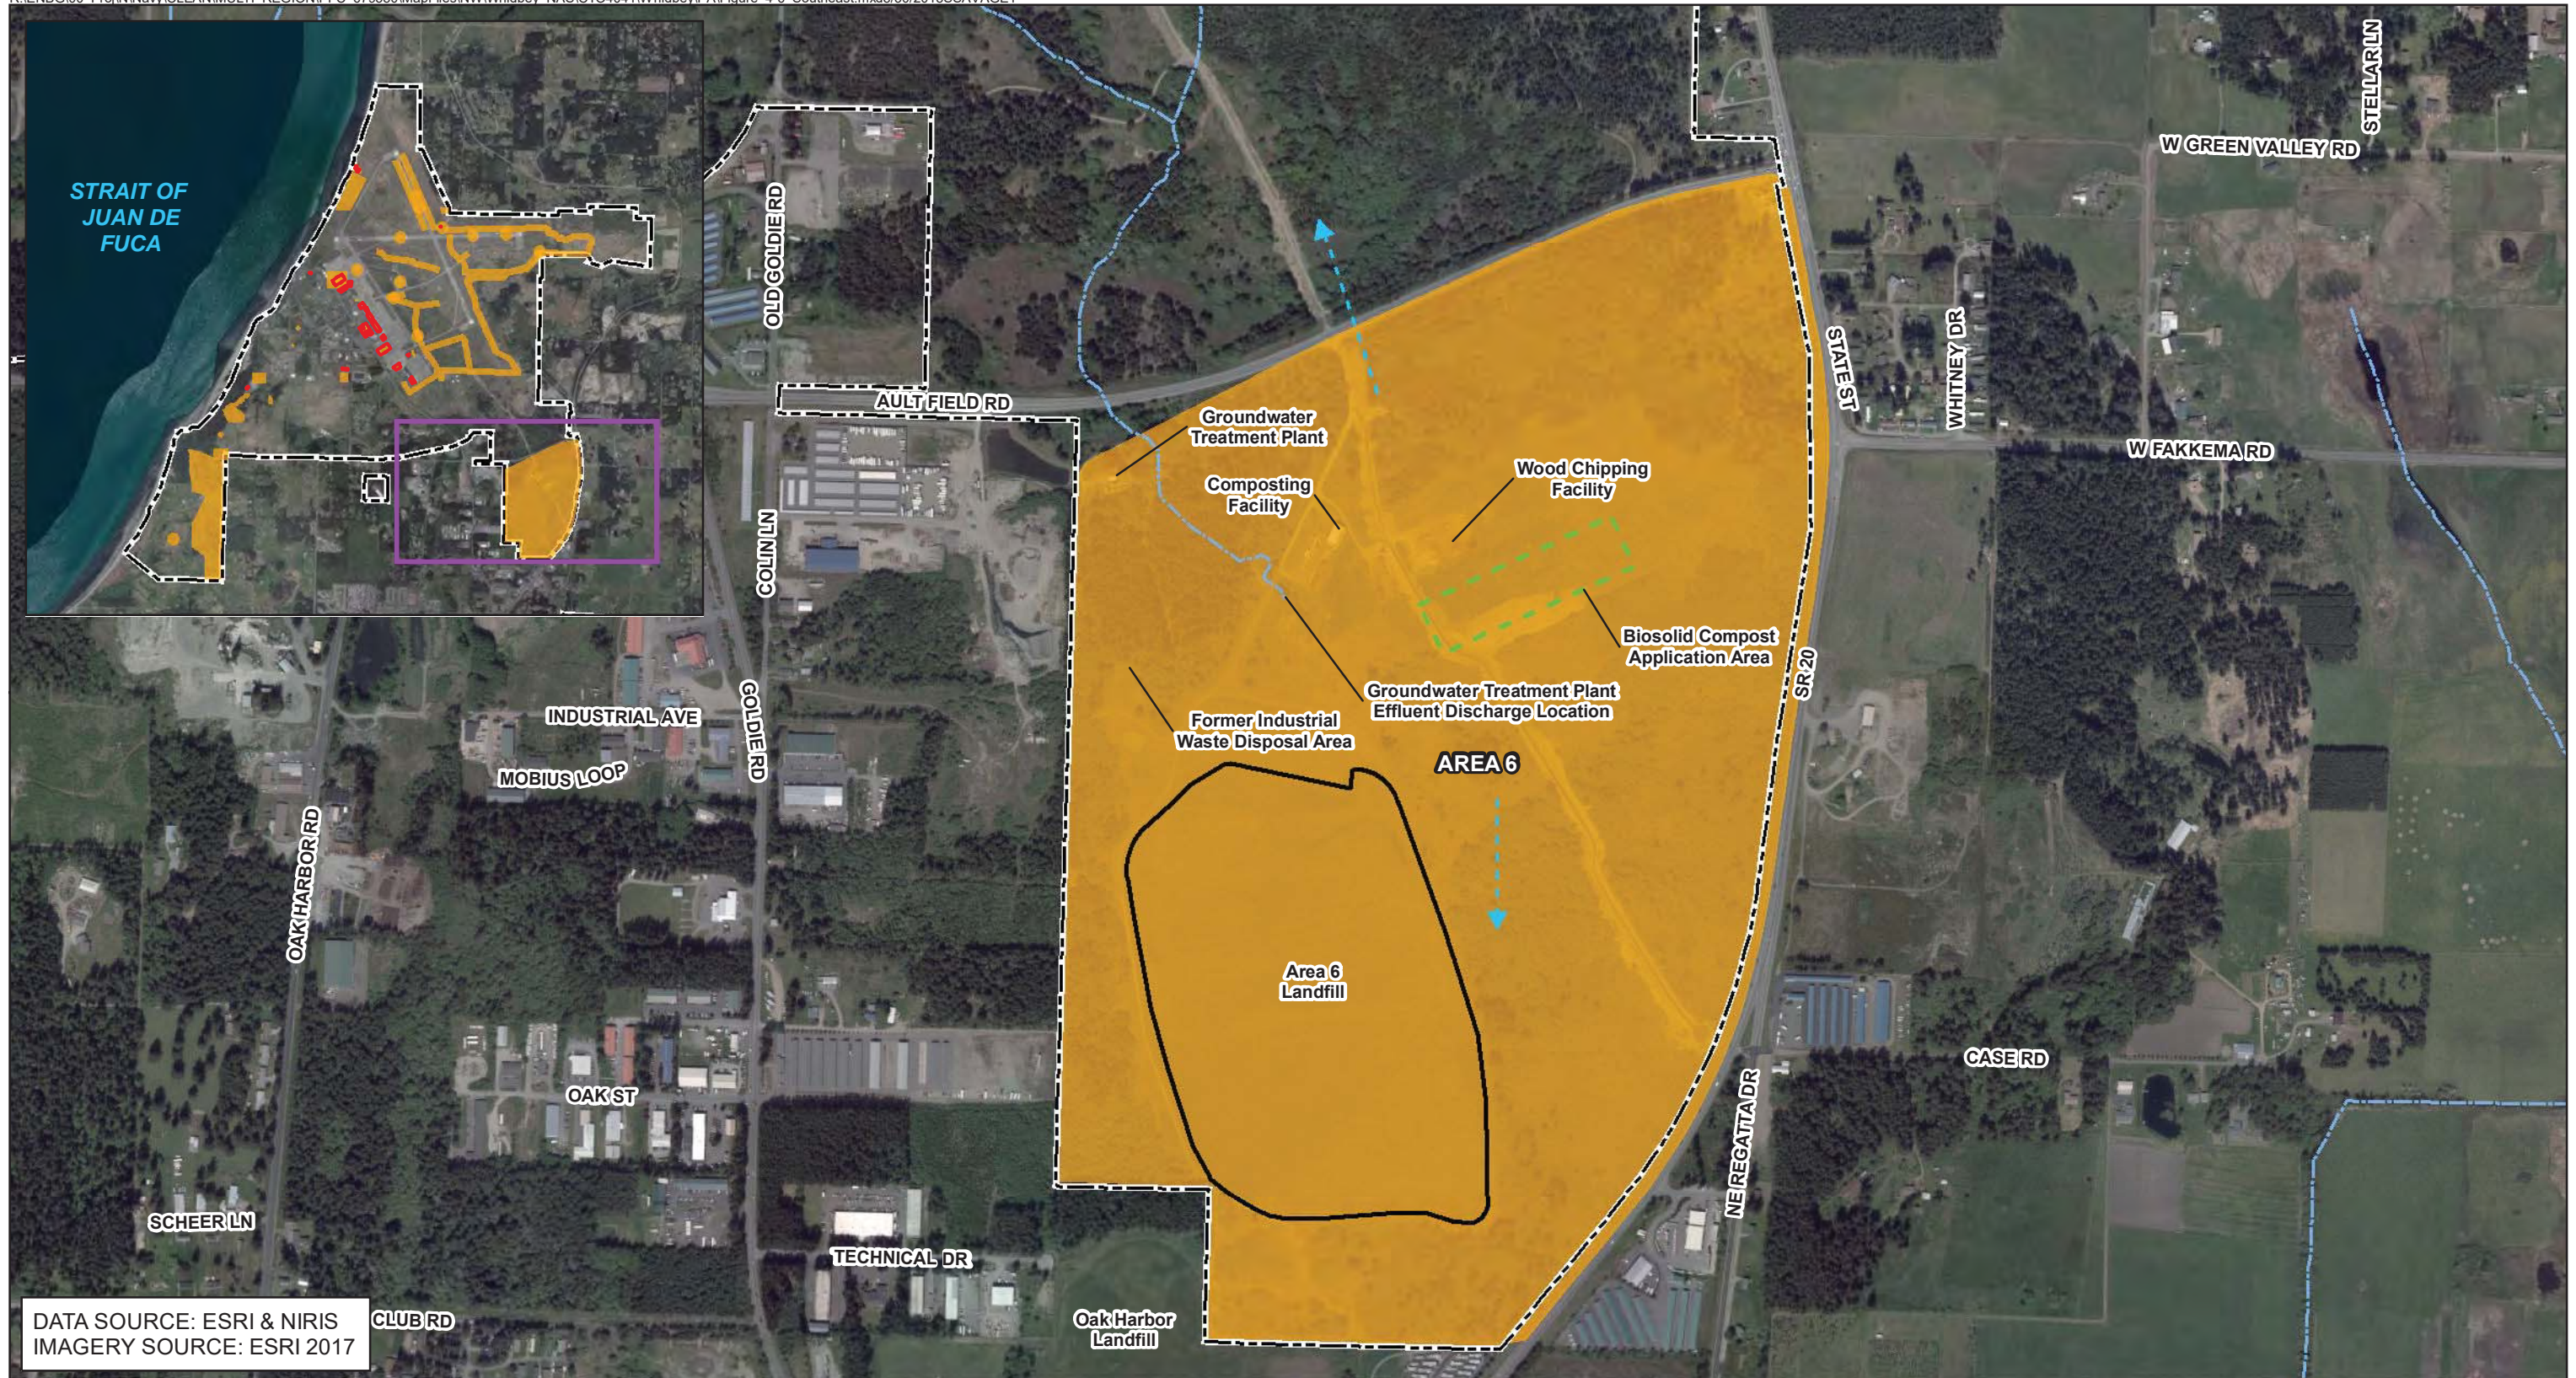
Figure 4-6
Potential PFAS Release Areas - Area 6
Naval Air Station Whidbey Island
Oak Harbor, Washington

The former industrial waste disposal area is located northwest of the Area 6 landfill (**Figure 4-6**). It is estimated that approximately 700,000 to 3,000,000 gallons of acids, caustics, solvents, and potentially PFAS-containing solutions between the 1970s and 1980s (CH2M, 2017c).

The composting facility is located north of the Area 6 landfill and west of the wood chipping facility (**Figure 4-6**). According to the Hazardous Waste Manager, starting in 2009, biosolids from the current WWTP have been sent to the composting facility and eventually spread out at the application area east of the wood chipping facility (Hazardous Waste Manager, 2017, pers. comm.; **Appendix B**). In 2014, a release of approximately 3 gallons of AFFF occurred in Hangar 11 which drains to the current WWTP potentially resulting in PFAS-contamination of the biosolids (Engineering Technician, 2017, pers. comm.; **Appendix B**). Additional biosolid contamination may have

Any AFFF or PFAS-contaminated wastes or biosolids disposed of or composted at Area 6 would have likely leached through the vadose zone into the groundwater. Apparent groundwater flow at Area 6 is generally to the south towards Oak Harbor (**Figure 4-6**). However, there is a potential groundwater divide north of Area 6 that may direct water discharged from the Navy's groundwater treatment plant north towards Clover Valley Stream. Depth to the surficial aquifer at this location is assumed to be 5 to 20 feet bgs. Groundwater at Ault Field is not used as a drinking water source; therefore, there is no current exposure pathway for groundwater to on-Base residents or workers through drinking water. There are 630 private and/or community water wells within 4 miles, 7 of which have concentrations of PFOS or PFOA above the LHA (**Section 2.3**). Two of the seven wells with exceedances are located 1.4 miles to the north and 2.3 miles to the west, while five of the wells are grouped in relatively small cluster 0.8 mile to the southwest. The groundwater flow direction between this location and the water wells is not entirely known, which presents a potential exposure pathway for off-Base residents (CH2M, 2017b).

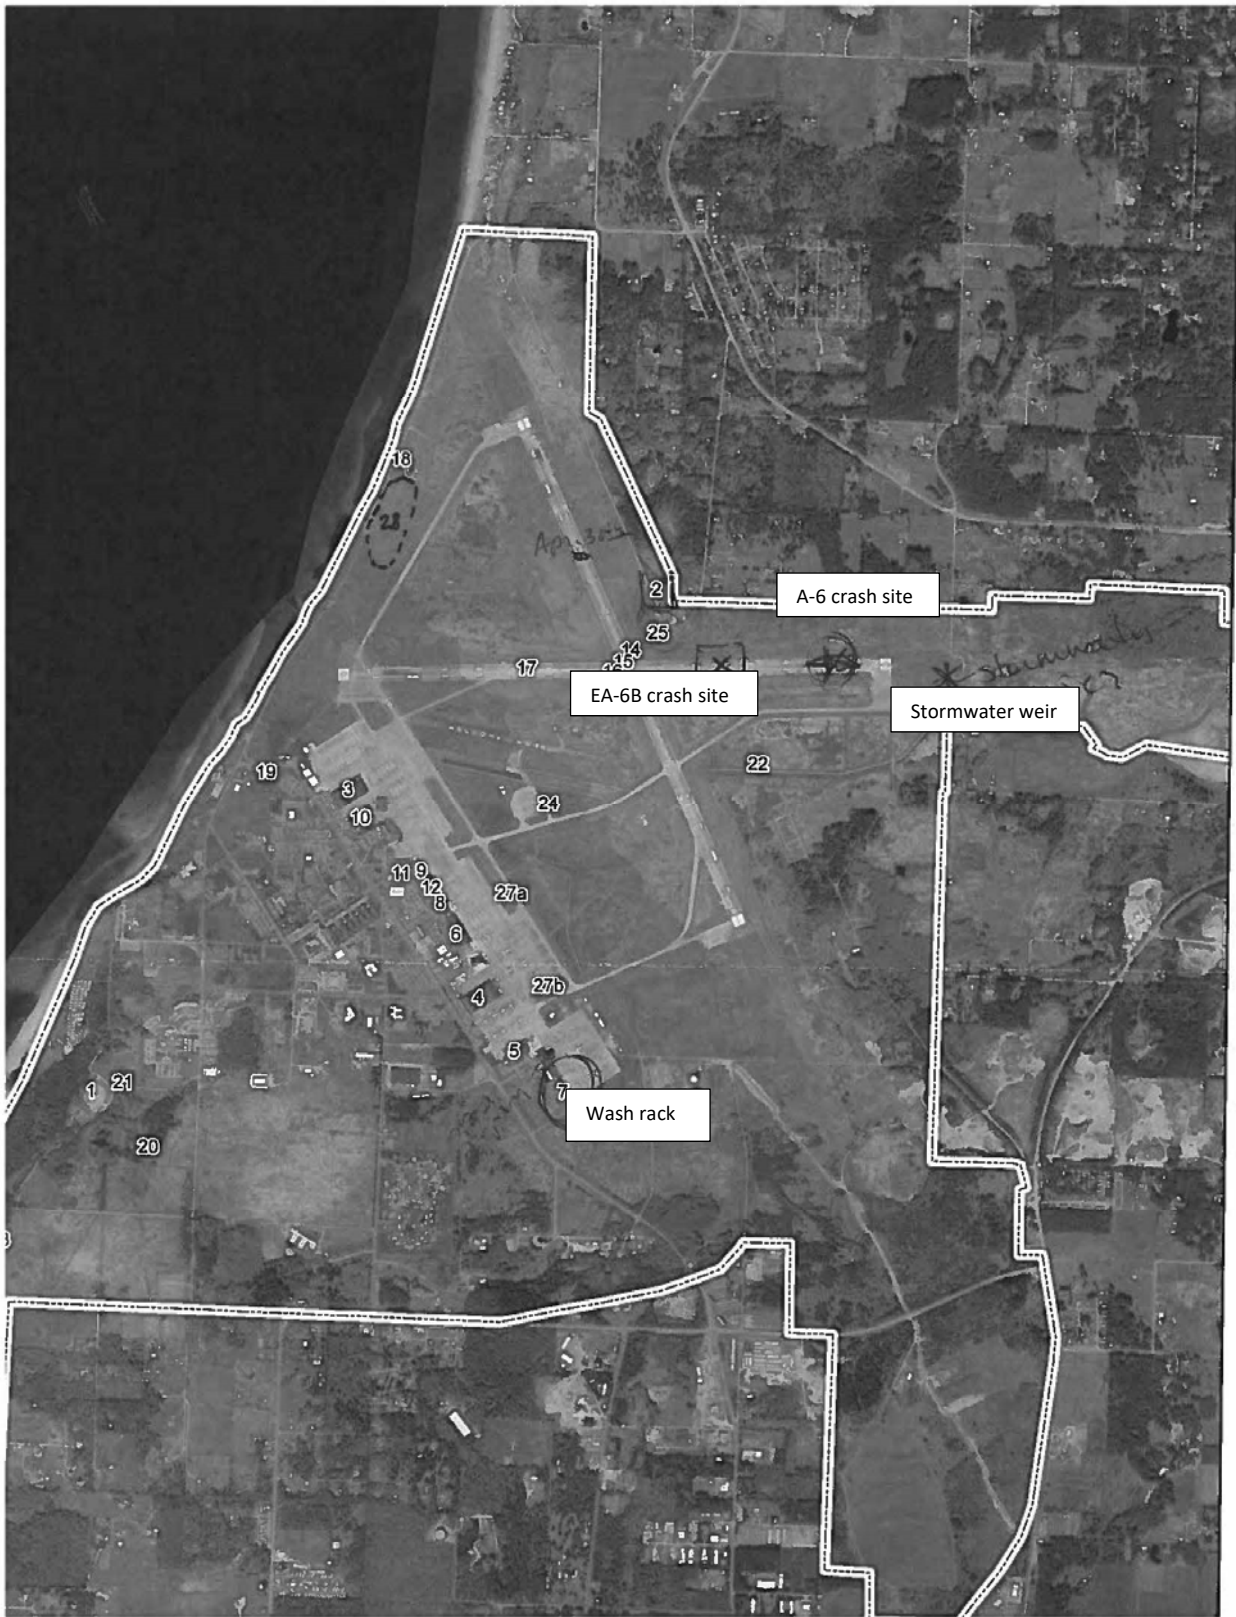
Figure 1
Ault Field

Mr. Hornsby recalled that the P3A crash occurred farther north at Runway 13-31 than what was presented on the figure (location #15 on Figure 1).	
Mr. Hornsby stated the Fire Department logbooks could be a source for crash information, which may include Aircraft Incident Reports. Mr. Hornsby said Allen Sprouse ² , the Fire Inspector at the Fire Station, has access to the logbooks. Those records could be available from Aviation Safety or AirOps, and may include the volume of aqueous film forming foam (AFFF) used when the crashes occurred.

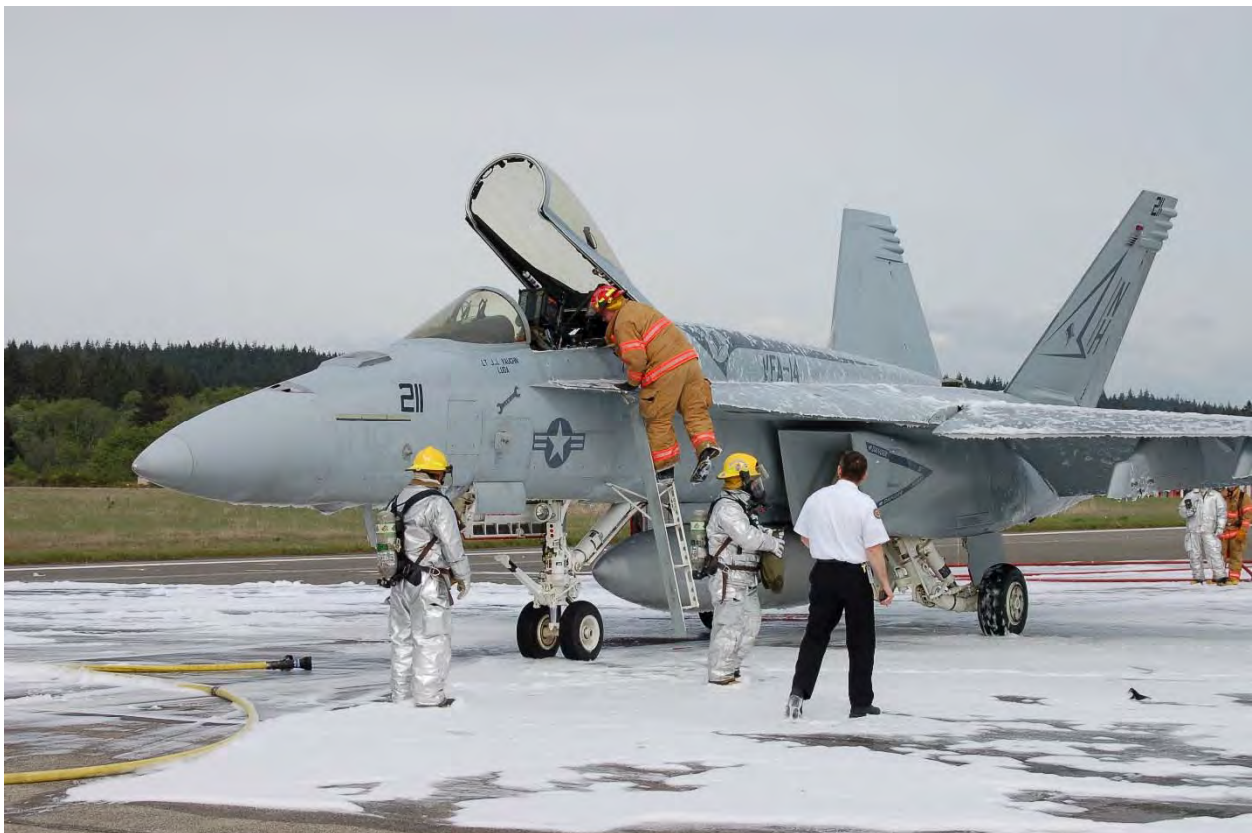
Figure 1
Ault Field

Mr. Prince confirmed the locations of the two hotpits, but during his time as a firefighter, he said that, to his knowledge, no foam was used at either location.	
Mr. Prince provided a photo of an F-18 plane crash and the approximate location (Figures 1 and 2) at the north end of Runway 13-31 at approximately the 2,000-foot marker on 30 April 2006. Mr. Prince was the firefighter who responded, and applied AFFF to three portions of the F-18, over the nose of the F-18, the tail, and on a burning fuel hose. He recalled that each of the three applications of AFFF lasted approximately 3 to 5 seconds. The quantity of AFFF used to put out the fire was unknown, but Mr. Prince recalls that 80 to 90 percent of the water was left in the truck tank. Mr. Prince stated that runoff of AFFF was controlled with

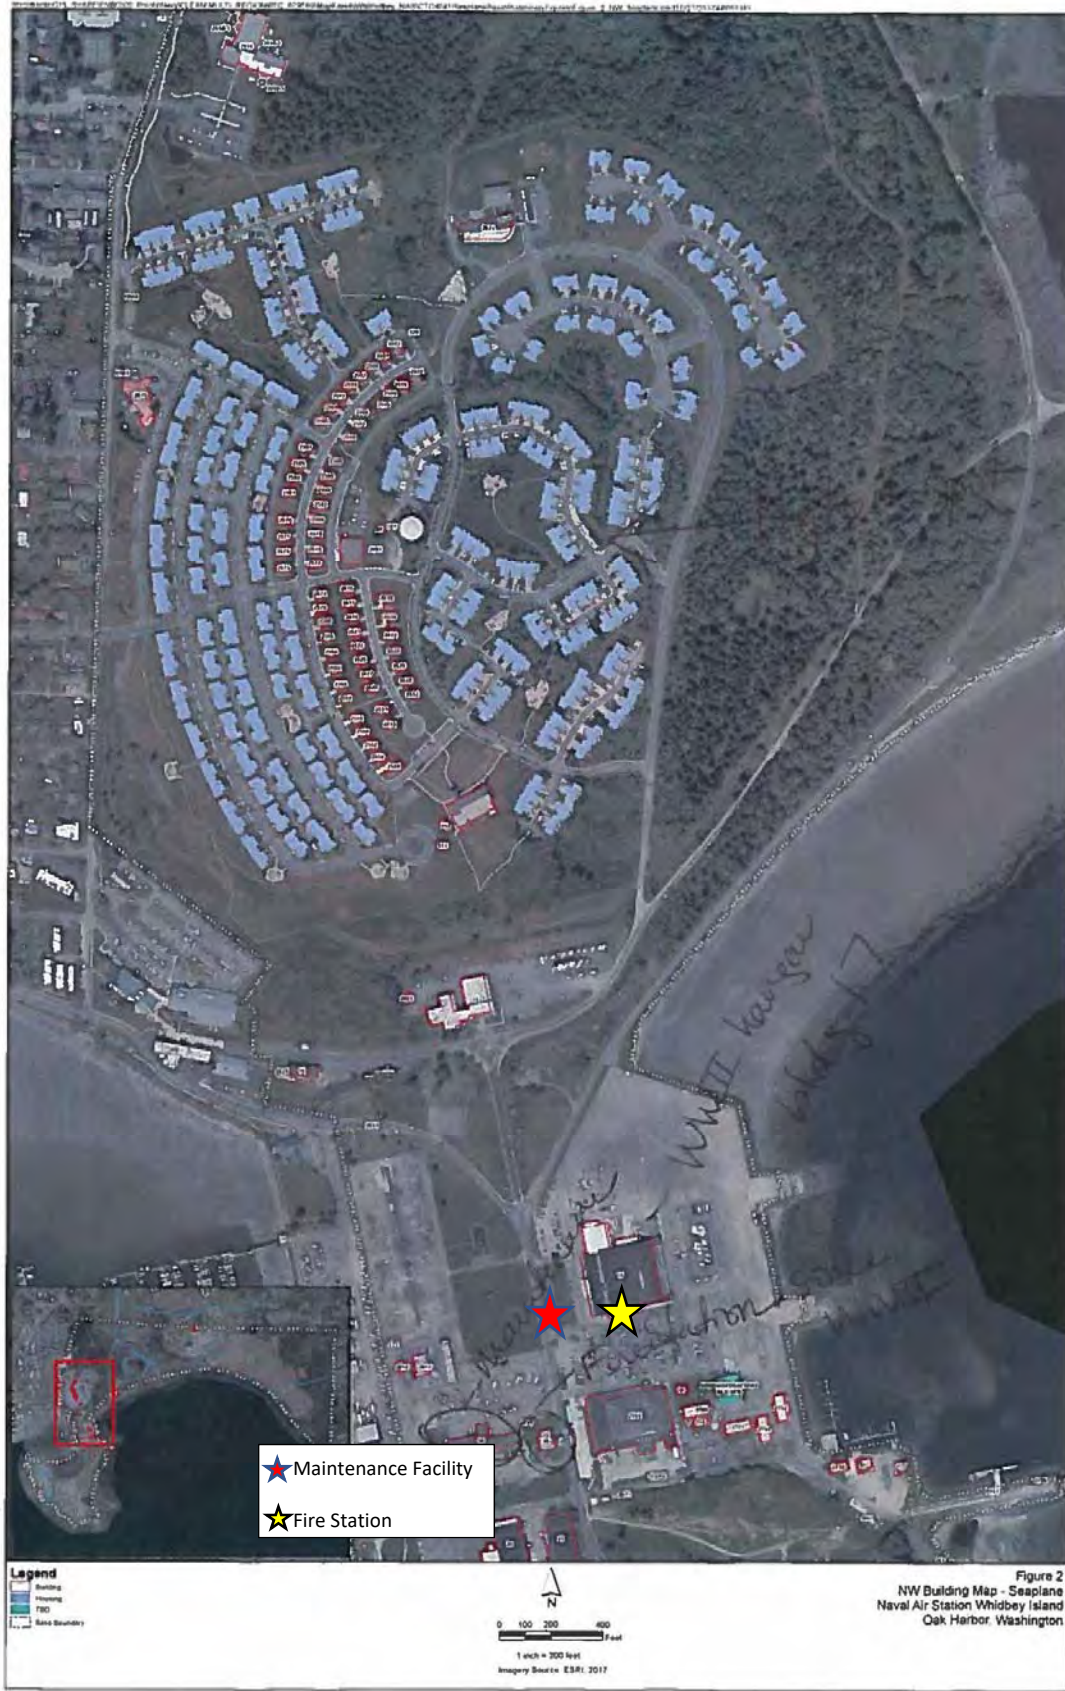
Figure 3
Seaplane Base

Mr. Prince confirmed that the Fire Station and adjacent maintenance facility at Seaplane Base have been in the same locations since World War II. Mr. Prince circled the location of both **(Figure 3)**.
