**Preliminary Assessment for
Per- and Polyfluoroalkyl Substances (PFAS) Ault Field**

Naval Air Station Whidbey Island
Oak Harbor, Washington

November 2018

Prepared for NAVFAC Northwest
by CH2M HILL, Inc.
Bellevue, Washington
Contract N62470-16-D-9000
CTO 4041

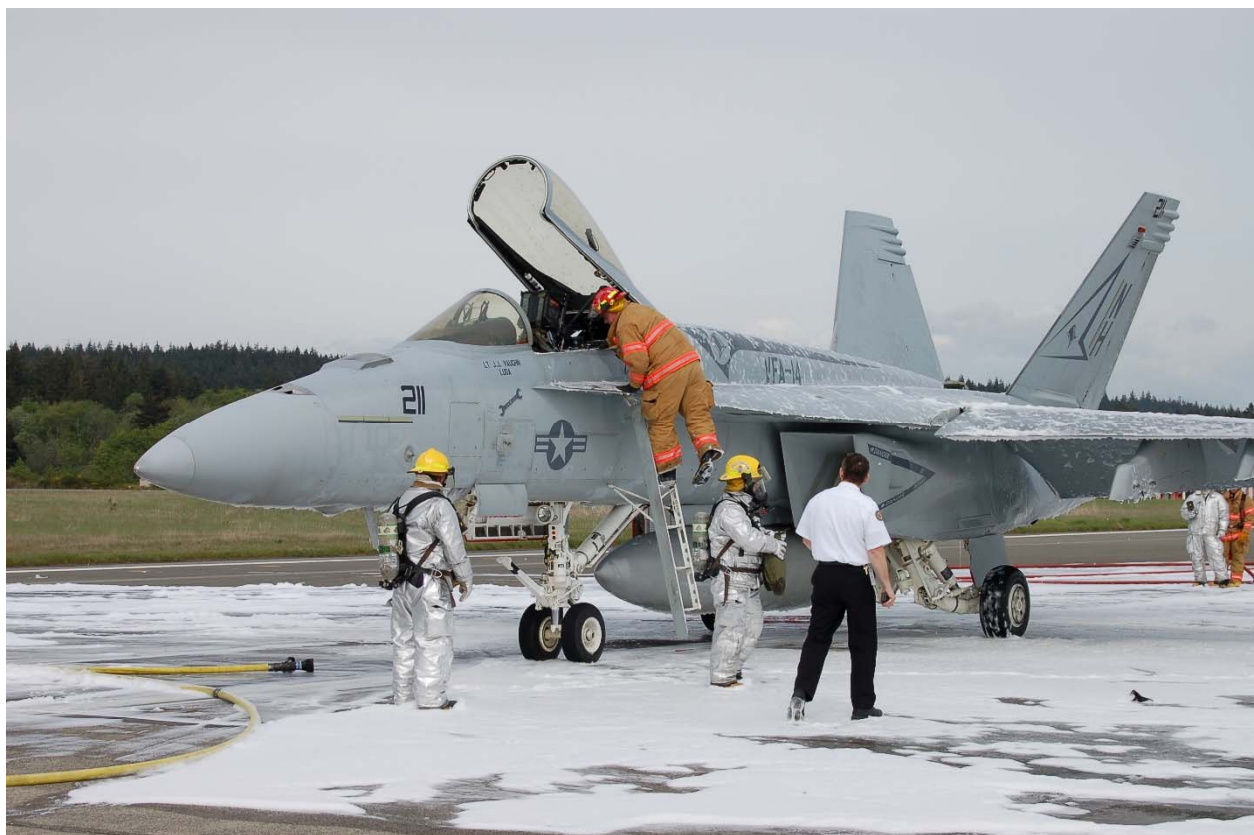
Figure 1
Ault Field

Mr. Prince confirmed the locations of the two hotpits, but during his time as a firefighter, he said that, to his knowledge, no foam was used at either location.	
Mr. Prince provided a photo of an F-18 plane crash and the approximate location (Figures 1 and 2) at the north end of Runway 13-31 at approximately the 2,000-foot marker on 30 April 2006. Mr. Prince was the firefighter who responded, and applied AFFF to three portions of the F-18, over the nose of the F-18, the tail, and on a burning fuel hose. He recalled that each of the three applications of AFFF lasted approximately 3 to 5 seconds. The quantity of AFFF used to put out the fire was unknown, but Mr. Prince recalls that 80 to 90 percent of the water was left in the truck tank. Mr. Prince stated that runoff of AFFF was controlled with

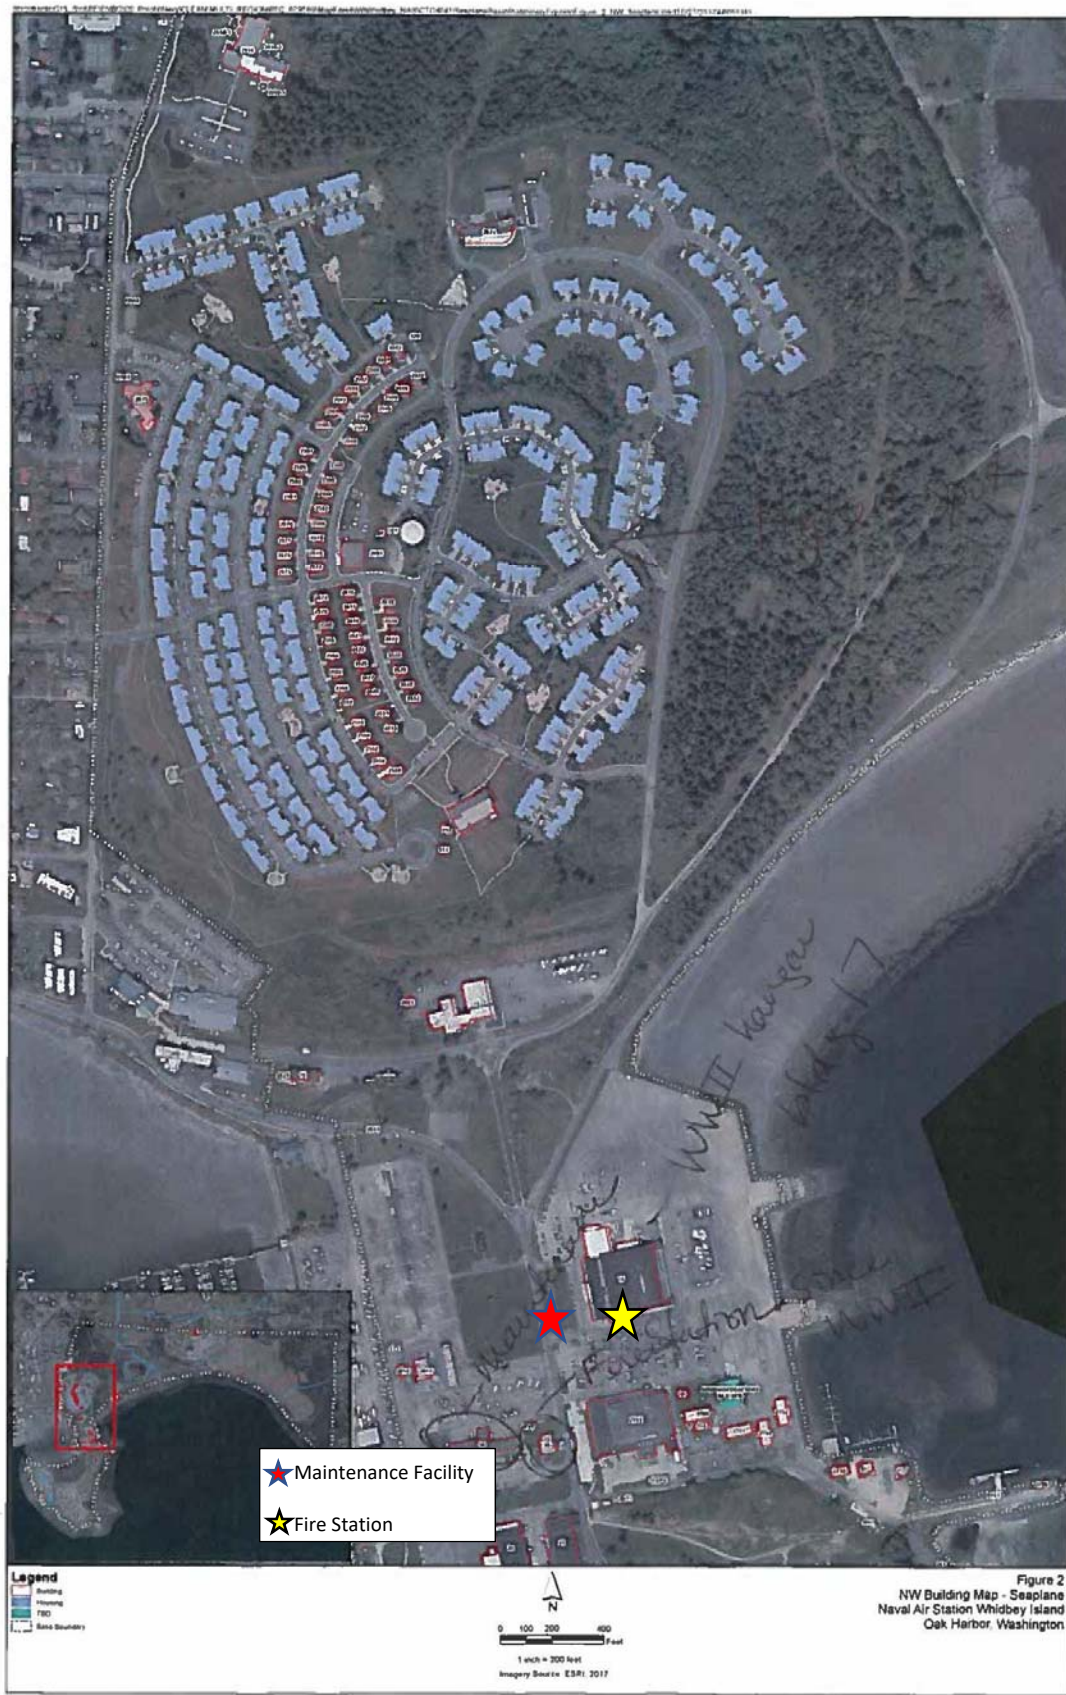
Figure 3
 Seaplane Base

Mr. Prince stated that presently there is AFFF stored in the caged area at the current Fire Station at Ault Field.
Mr. Prince verified that the current Ault Field Fire Station (Building 2897) is built on the same footprint as the former Fire Station. The demolition and new construction of the Fire Station took 2 to 3 years to complete, and a portion of the former Fire Station concrete slab still exists at the new Fire Station.
Mr. Prince stated that all fire training activities for Ault Field, Seaplane Base, and OLF Coupeville have occurred at Ault Field at either the Runway Fire School (Area 31), or the current FTA.
Mr. Prince confirmed that the Fire Station and adjacent maintenance facility at Seaplane Base have been in the same locations since World War II. Mr. Prince circled the location of both (Figure 3) .
Mr. Prince stated the only AFFF stored at Seaplane Base is in the fire trucks.

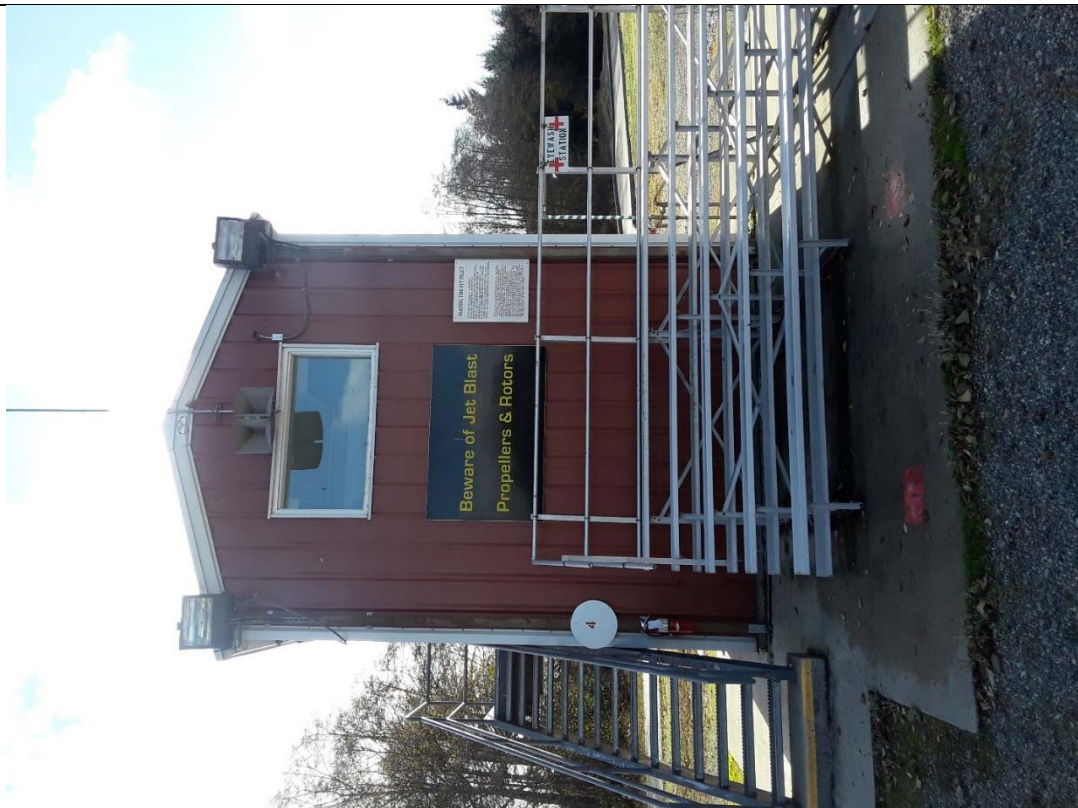
-Control tower for fire training area (facing southeast)

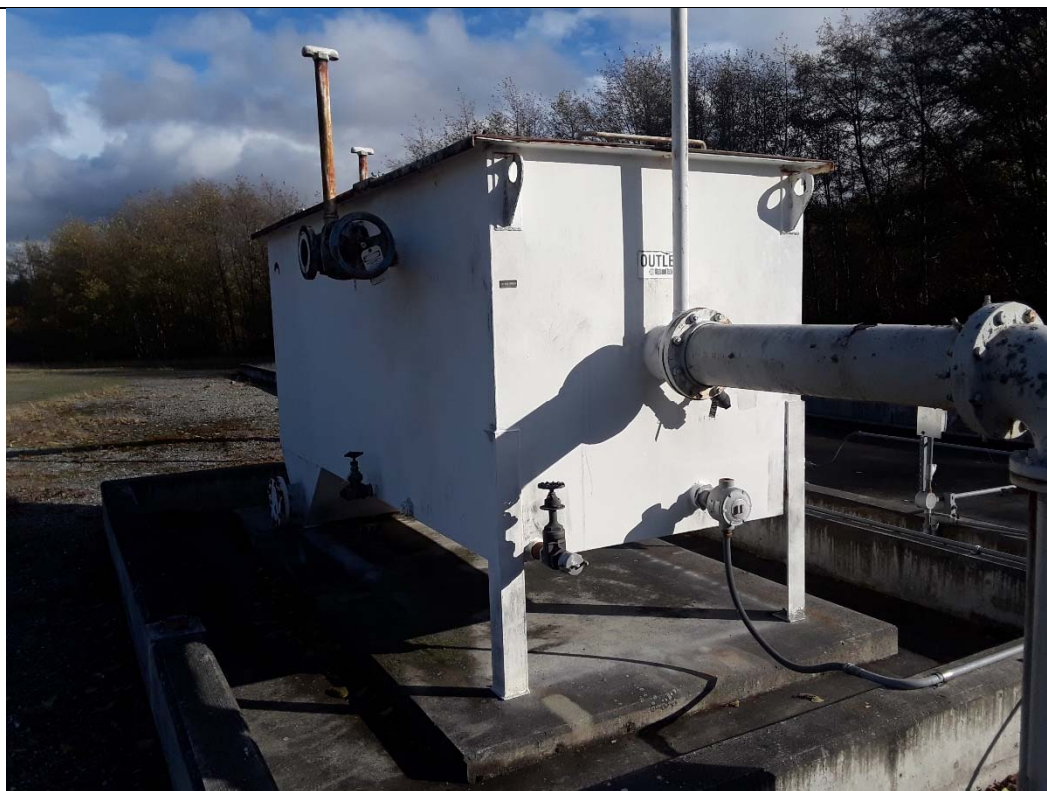
-Aboveground oil/water separator (facing southeast)

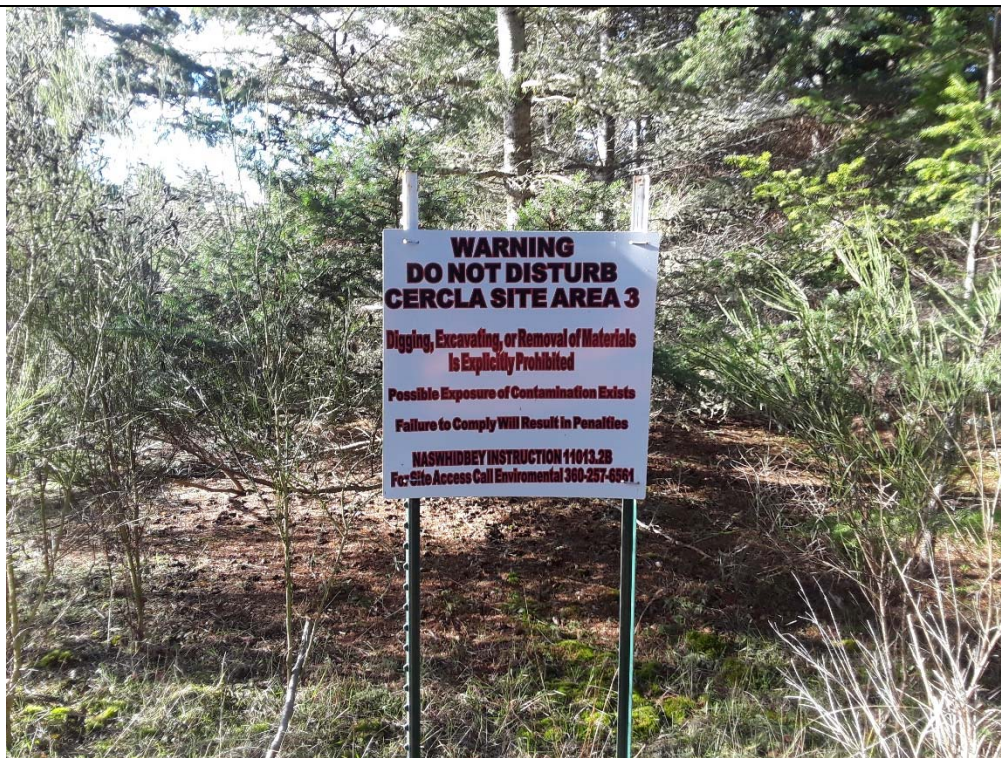
<p>-Area 3 (facing the southwest)</p>
1300	-Depart with Charlie and Steve and head to Badge and ID office to pick up DBIDS pass
1430	-Receive DBIDS pass
