Third Five-Year Review

Naval Base Kitsap Bangor

Silverdale, Washington

Department of the Navy Naval Facilities Engineering Command Northwest 1101 Tautog Circle Silverdale, WA 98315

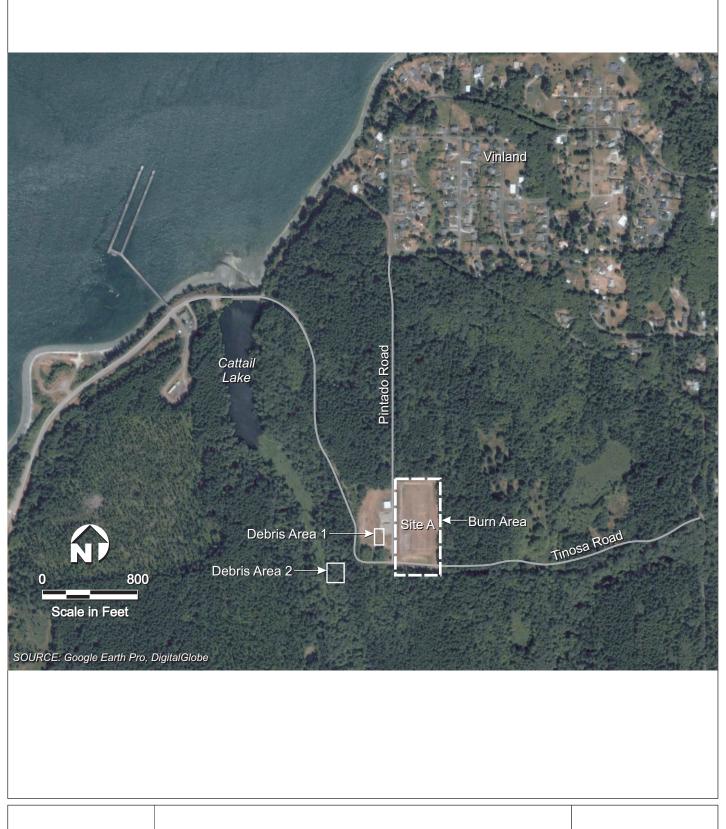
Figure 3-1 Site A Location Map

The 12-acre Bangor Ordnance Disposal site (Site A) is located in the northern portion of NBK Bangor. Land use immediately adjacent to the site is undeveloped forest land, with Cattail Lake downhill to the west and the off-base community of Vinland located approximately 2,000 feet to the north. Hood Canal, which borders NBK Bangor, is located to the west of Site A, Vinland, and Cattail Lake (Figure 3-1, located at the end of Section 3).

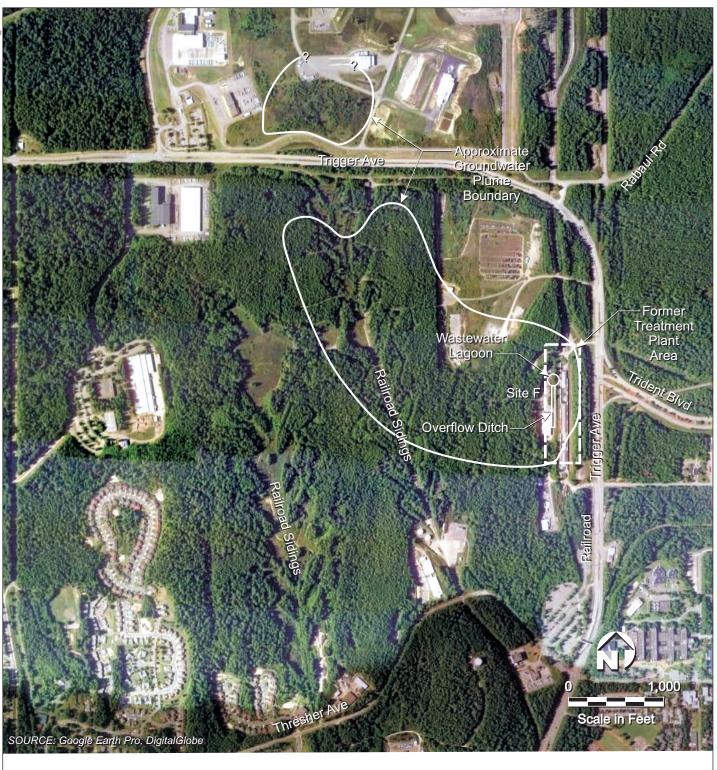
Figure 3-2 Site F Location Map

Site F (Figure 3-2, located at the end of Section 3), a former wastewater lagoon and overflow ditch, was used between approximately 1960 and 1970 for the disposal of wastewater produced during the demilitarization (demil) of ordnance items in the adjacent segregation facility building. Between approximately 1957 and 1978, the segregation facility's primary function was demil of ordnance items using steam cleaning and/or steam melt-out procedures. Prior to 1972, wastewater from the demil process was discharged into an unlined wastewater lagoon. The wastewater contained relatively high concentrations of TNT and RDX and lower concentrations of other explosive compounds. Much of the wastewater apparently infiltrated through the lagoon bottom. During periods of heavy discharge, wastewater overflowed the lagoon to a narrow ditch south of the lagoon. Periodically, the wastewater lagoon was allowed to drain, and waste materials at the surface of the lagoon were "burned off" in place or transported to Site A for burning and disposal. Beginning in 1972 to 1973, the lagoon was taken out of service and the wastewater was collected into barrels and delivered to the base liquid-waste incinerator (Sites 16/24).

5.	Figure 3-2 – The aerial photo base for this map should be shifted north to encompass the entire downgradient plume.	The photo base will be shifted as suggested.

15.	Page 4-13, line18 – It's not clear how off-site is defined here. Is it anywhere outside the Site F box shown on Figure 3-2 and the plume as currently defined (including downgradient)?	The term "off-site" will be replaced with "further downgradient."

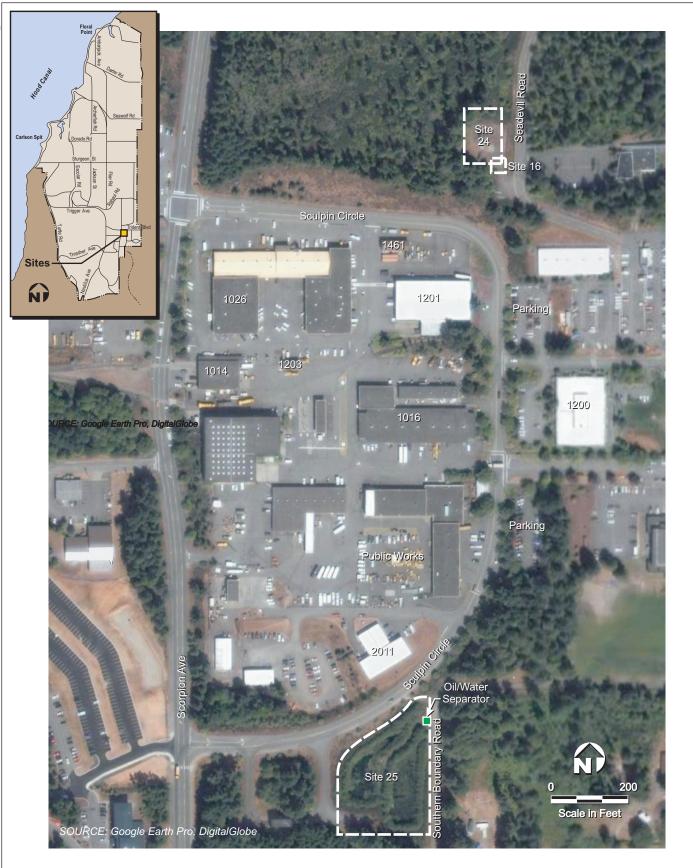
Figure 3-3 OU 3, Sites 16/24 and 25 Location Map

OU 3, located in the southeastern portion of the base, consists of Sites 16, 24, and 25 (Figure 3-3, located at the end of Section 3). Sites 16 and 24 are the locations of former solid- and liquid-waste incinerators and a drum storage area. Because of their proximity, they are addressed together as Sites 16/24. Between 1973 and 1983, the liquid-waste incinerator reportedly burned demil wastewater from Site F, Otto fuel wastewater, and waste solvents. The solid-waste unit burned solid waste, including rags, sawdust, and protective clothing and carbon filters contaminated with Otto fuel. Both incinerators were deactivated and removed in 1983. Site 25, downgradient of Sites 16/24, is the location of a former sewage treatment plant outfall from the base's industrial area. Site 25 has since been regraded and currently consists of two stormwater detention ponds that discharge to Clear Creek.

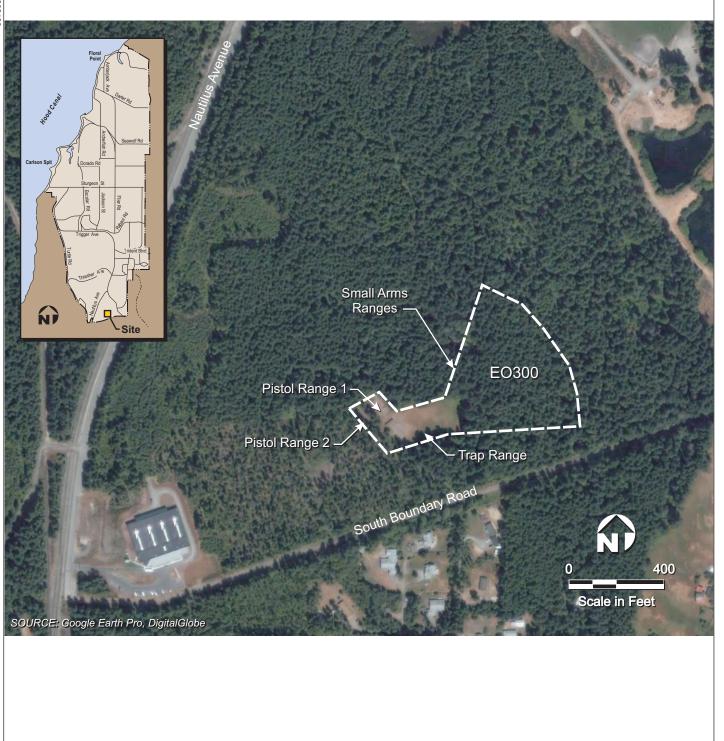
Figure 3-15 Site EO300 Location Map

EO300 comprises two former pistol ranges and a skeet range (Figure 3-15, located at the end of Section 3). Soil sampling was conducted in 2008. Lead was identified in soil at concentrations exceeding the MTCA Method A cleanup level for unrestricted land use of 250 mg/kg. An RI/FS was initiated based on the preliminary soil sampling results. However, the site was identified as a high recreational use area and a time-critical removal action was planned for the pistol range (U.S. Navy 2009e). The RI/FS was temporarily suspended. Additional sampling was conducted during the time-critical removal action. The time-critical removal action has been completed and a completion report is pending. The RI/FS is scheduled to be finalized during September 2010 (U.S. Navy 2010b).

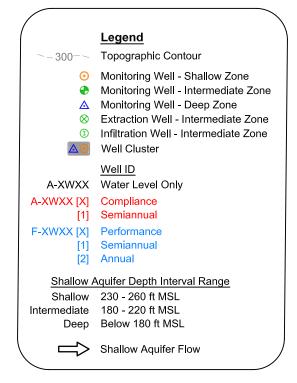
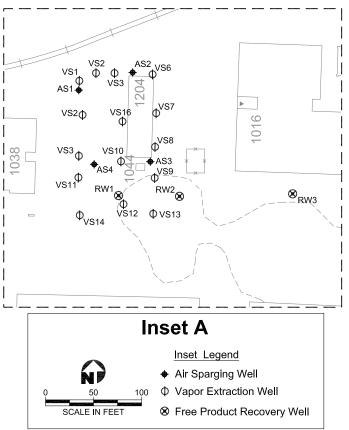
Figure 4-4 Operable Unit 8 Compliance and Performance Monitoring Well Network

The Navy began the LNAPL removal component of the OU 8 remedy in January 2001, when a passive LNAPL skimming pilot test was conducted. Passive skimmers were installed in wells VS2, VS7, VS8, VS10, VS12, MW05, and 8MW49 (Figure 4-4, located at the end of Section 4) and serviced at 1- to 3-day intervals over a 16-day period. LNAPL was also bailed from the wells with the greatest LNAPL thickness (including VS4, in which a skimmer could not be installed because of a constriction near the top of the well casing). Nearly 15 gallons of LNAPL were recovered during the pilot test, 9 by bailing and 6 by skimming (U.S. Navy 2001c).

MNA monitoring was initially conducted quarterly, with the frequency decreased to semiannually after November 2001. The monitoring well network is shown on Figure 4-4, located at the end of Section 4. Table 4-4 (located at the end of Section 4) summarizes the planned versus actual monitoring program from 2005 through 2009. Table 4-4 shows that the MNA monitoring plans have been successfully implemented.

16.	Page 4-31, line 13 – A figure showing the location of the VS wells would be helpful, perhaps as an inset on Figure 4-4.	A figuring showing the location of the VS wells will be added as requested.

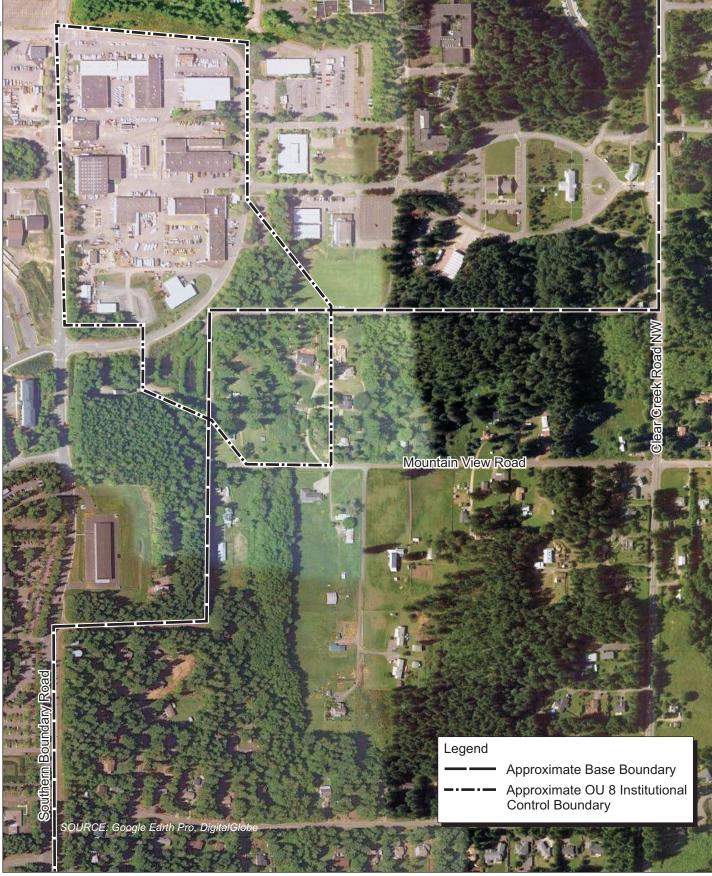
Figure 4-5 OU 8 Institutional Control Boundary

ICs are part of the remedy at OU 8. The ICMP for NBK Bangor was updated in 2007 (U.S. Navy 2007d). Restricted media, ICs, and engineering controls are summarized in Table 4-2 (located at the end of Section 4) and the OU 8 IC boundary is shown on Figure 4-5 (located at the end of Section 4).

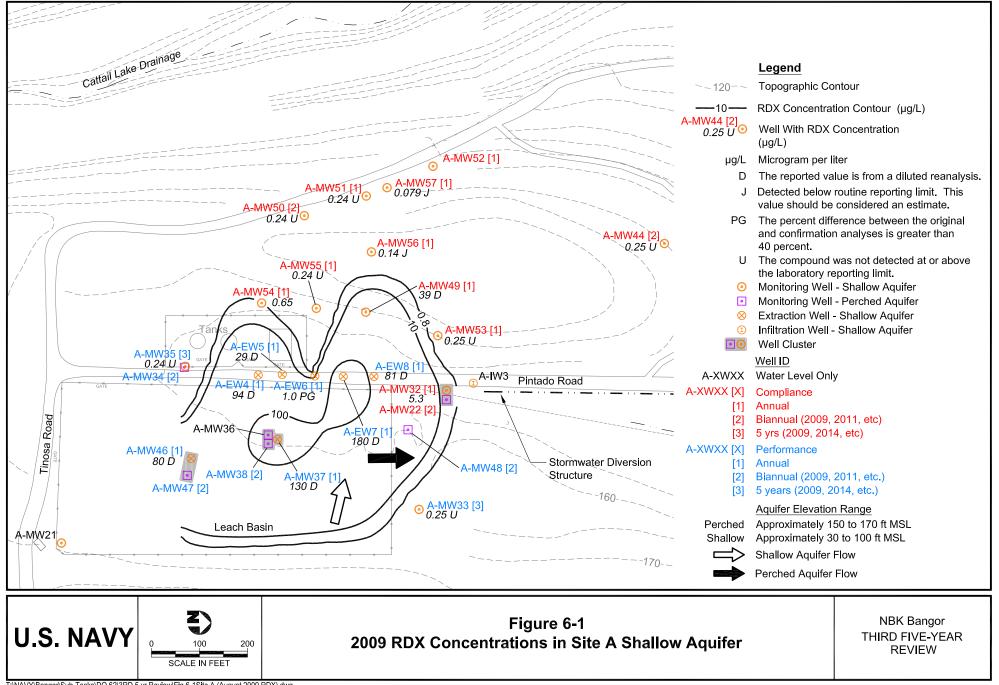
T:\NAVY\Bangon'Sub-Tasks\DO 62\3RD 5 yr Review\Fig 6-1Site A (August 2009 RDX).dwg Mod: 04/01/2010, 13:47 | Plotted: 04/02/2010, 14:12 | john_knobbs

No.	Comments	Responses
	location relative to gradient is even less relevant. I would rewrite this sentence to say: "The highest August 2009 monitoring well RDX concentration in the perched zone was in A-MW48, located just north of the Burn Area; in the shallow aquifer it was in A- MW49, located approximately 140 feet downgradient of A-EW-7 (Figure 6-1). There are no shallow aquifer monitoring wells located within the Burn Area."

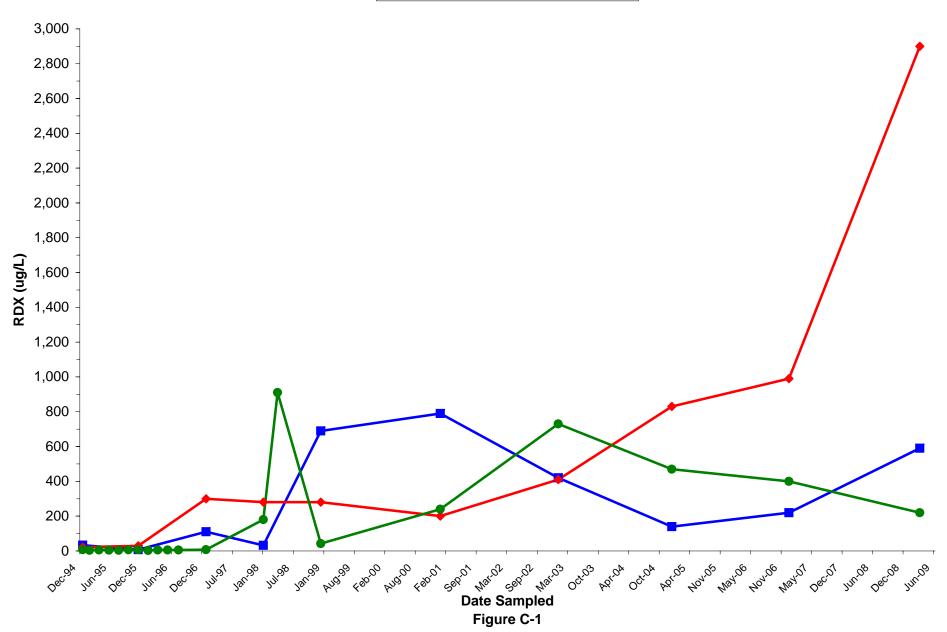
RDX Concentration in Selected Wells, Site F, OU 2
