# Fourth Five-Year Review

## Naval Base Kitsap

Keyport, Washington

**Department of the Navy**

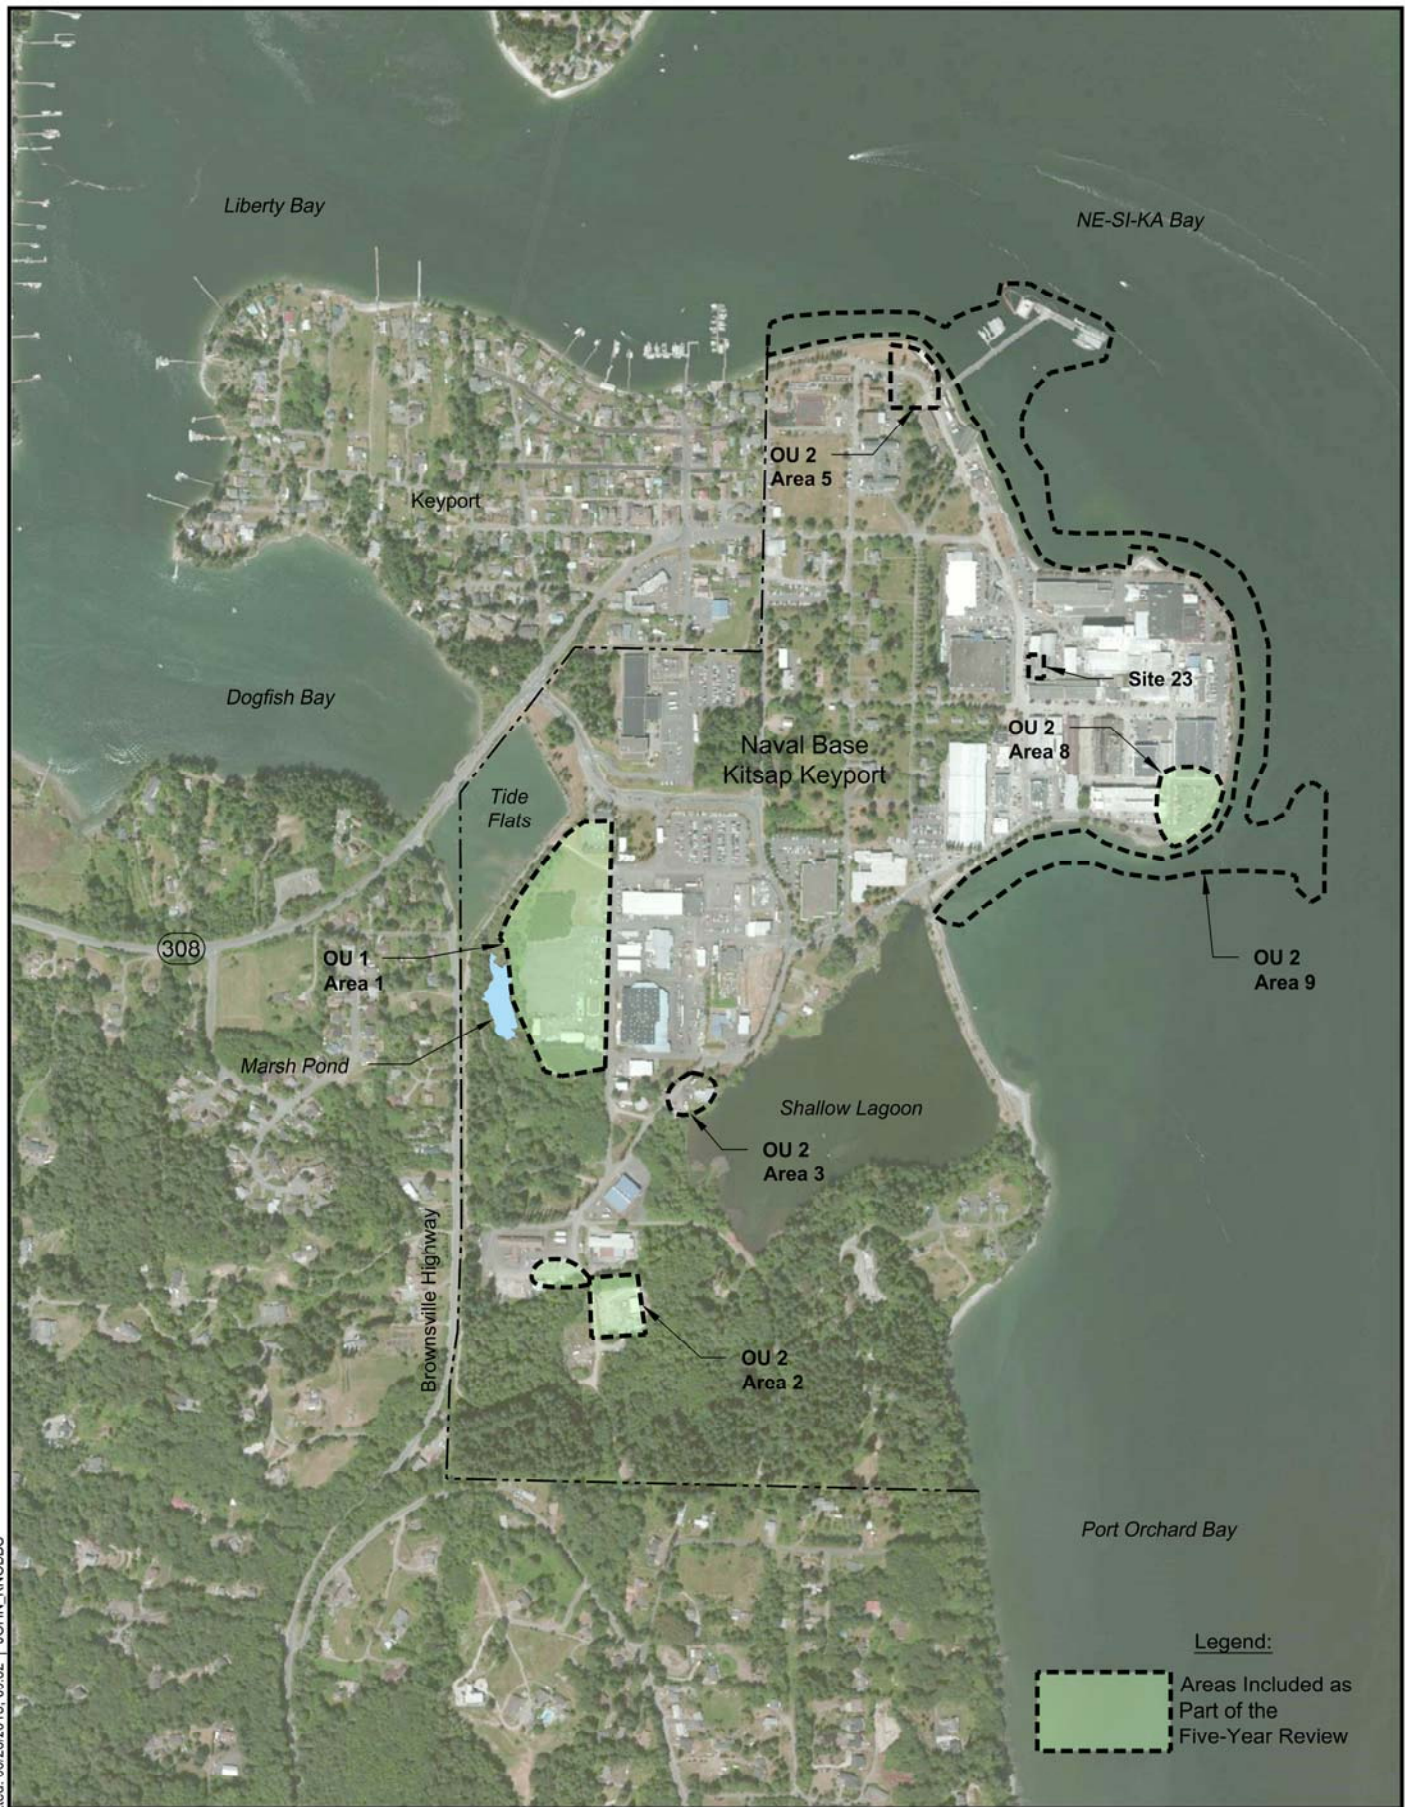
**Figure 2-1**  
**Locations of OU 1, OU 2,**  
**and Site 23 Areas**

This section summarizes dates of major events such as the initial discovery of contamination, National Priorities List listing, decision and enforcement documents, remedial and removal actions, construction completion, and prior 5-year reviews for Area 1 at OU 1, Areas 2 and 8 at OU 2, and Site 23 (Figure 2-1). Figure 2-2 illustrates the substantive events in the chronology of NBK Keyport. Additional text is provided in the third 5-year review included in Appendix A, and all 5-year review documents are available on the EPA website <http://cumulis.epa.gov/supercpad/cursites/csitinfo.cfm?id=1001102>. Post-ROD activities at the site are described in Sections 4 and 6 of this report.

Area 2 is located in the southwest corner of NBK Keyport (Figure 2-1). It is bounded to the north and east by Westfall Road, to the west by Keys Road, and to the south by a sharp topographic rise. Van Meter Road essentially bisects the area in a north-south direction. Area 2 is composed of three distinct sites: the Van Meter Road spill area, the former Building 734 drum storage area just west of Van Meter Road, and former Building 957 drum storage area immediately east of Van Meter Road (Figure 3-5). Land use is as a military installation, and public access is restricted. Currently the site is used for inert materials storage and intermittently for industrial purposes.

Area 8 occupies about 1 acre on the eastern portion of NBK Keyport and surrounds the location of the former plating shop (Building 72) (Figures 2-1 and 3-8). Building 72 was demolished in 1999 and replaced by an asphalt-paved parking area. The site is located in a heavily industrialized part of the facility bordered by Liberty Bay to the south and east (Figure 3-8). The area is predominantly flat and almost entirely paved or covered by buildings. Land use is as a military installation, and public access is restricted. The area is used for parking and has occupied buildings with office space and industrial uses.

Site 23 (Figure 2-1) includes former Building 21 and the immediate surrounding area, which was located in the industrial area of Naval Undersea Warfare Center Keyport west of remaining Building 15. Building 21, constructed in the 1940s, had been used to store lubricating oil and housed a filtering system for petroleum-based machining coolants. Immediately east of Building 21 was an enclosed wash rack that had two 2,000-gallon tanks for collecting and storing waste lubricants and rinsate from the cleaning of equipment. Immediately north of Building 21 and the wash rack was an open canopy under which was equipment used to shred scrap metals and separate machining oil from the metals. There were also unconfirmed reports that drums containing unspecified materials had been buried around Building 21. In June 1998, a limited field investigation identified the presence of oil and diesel-range TPH in excess of MTCA cleanup levels adjacent to and under Building 21.
